Monitoring Surveys at the
Field Verification Program (FVP)
Disposal Site in 1985

Disposal Area Monitoring System DAMOS

Contribution 52
August 1988

Report No.
SAIC- 87/7512&C62

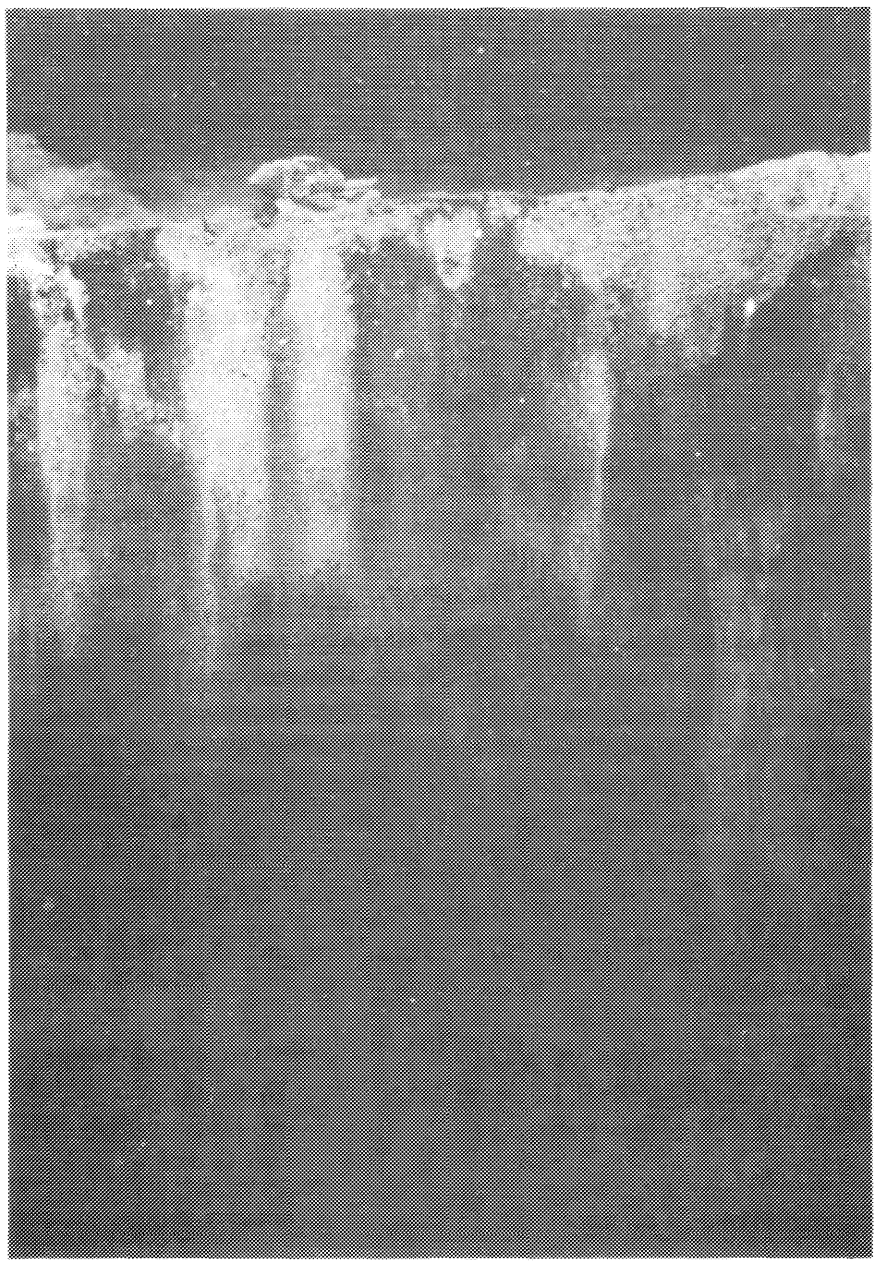
In June, approximately 80% of the FVP REMOTS® photos exhibited patches of reduced sediment and/or reduced mud clasts at or near the sediment-water interface. This material seemed to represent locally eroded Black Rock sediment which had recently been redistributed over the site as far as 1000E and 1000W. This material was not observed at CLIS-REF, and it had not been observed in previous FVP surveys. In the October survey, approximately 50% of the FVP images showed patches of reduced material at the interface (Figures 3-2 and 3-3). As in June, this material was distributed within the entire survey grid at the FVP site (Figure 3-1); moreover, reduced sediments were evident at the interface in two of the twenty CLIS-REF images

Figure 3-3. A REMOTS image from station 200S showing patches of reduced sediment at the sediment-water interface. Also, note the mudclasts in the background at left edge of image. Scale = 1X.

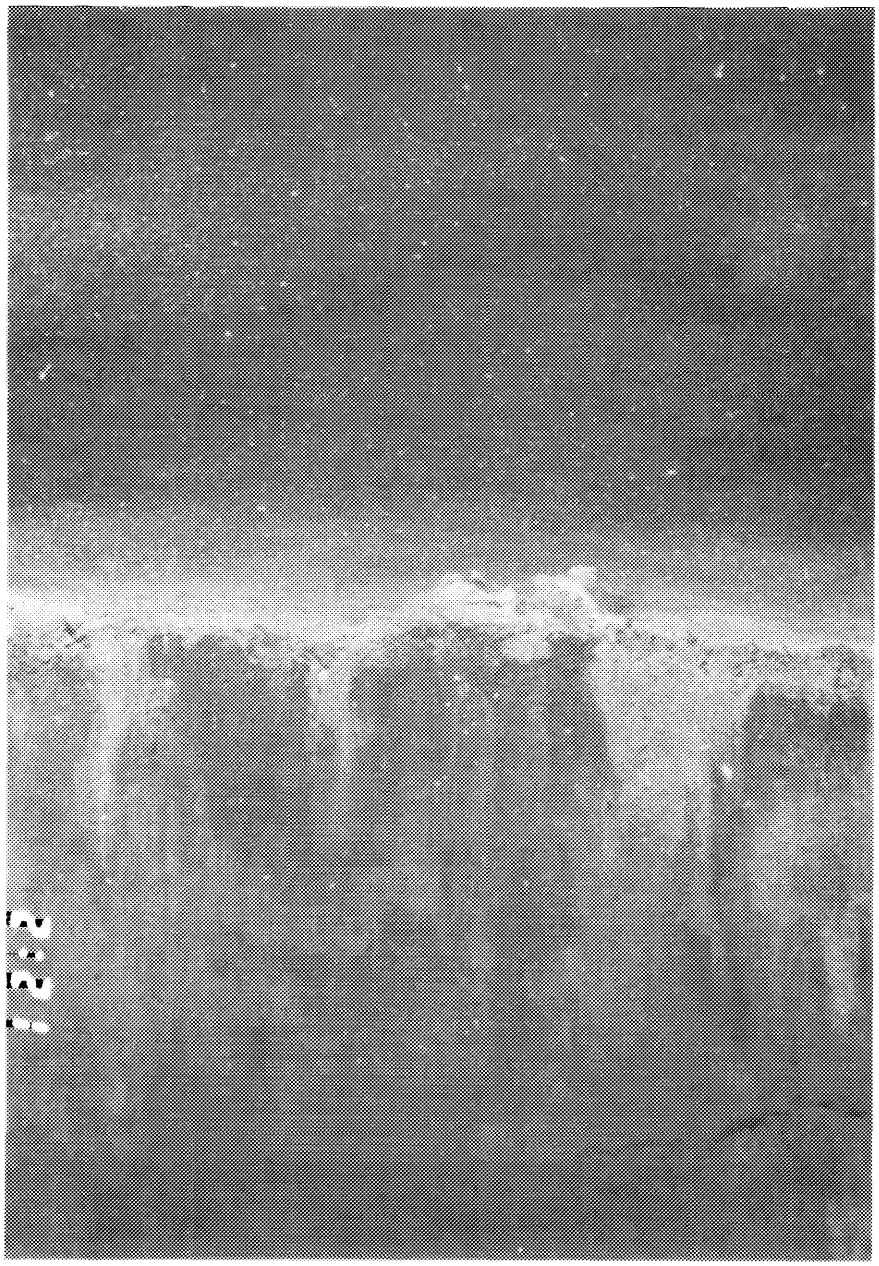
(Figure 3-4). The wide-spread distribution of reduced material suggests recent local erosion on a much broader scale, an apparent result of Hurricane Gloria.

Figure 3-4. A REMOTS image from the CLIS-reference site showing reduced sediments near the interface. Mudclasts are also evident in the center of the image. Scale = 1X.

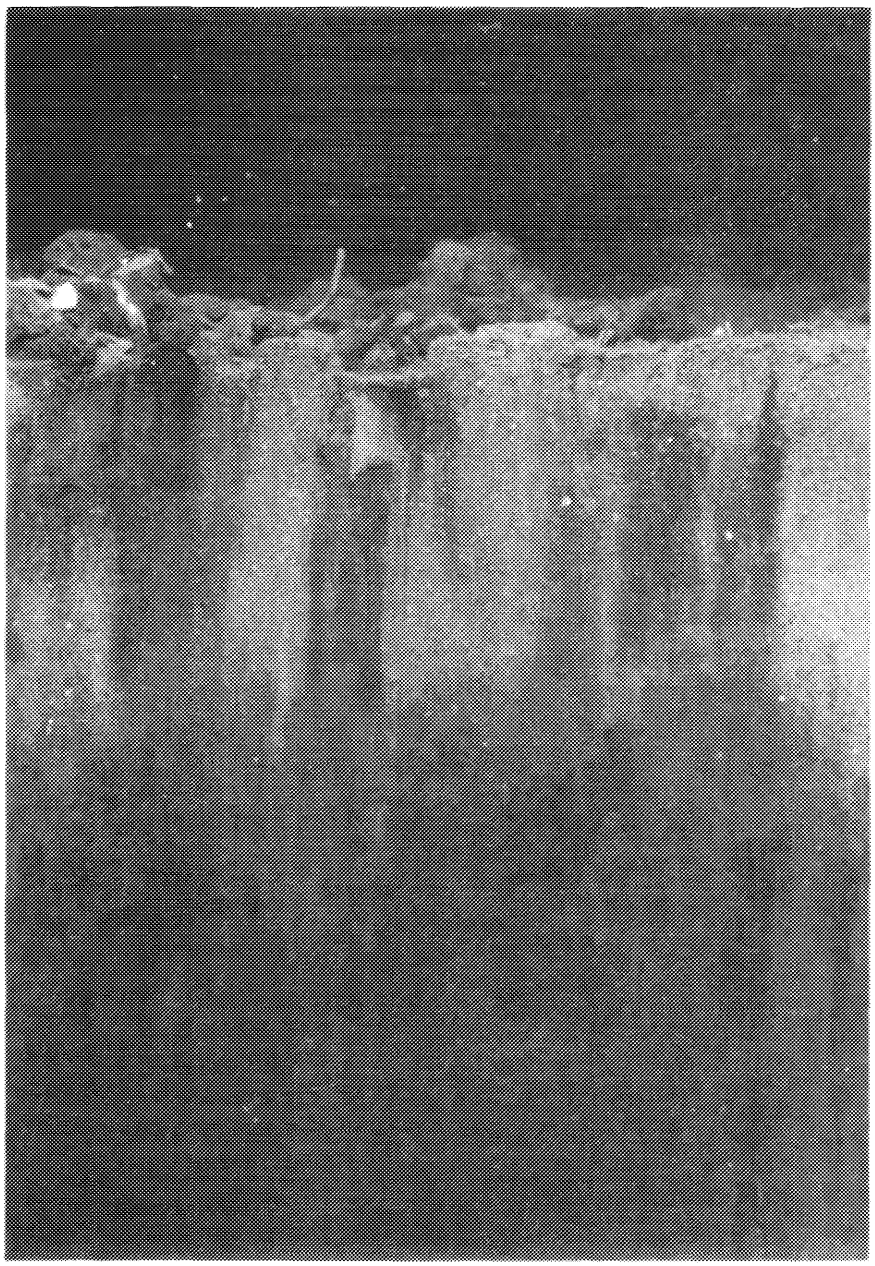
The frequency distributions of boundary roughness values for the dredged material mound, edge and ambient stations, and the CLIS-REF site were similar for all three areas, with the major mode for small-scale topographic relief being 0.8 cm (Figure 3-5). Boundary roughness values have increased significantly in all three areas since the June survey (Mann-Whitney U-tests, $p < 0.05$; Figure 3-6). This represents the first change in small-scale topographic relief at the site since December 1984. Both seasonal changes in the rates of biogenic reworking and physically-induced surface erosional and depositional events can result in changes in boundary roughness. The boundary roughness observed in this survey appeared to be physically induced; again, it was apparently related to the influence of Hurricane Gloria. Many images revealed erosional features such as mud clasts and exposed worm tubes (Figure 3-7).

Figure 3-7. A REMOTS image from station 200S/300E showing evidence of erosion. Reduced and oxidized mud clasts litter the surface and an exposed worm tube is present in the center of the image. Scale = 1X.

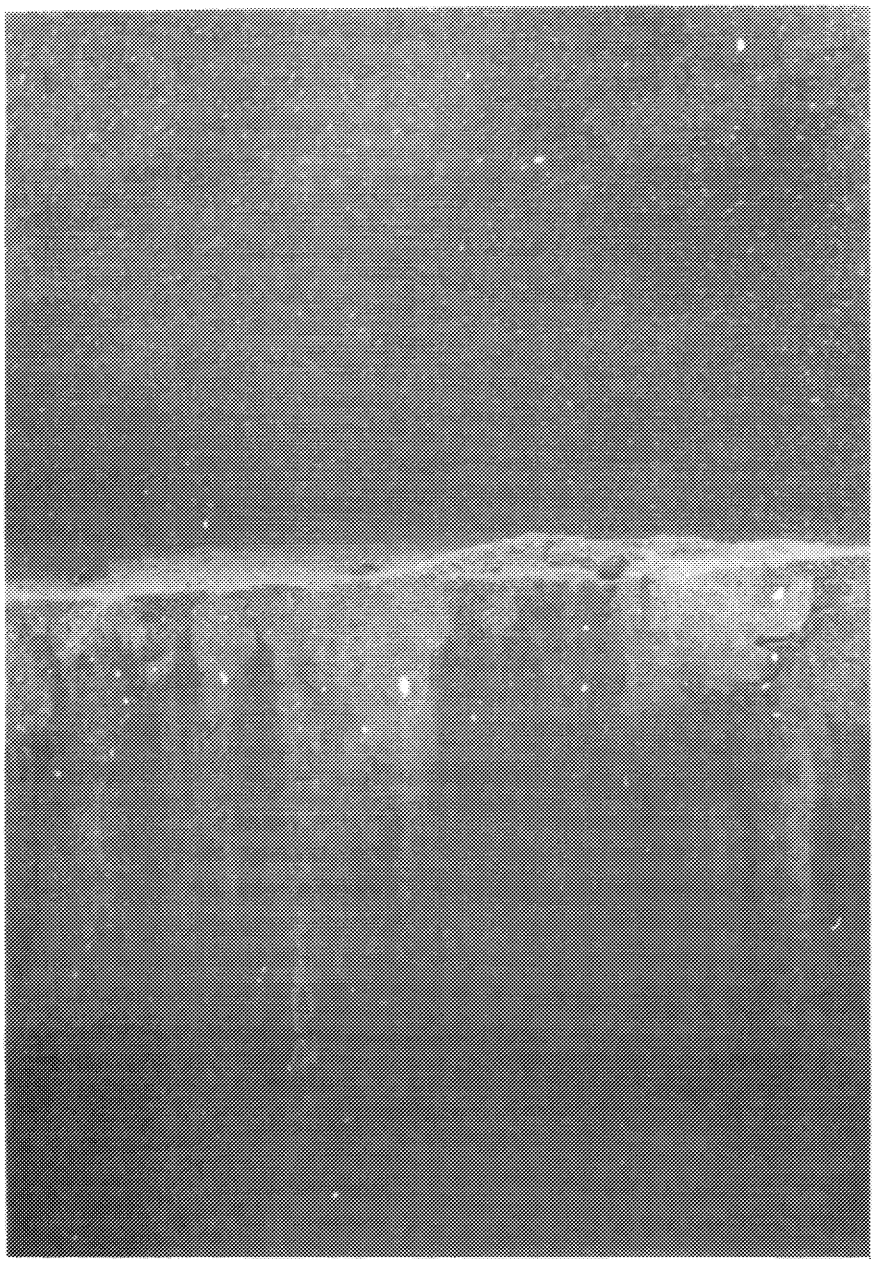
The atypically shallow RPD depths observed at both the reference and grid stations during the October survey were largely a result of the physical disturbance caused by Hurricane Gloria. Several REMOTS® photos revealed oxygenated surface sediment layers which appeared to be truncated (Figure 3-11). Scour by bottom currents probably resulted in erosion of surface sediment layers over large areas of the Sound, especially in shallower regions. Near-surface, biogenically reworked sediments are susceptible to erosion due to their low shear strength, increased porosity and high water content. In the center of the

Figure 3-11. A REMOTS image from station 500E showing shallow RPD which appears to be truncated. This suggests that overlying oxidized material has recently been removed by bottom scour. Scale = 1X.

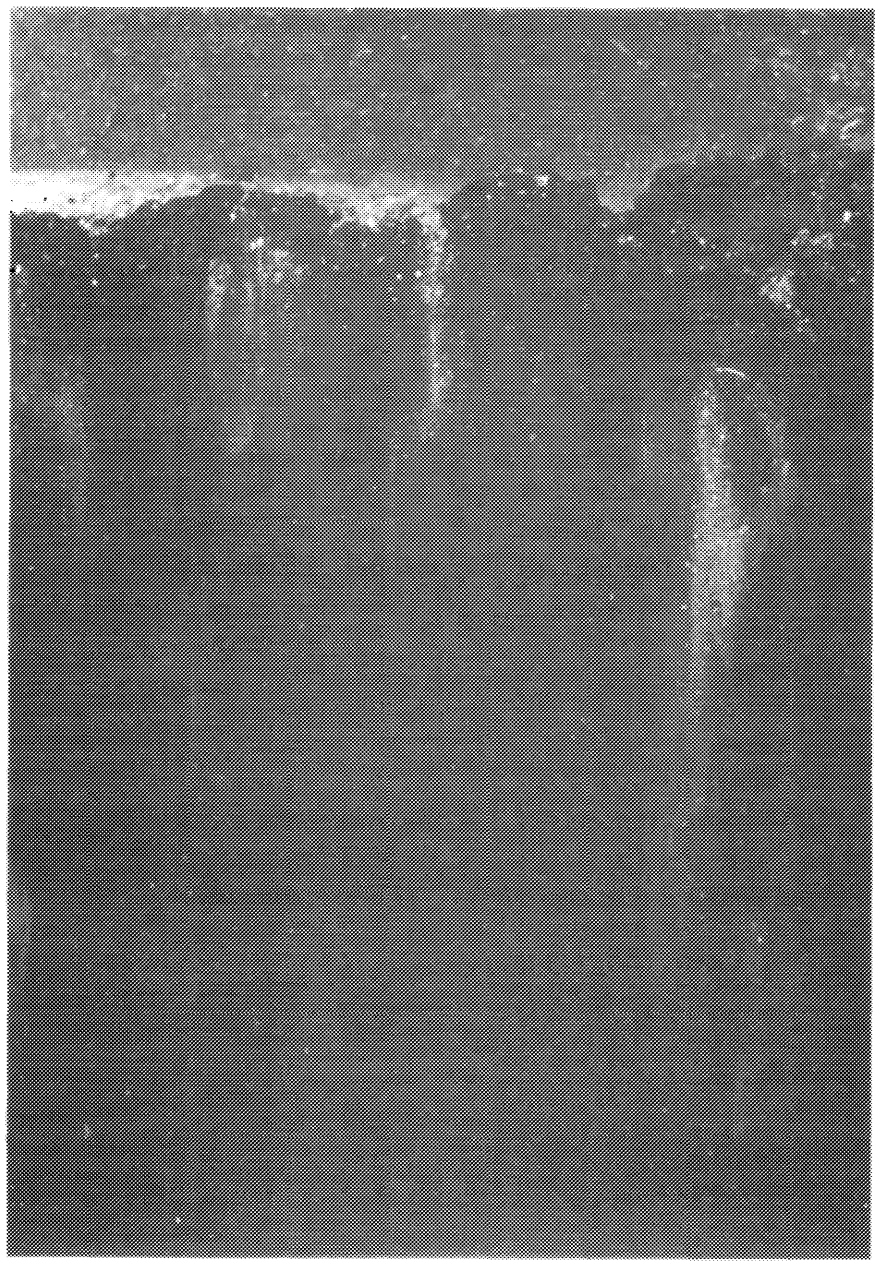
disposal area, this scouring resulted in some images lacking or exhibiting very shallow redox layers; highly reduced dredged material that was formerly underlying aerated sediment was evident at the sediment-water interface (Figure 3-12). In adjacent ambient regions, evidence of significant surface erosion was indicated by the presence of methane. Methanogenesis occurs at depth in the sedimentary column whenever pore-water sulphate is exhausted. In central Long Island Sound, methane production usually occurs below the REMOTS® prism penetration depth (15-20 cm; Needell et al., 1987); methane has not been observed previously at the FVP site. In this survey, station 1000E showed a relatively shallow RPD and sedimentary methane pockets (Figure 3-13). These features suggest that a notable amount (5-10 cm) of surface sediments had recently been removed.

Figure 3-12. A REMOTS image from station CTR showing reduced dredged material at the interface. Apparently, oxidized surface sediments were completely removed by the severe bottom scour produced by Hurricane Gloria. Scale = 1X.

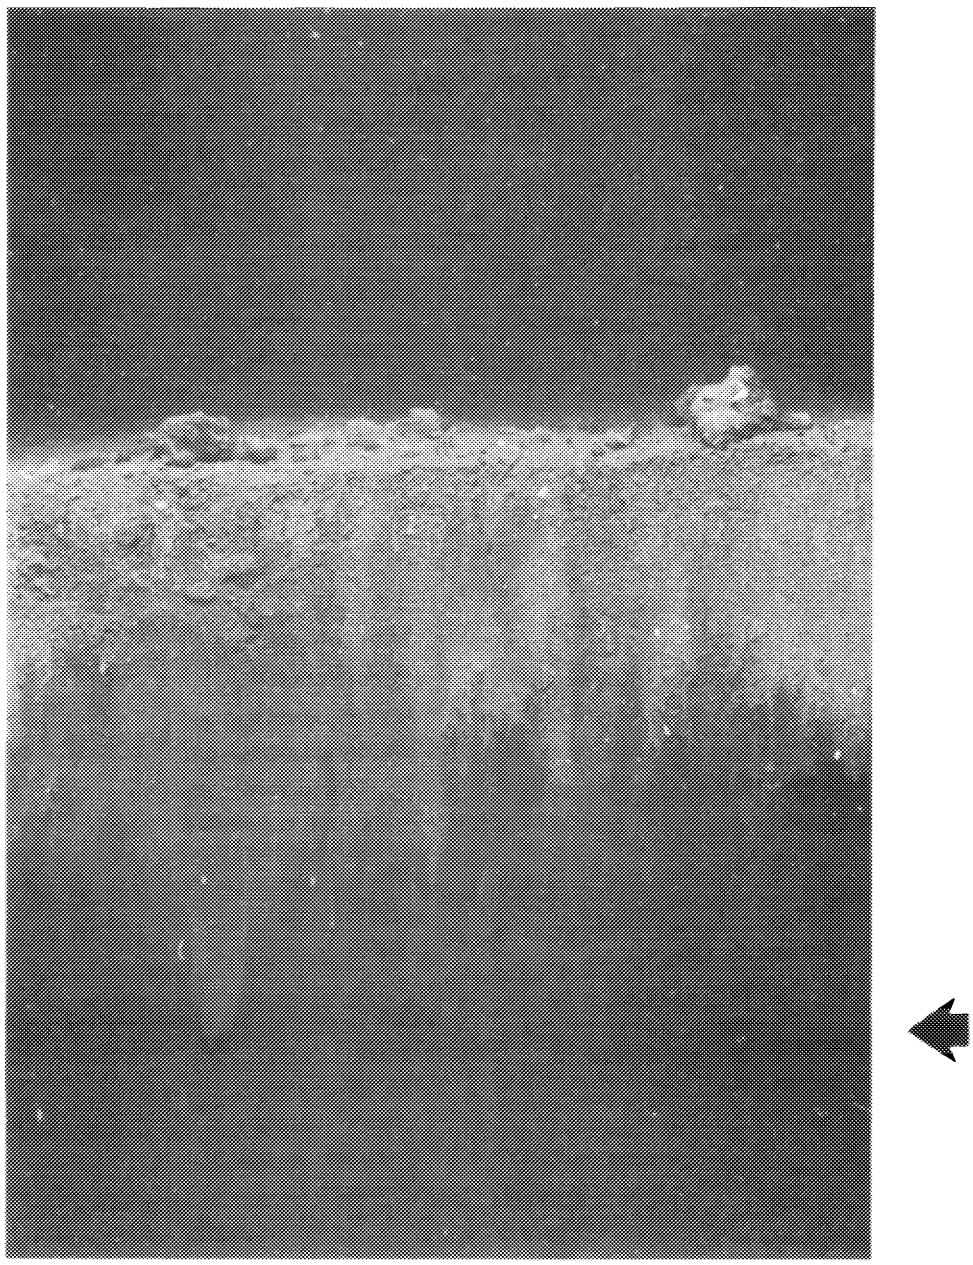
Figure 3-13. A REMOTS image from station 1000E showing an apparently truncated RPD, mud clasts, and methane gas pockets at depth (arrow). Scale = 1X.
