FINAL REPORT TO CONGRESS

THE STREAMBANK EROSION CONTROL EVALUATION AND DEMONSTRATION ACT OF 1974 SECTION 32, PUBLIC LAW 93-251

Appendix E - Missouri River Demonstration Projects

Volume 1 of 2

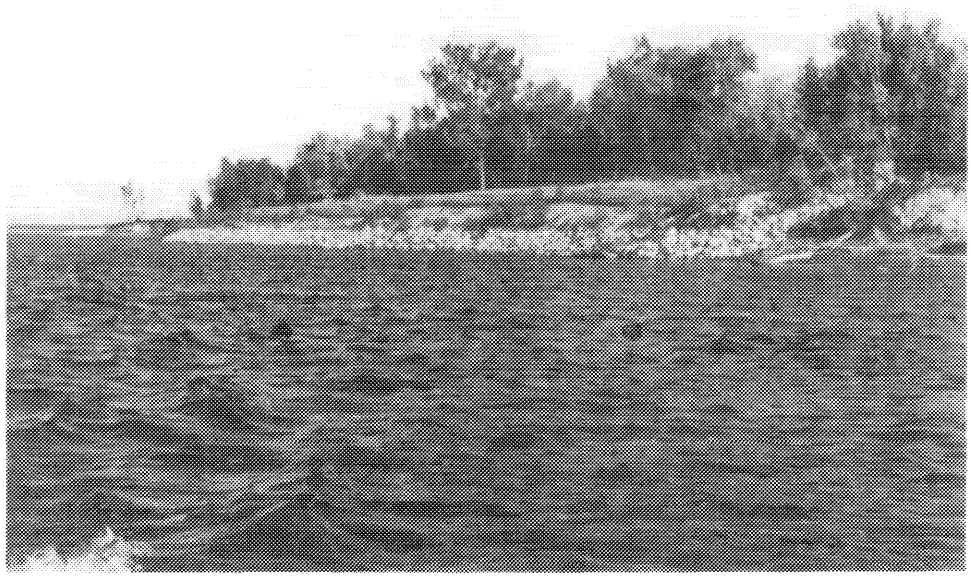
Photo 1. Reinforced Revetment 1368.6, Station 35+00 to 40+00, approximately 13 months after completion. (Photo taken July 1979)

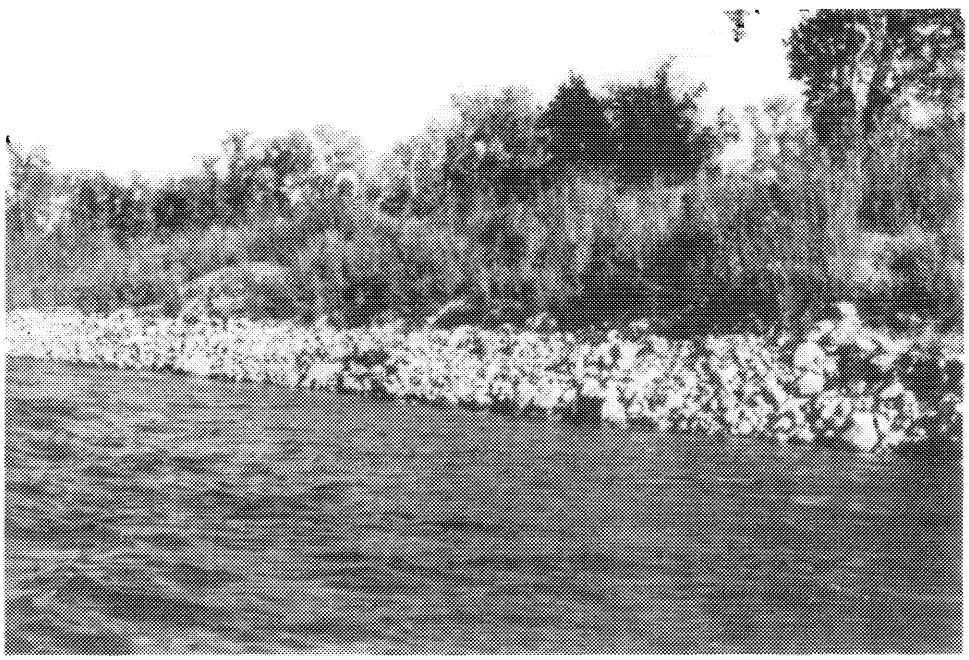
Photo 2. Reinforced Revetment 1368.6, Station 43+00 to 48+00, approximately 13 months after completion. (Photo taken July 1979)

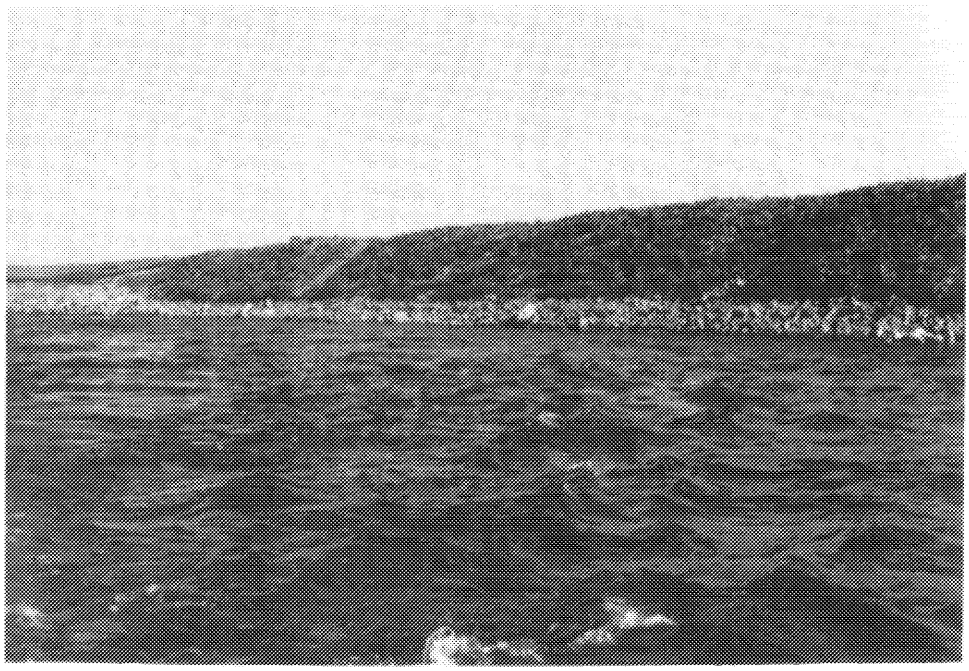
Photo 3. Reinforced Revetment 1366.7, Station 3+00 to 7+00, approximately 9 months after completion.

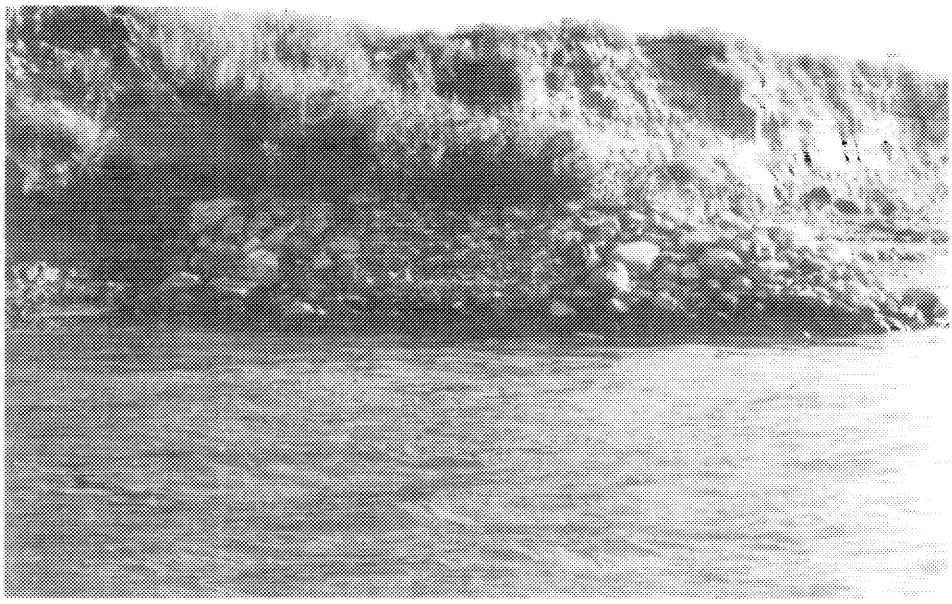
Photo 4. Hardpoint 1366.8, approximately 9 months after completion. (Photo taken July 1979)

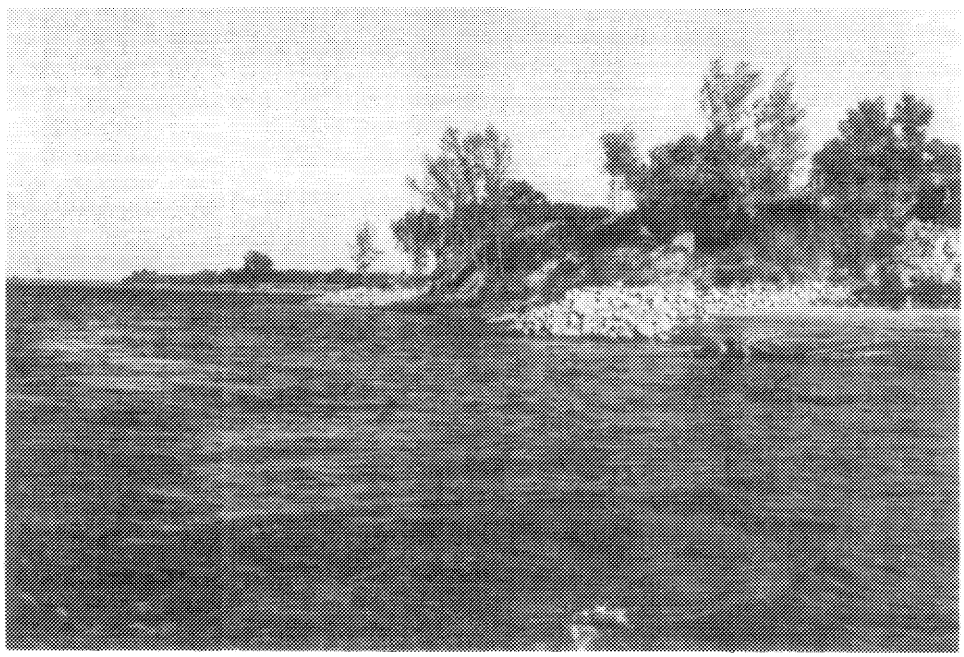
Photo 5. Hardpoints 1366.4 and 1366.3. (Photo taken July 1979)

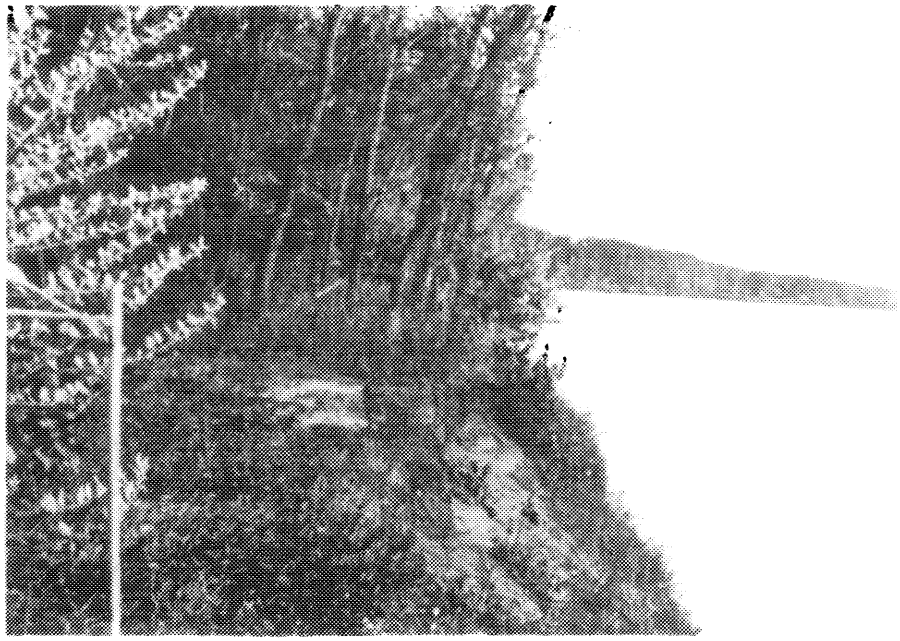
Photo 6. Reinforced Revetment 1357.50, prior to construction. (Photo taken 15 September 1978)

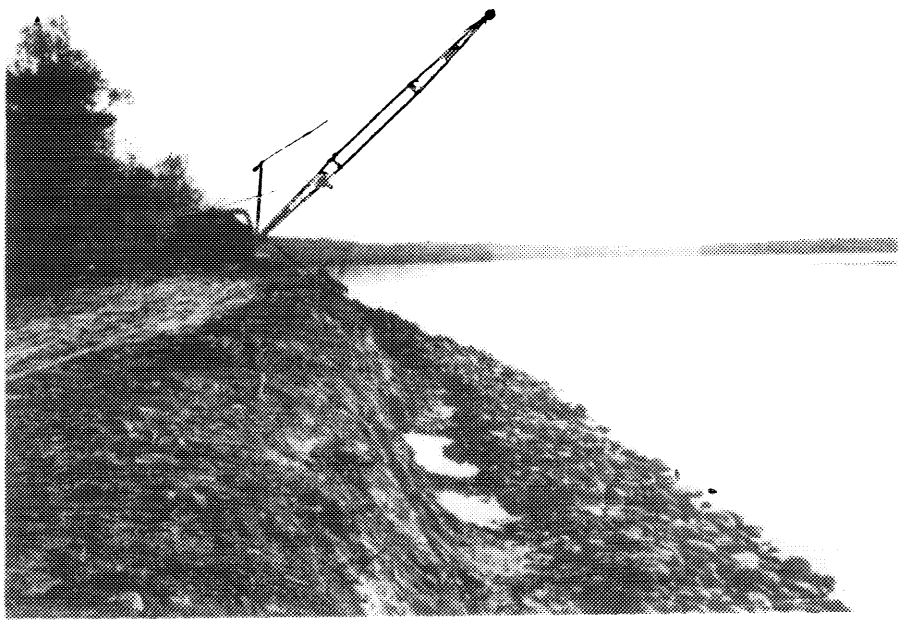
Photo 7. Placement of rock toe on Revetment 1357.50 (Photo taken 15 September 1978)

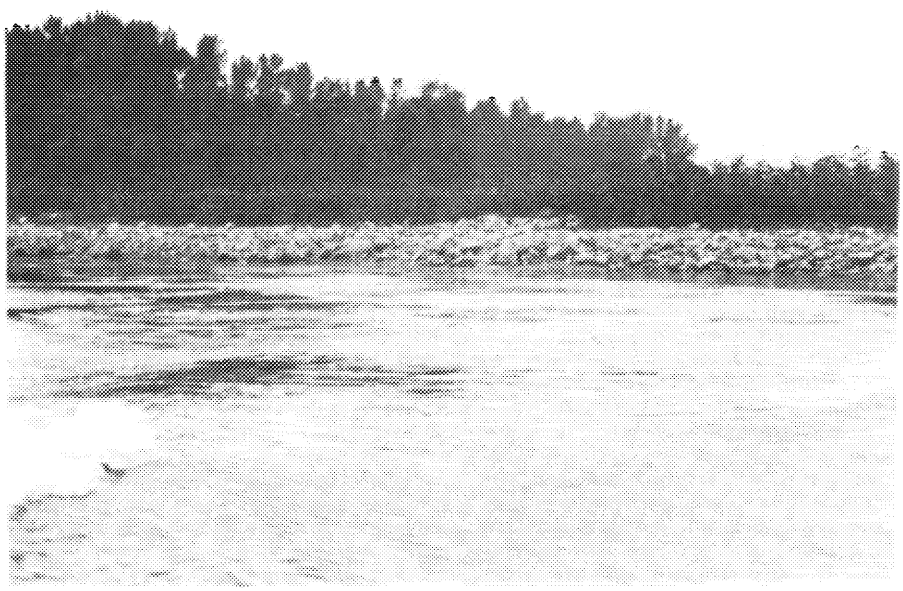
Photo 9. Downstream portion of Reinforced Revetment 1357.73 approximately 8 months after completion. (Photo taken 22 August 1979)

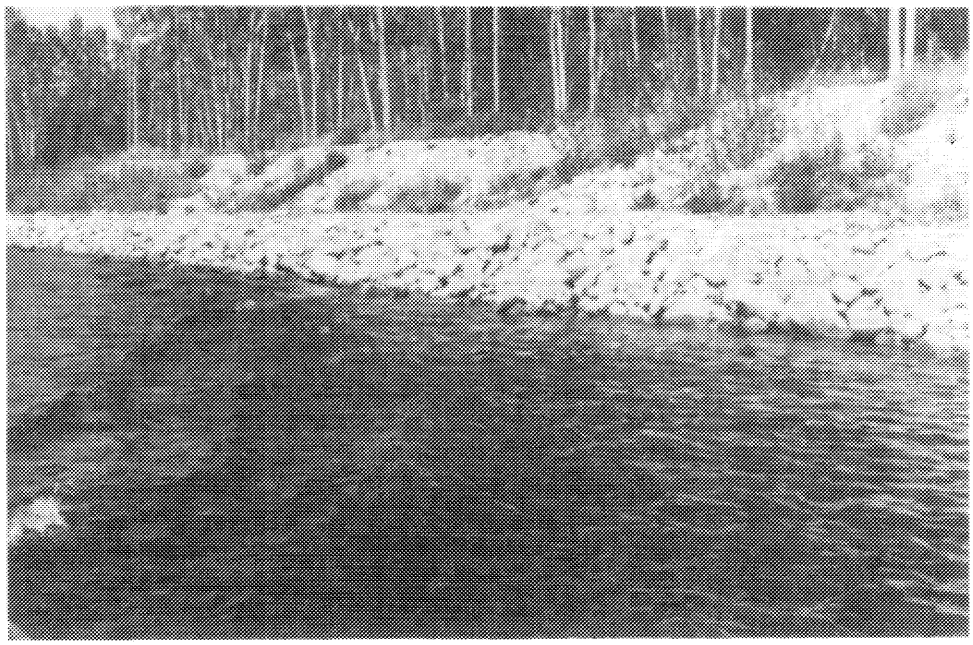
Photo 10. Reinforced Revetment 1357.73, approximately 9 months after completion.
(Photo taken 15 September 1979)

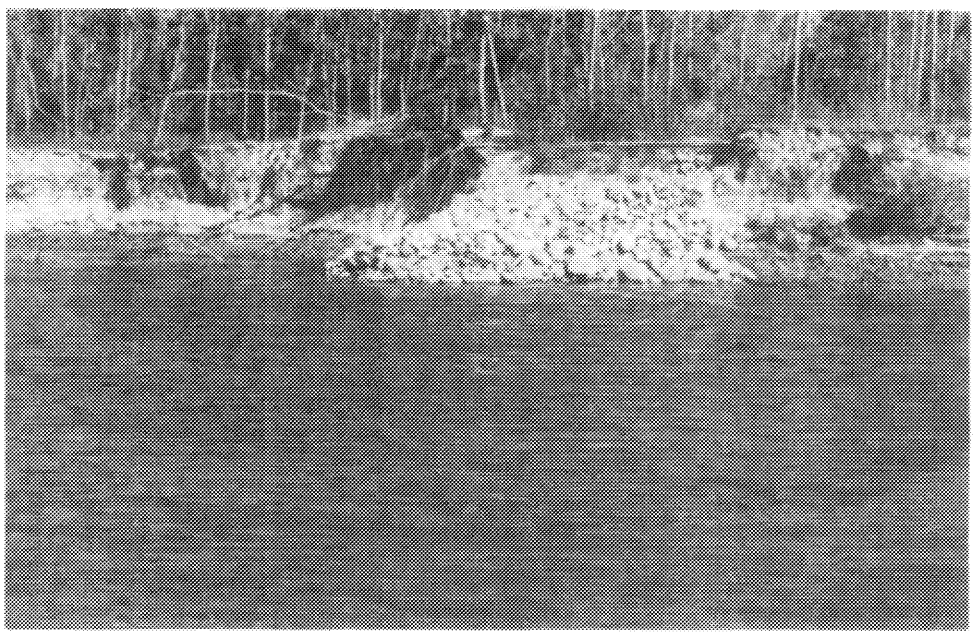
Photo 11. Hardpoint 1356.84, approximately 8 months after completion.
(Photo taken July 1979).

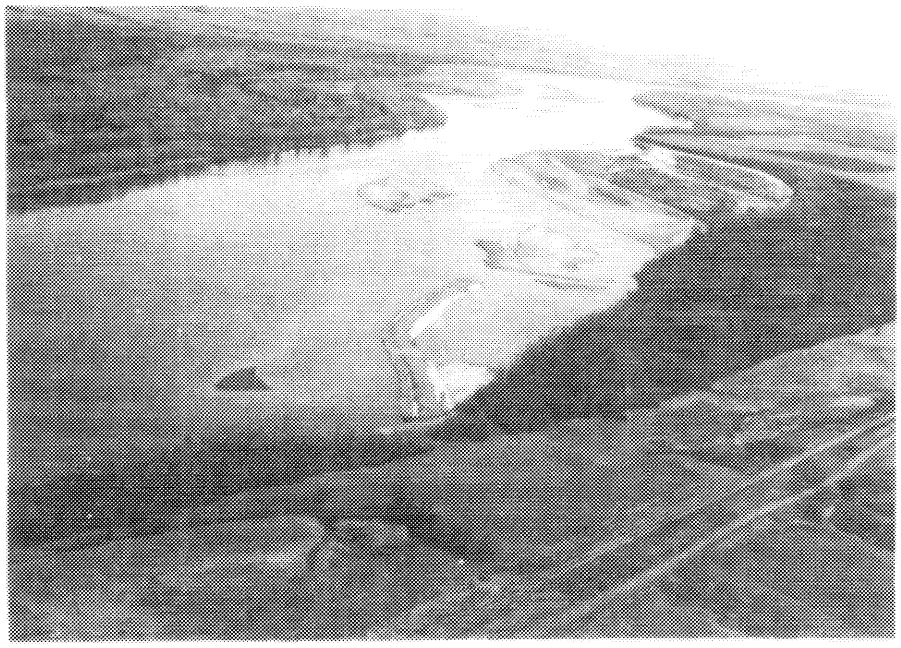
Photo 13. Aerial View of Earth Core Dike 1345.5 loading downstream (Photo taken 15 April 1980)

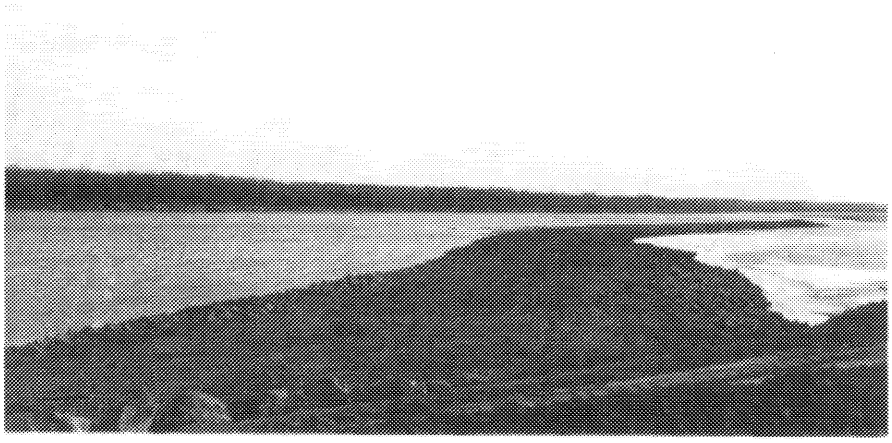
Photo 15. Earth Core Dike 1345.5 immediately after completion and prior to planting of crown vegetation. (Photo taken 16 November 1979)

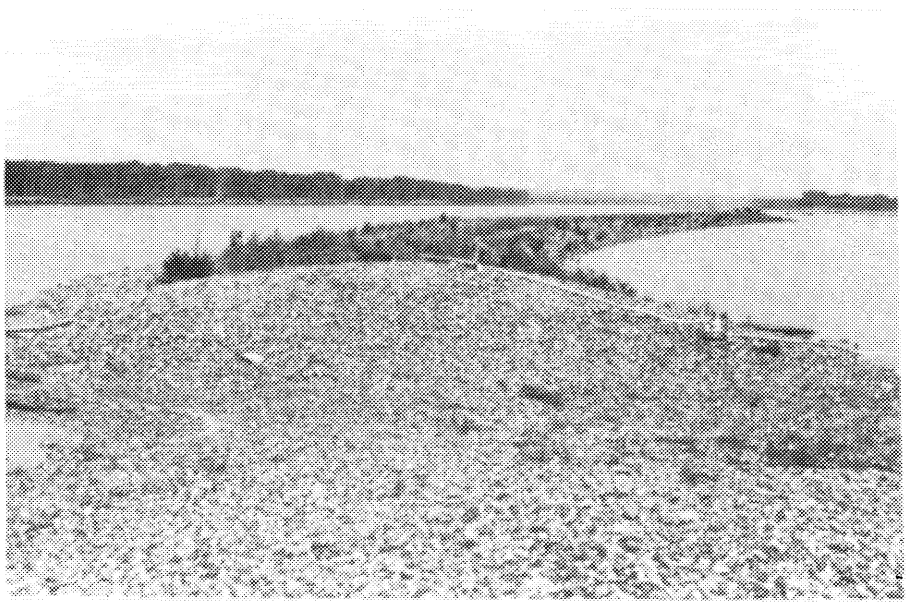
Photo 16. Environmental notch in foreground and downstream portion of earth core dike. The vegetation on the dike was planted in May 1980, two months before this photograph was taken. (Photo taken 17 July 1980)

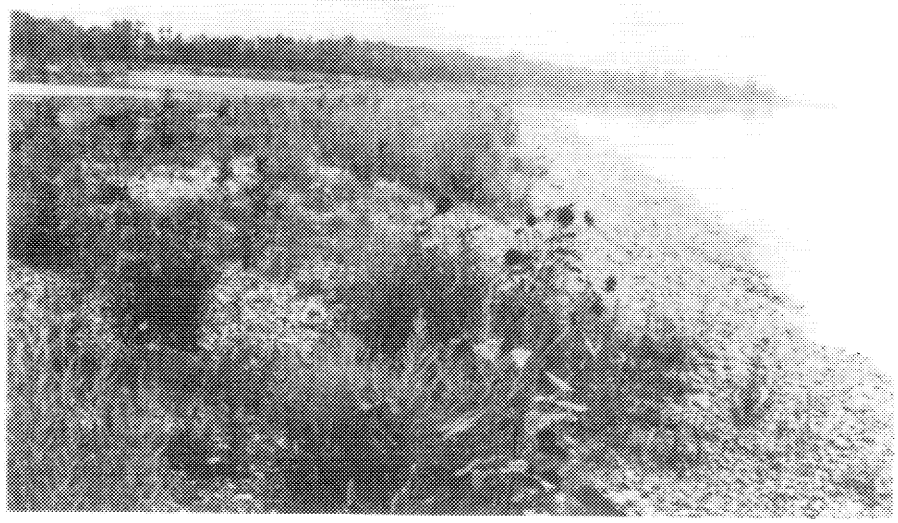
Photo 17. Looking downstream along downstream site of earth core. Dike 1345.5, 2 months after vegetation planting in May 1980

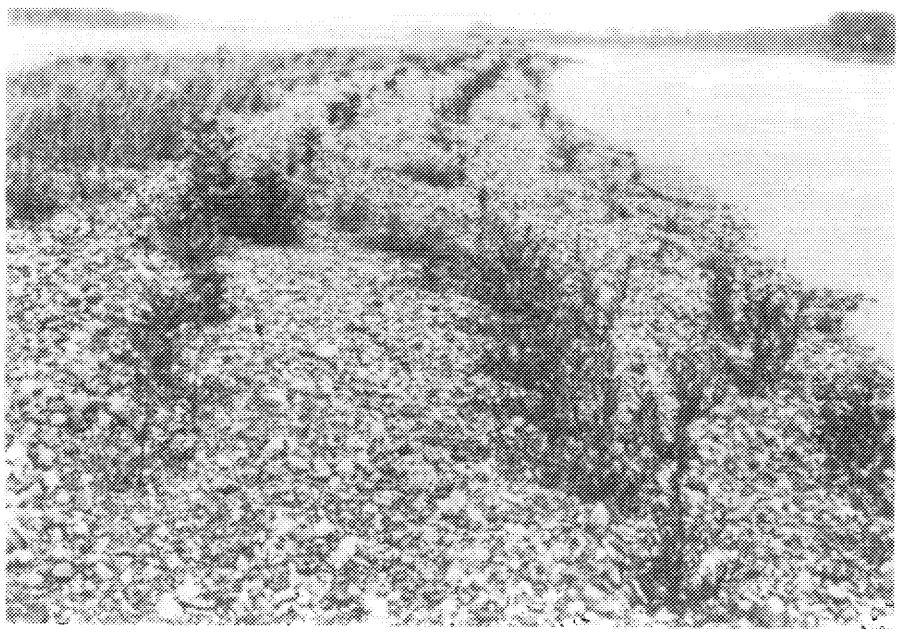
Photo 18. Looking upstream along upstream side of Earth Core Dike 1345.5, 2 months after vegetation planting in May 1980. (Photo taken 17 July 1980)

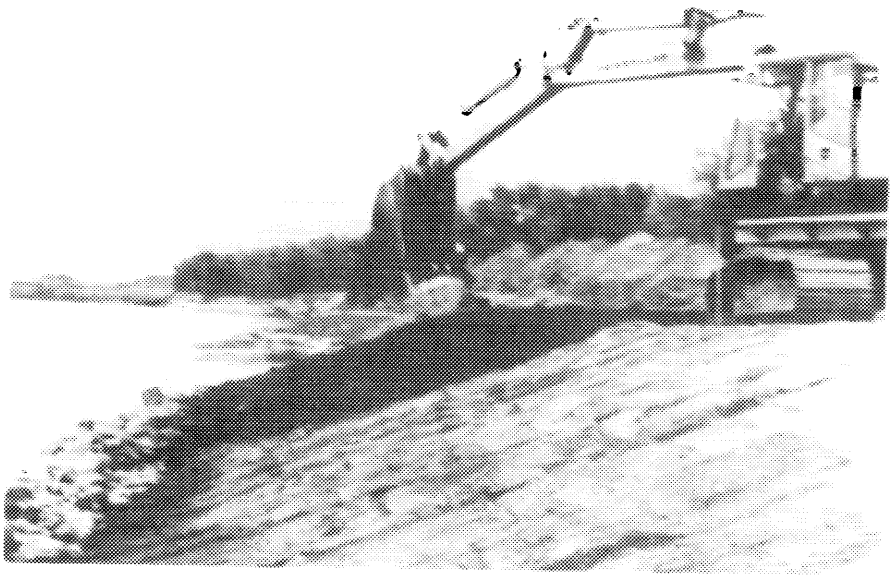
Photo 22. Clay placement on Composite Revetment Type E 1323.05, Station 26+50. (Photo taken 29 September 1977)

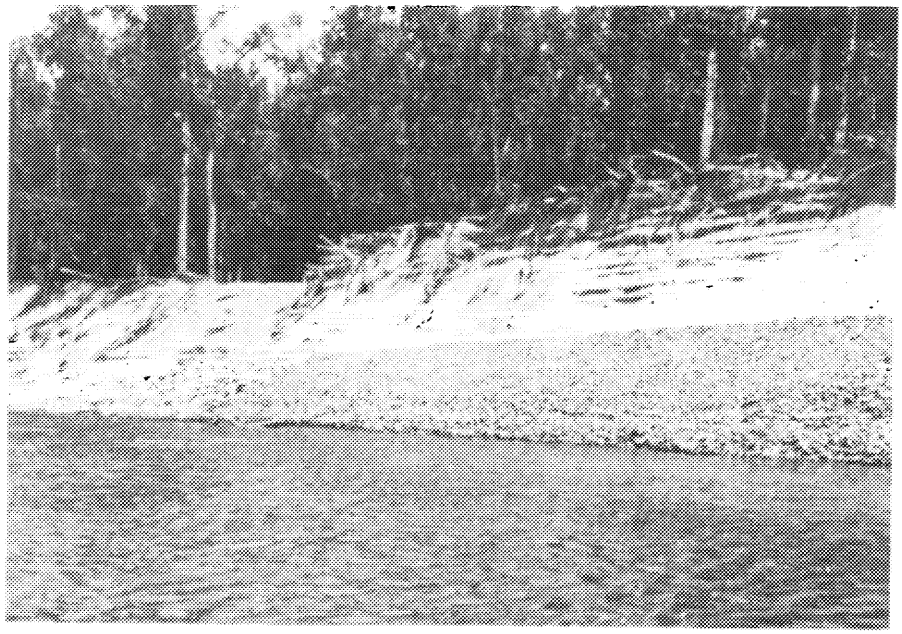
Photo 23. Composite Revetment - Type A 1323.05, Station 0+00 to 7+50, with gravel cover. (Photo taken June 1978)

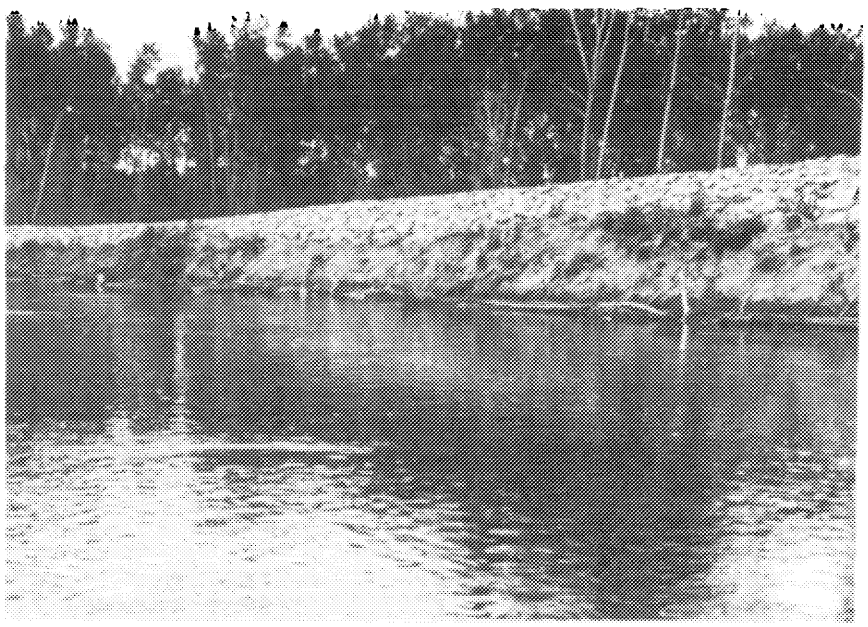
Photo 24. Windrow Revetment 1323.8, Station 12+80 to 17+20, approximately 6 months after completion. (Photo taken September 1977)

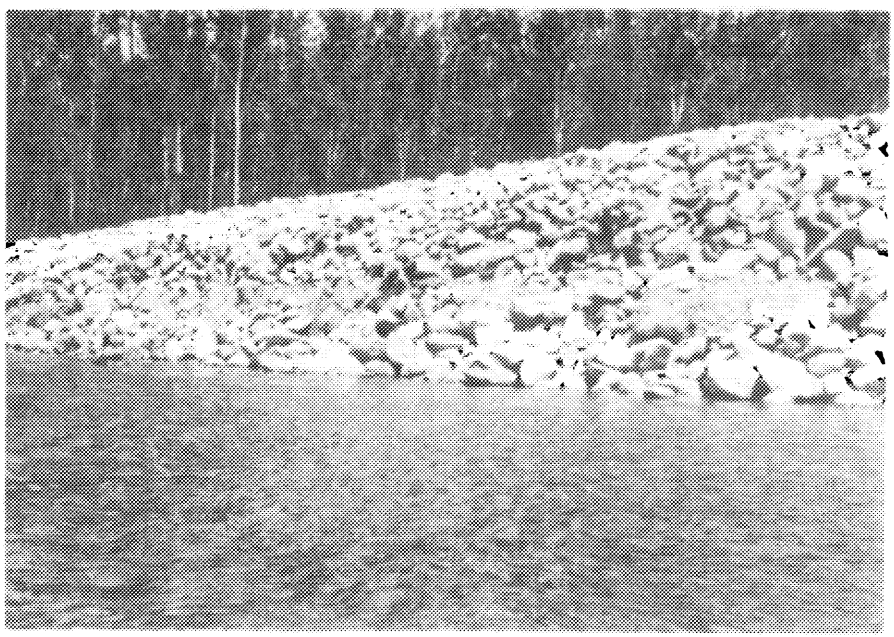
Photo 25. Windrow Revetment 1323.8, Station 0+00 to 4+40, approximately 15 months after completion. (Photo taken June 1978)

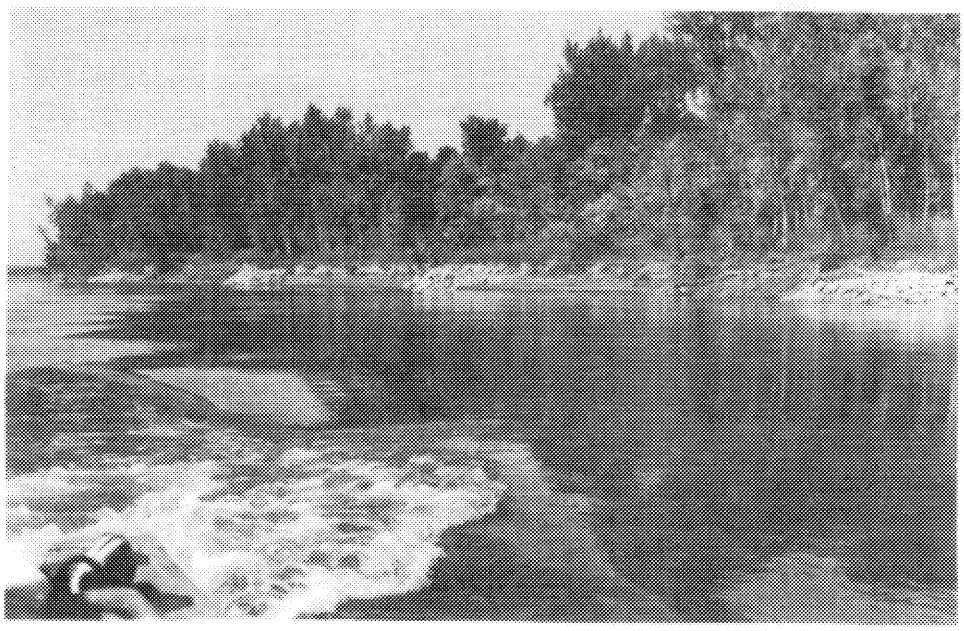
Photo 26. Looking upstream along the Hardpoint System at the downstream end of the project. (Photo taken July 1979)

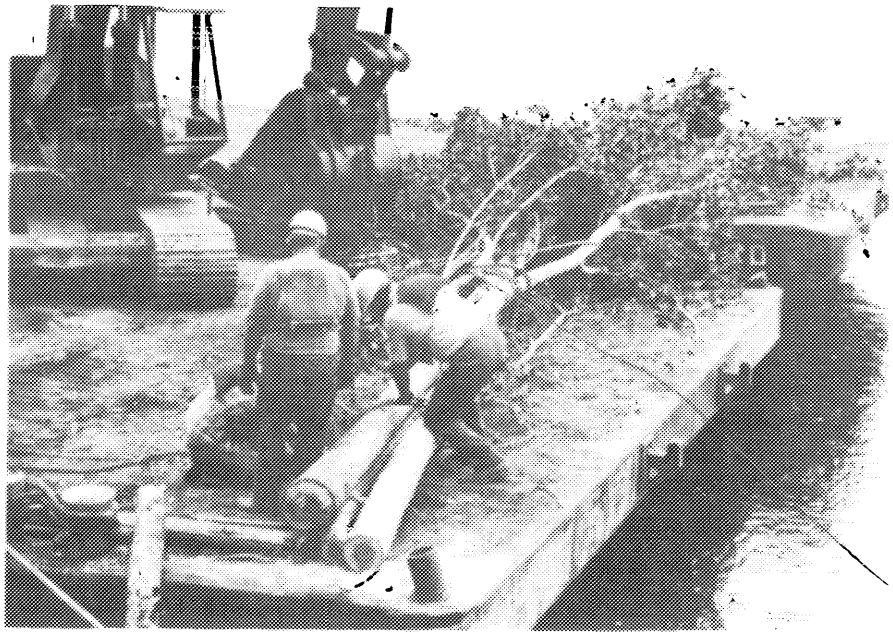
Photo 27. Tree Retard 1324.19 during construction.
(Photo taken September 1977)

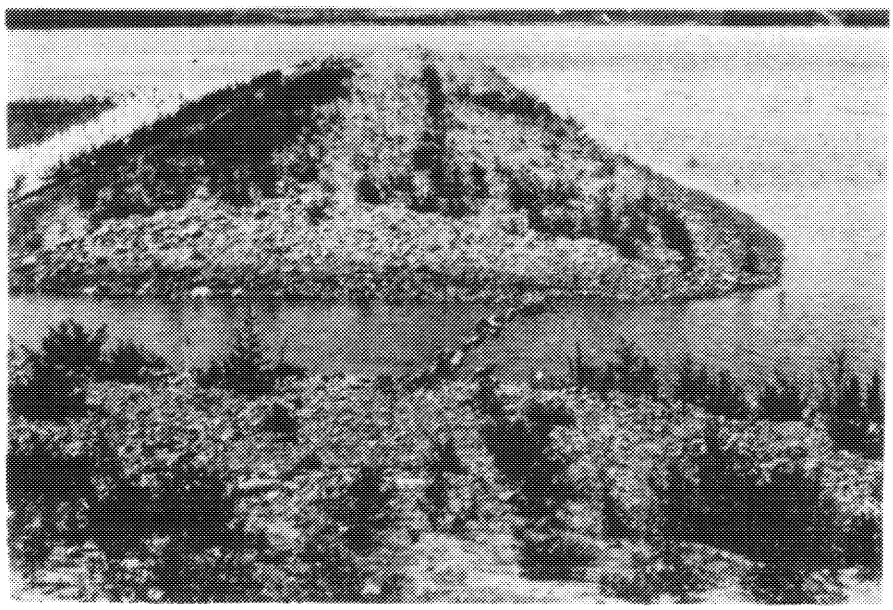
Photo 32. Dike 1320.8, with environmental gap shown in the foreground, approximately 9 months after completion. (Photo taken 18 July 1960)

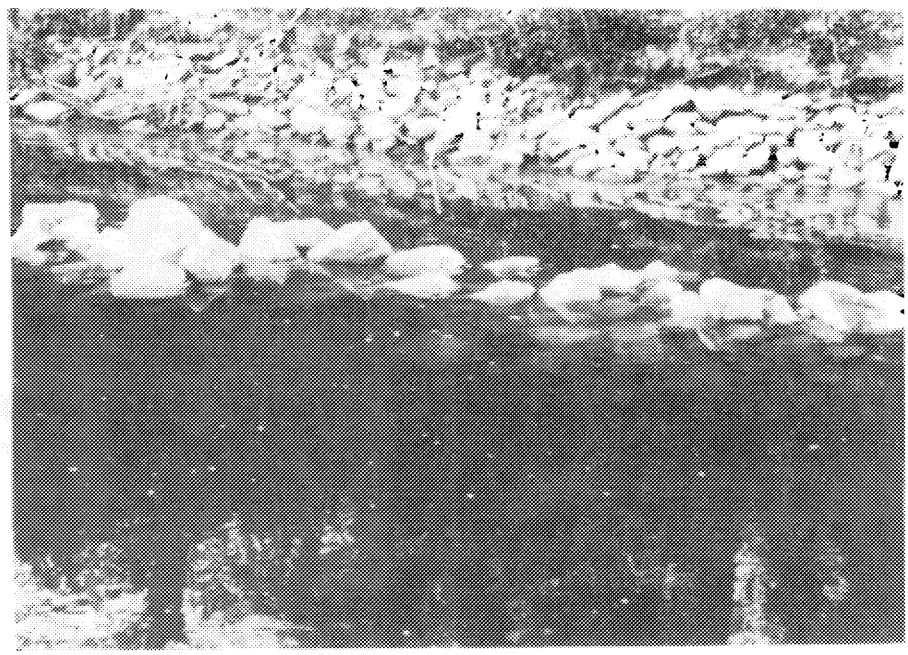
Photo 34. Soil-Cement toe prior to stone cover. (Photo taken 15 August 1980)

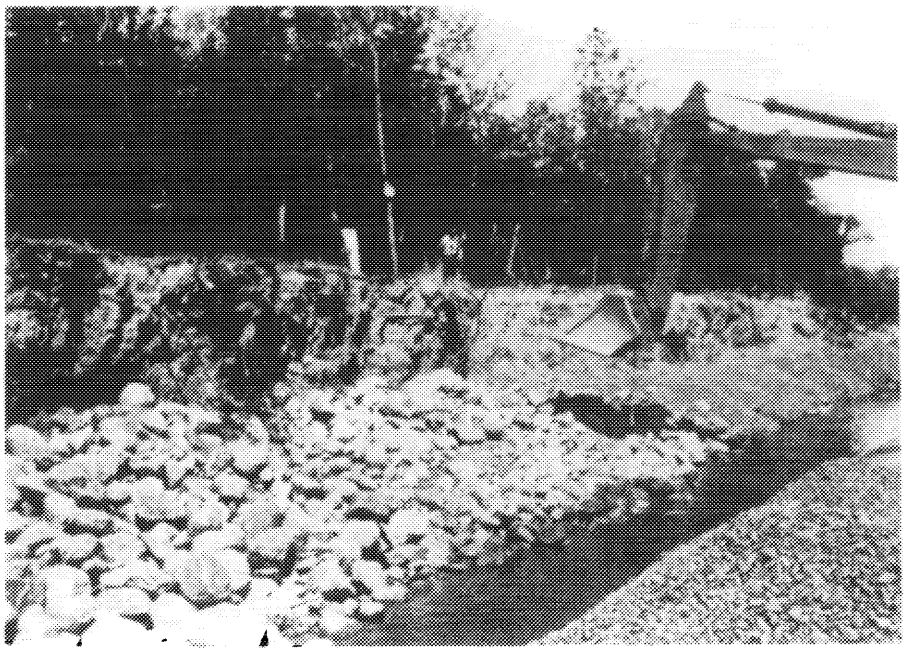
Photo 35. Composite Revetment during placement of gravel cover at Stations 7+50 to 11+75. (Photo taken 26 August 1980)

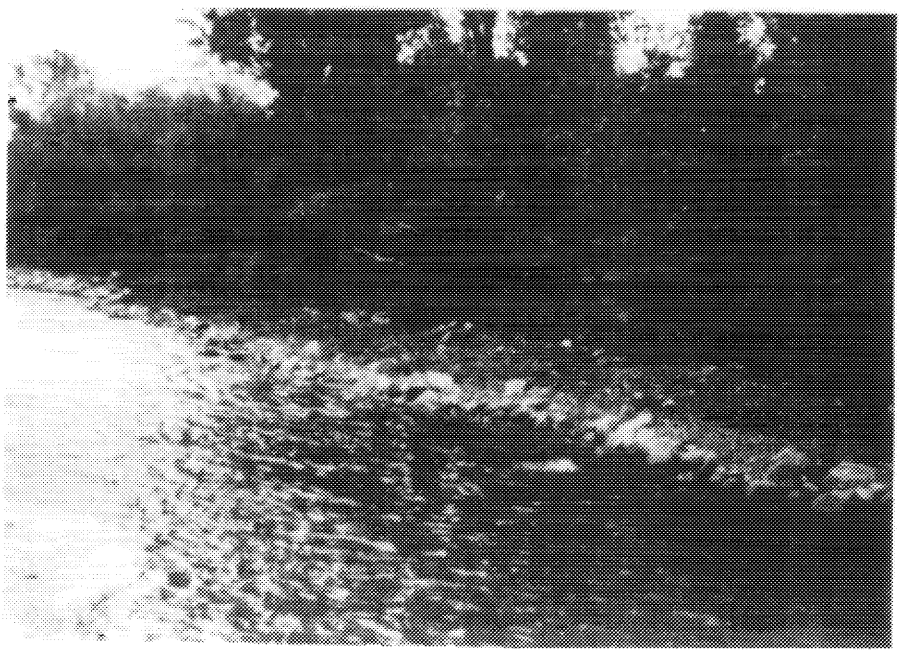
Photo 36. Composite Revetment 1317.78 approximately 3 months after completion. (Photo taken 2 September 1980)

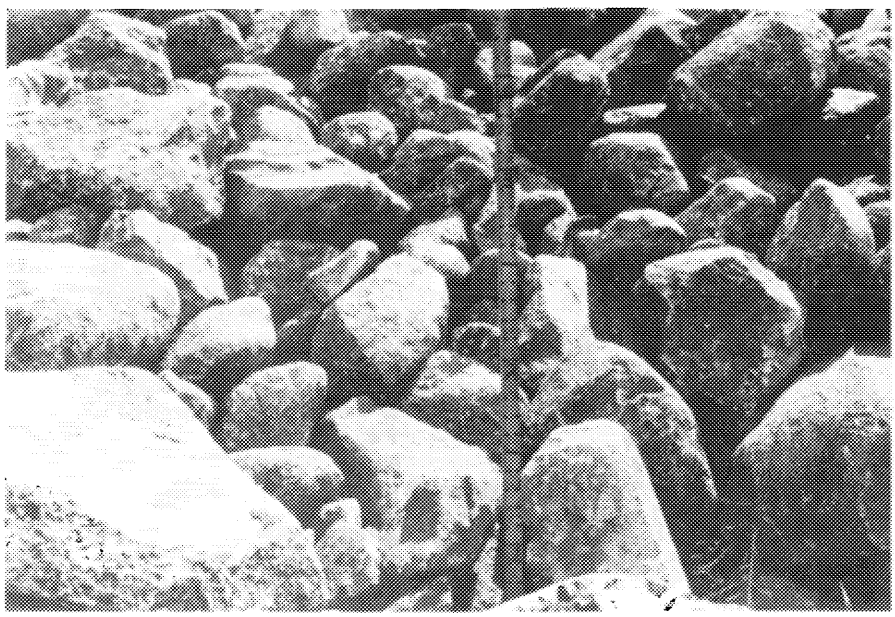
Photo 38. 500 pound gradation test. (Photo taken 12 May 1980)

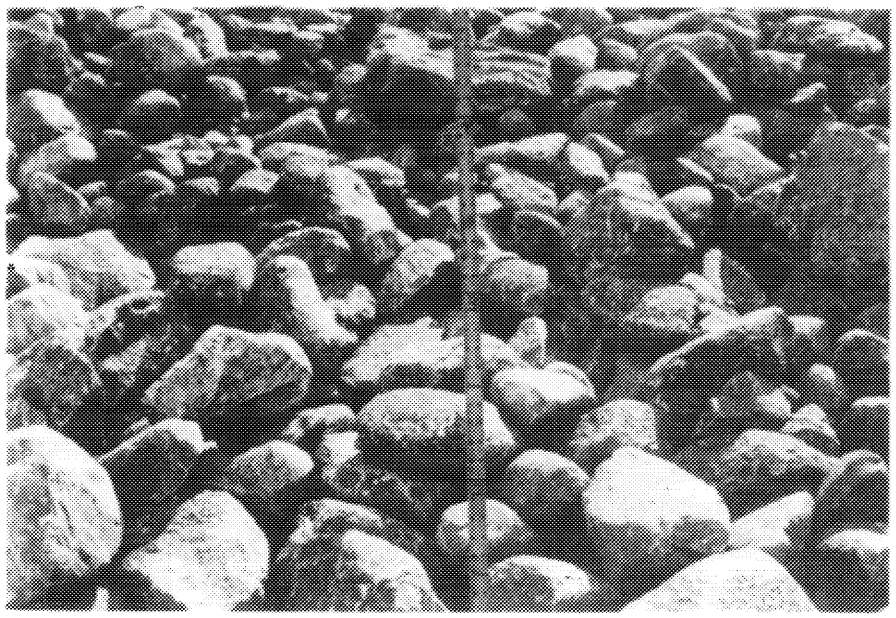
Photos 38 and 39 show 500 lb. and 200 lb. gradation tests. The stone material used in the construction of this project was required to meet the following standards: bulk specific gravity, saturated surface-dry basis, Method CRD-C 107-69, required not less than 2.35. Soundness in magnesium sulfate, ASTM Standard C88-76, required a loss of 5 cycles of not more than 12 percent; soundness in freezing and thawing for Ledge Rock Method Modified Designation T103-62, required a loss at 12 cycles not to exceed 10 percent.

Photo 39. 200 pound gradation test. (Photo taken 12 May 1980)

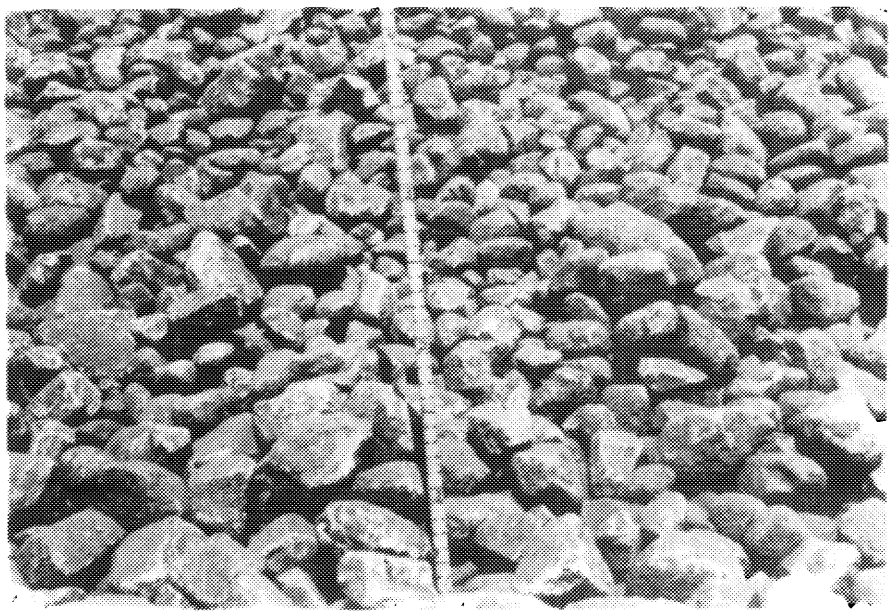
Photo 40. Cobbles and spalls gradation test. (Photo taken 12 May 1980)

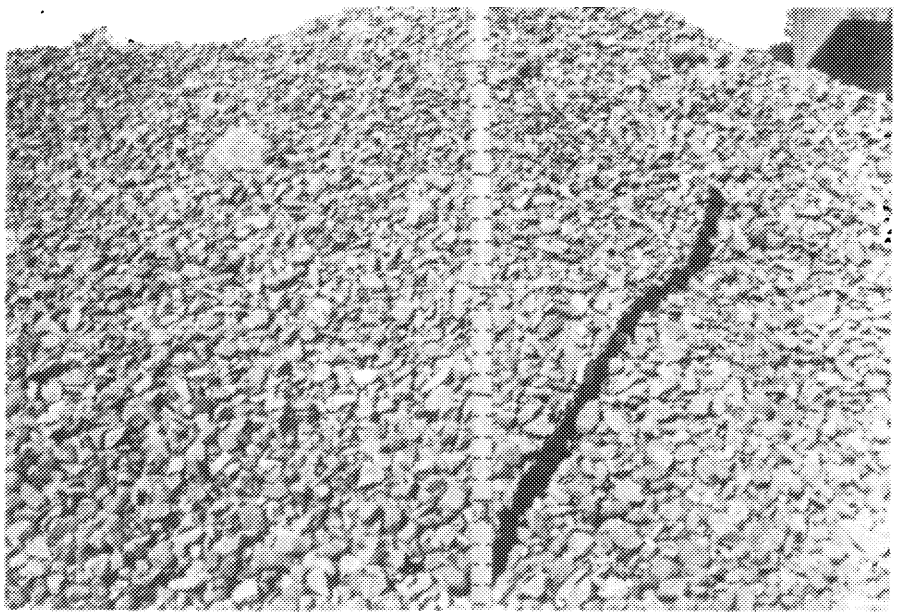
Photo 41. Gravel stockpile. (Photo taken 12 May 1980)

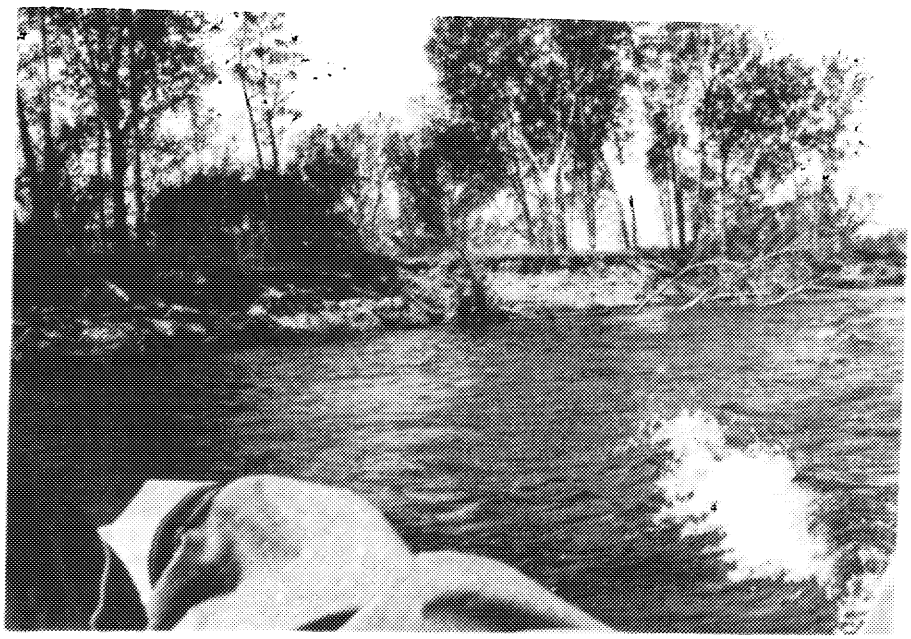
Photo 43. Typical downstream bankline along Pretty Point-Phase I Area prior to construction. (Photo taken 22 May 1980)

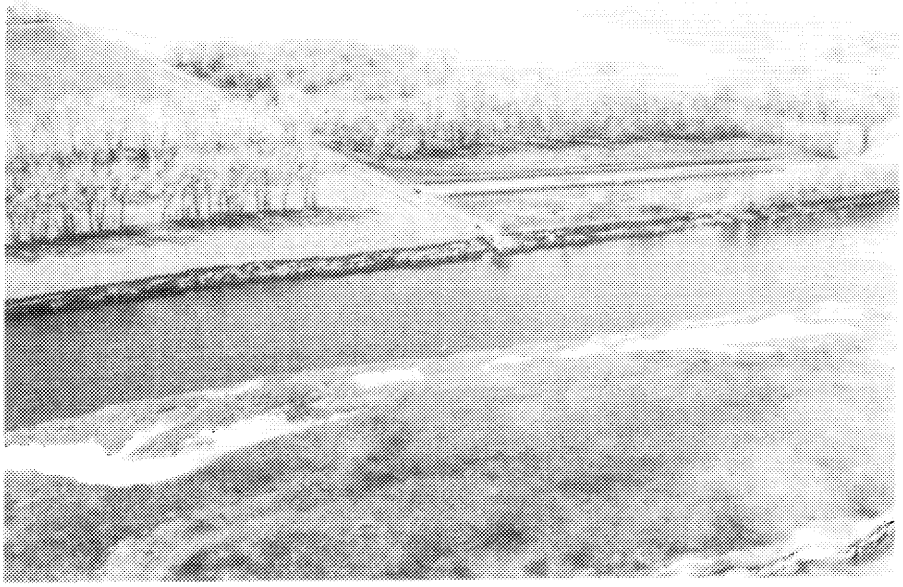
Photo 44. Aerial view of Price-Part I Phase I area, prior to construction. (Photo taken 15 April 1980)

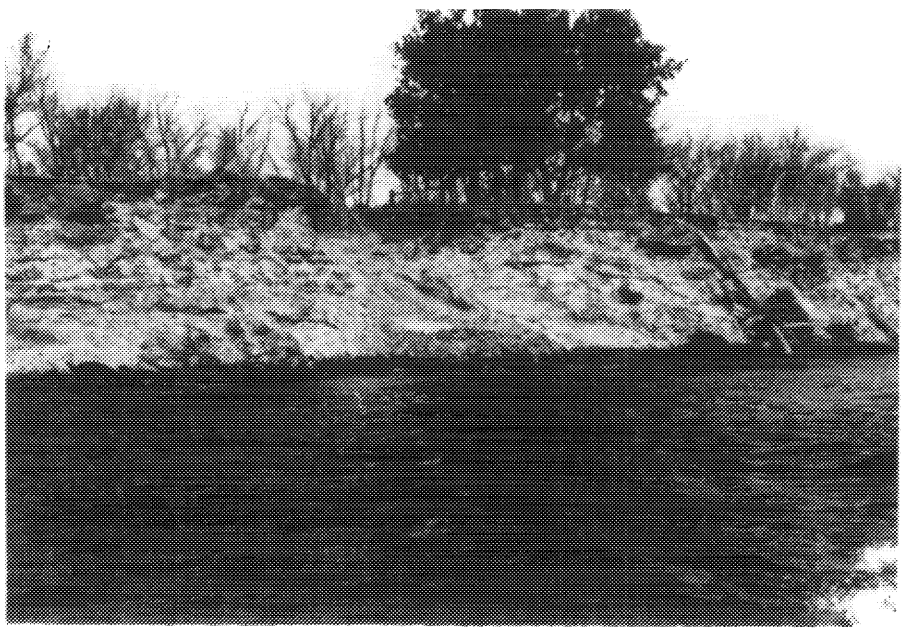
Photo 45. Typical eroding bankline. (Photo taken 22 May 1980)

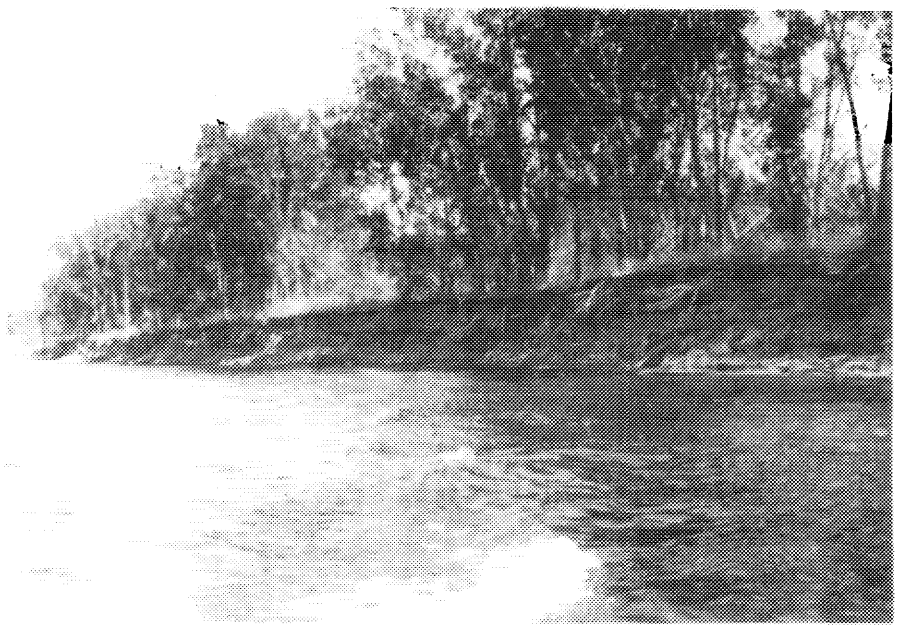
Photo 48. Typical eroding bankline along Wildwood - Phase I project area. (Photos taken 22 May 1980)

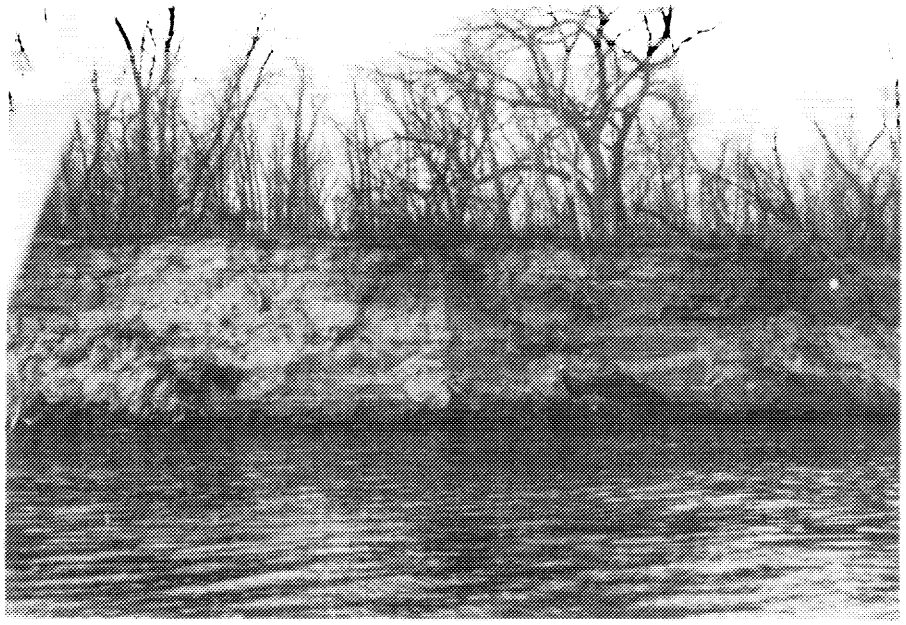
Photo 50. Typical eroded bankline along upstream portion of the Horseshoe Butte-Phase project area. (Photo taken 9 October 1980)

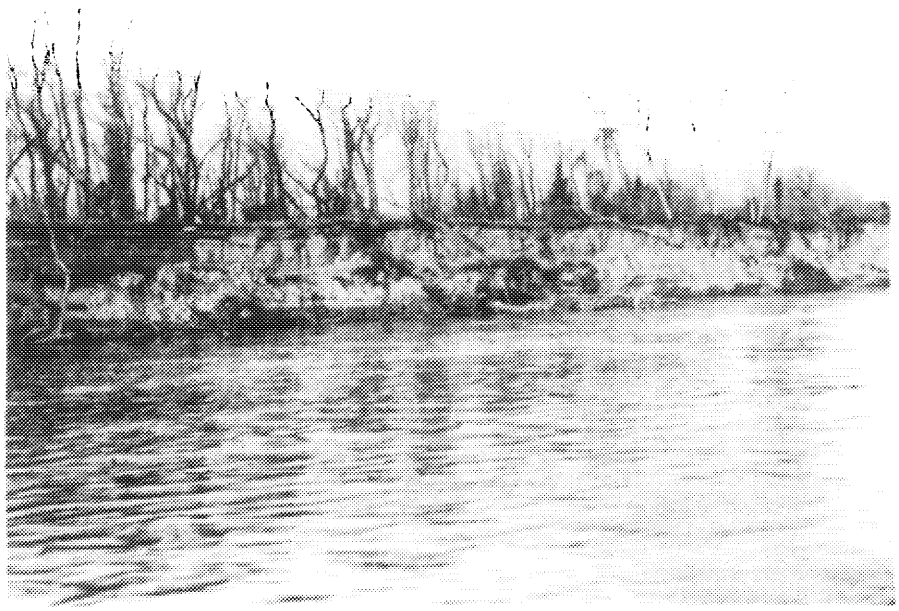
Photo 51. Typical eroding bankline along Horseshoe Butte-Phase I project area. (Photo taken 9 October 1980)

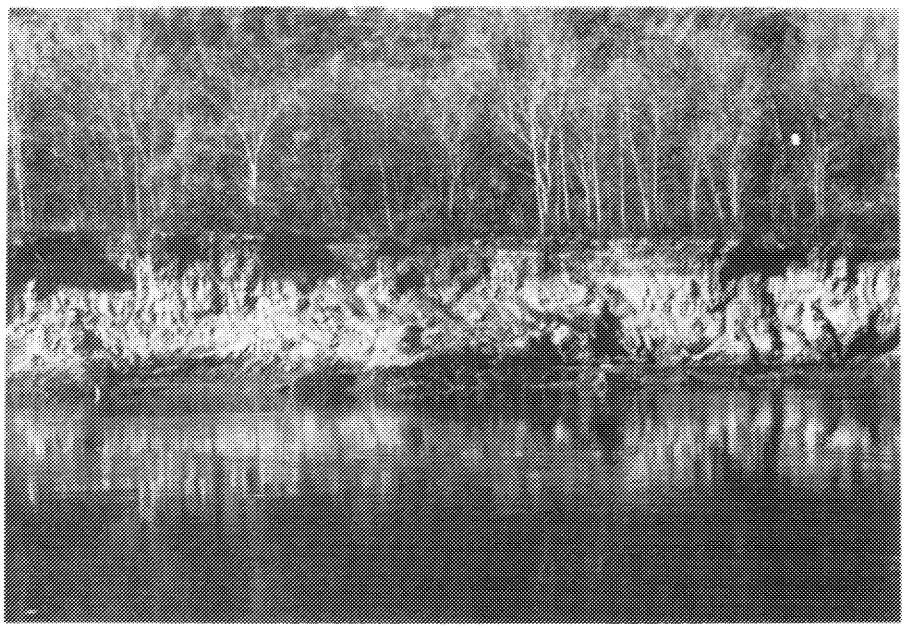
Photo 52. Typical eroding bankline along upstream portion of the project area. (Photo taken 8 October 1980)

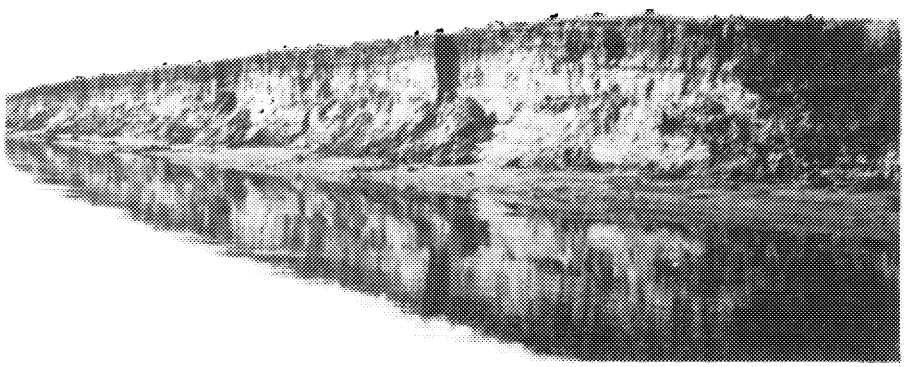
Photo 53. Typical eroding bankline along downstream portion of the project area. (Photo taken 18 July 1980)

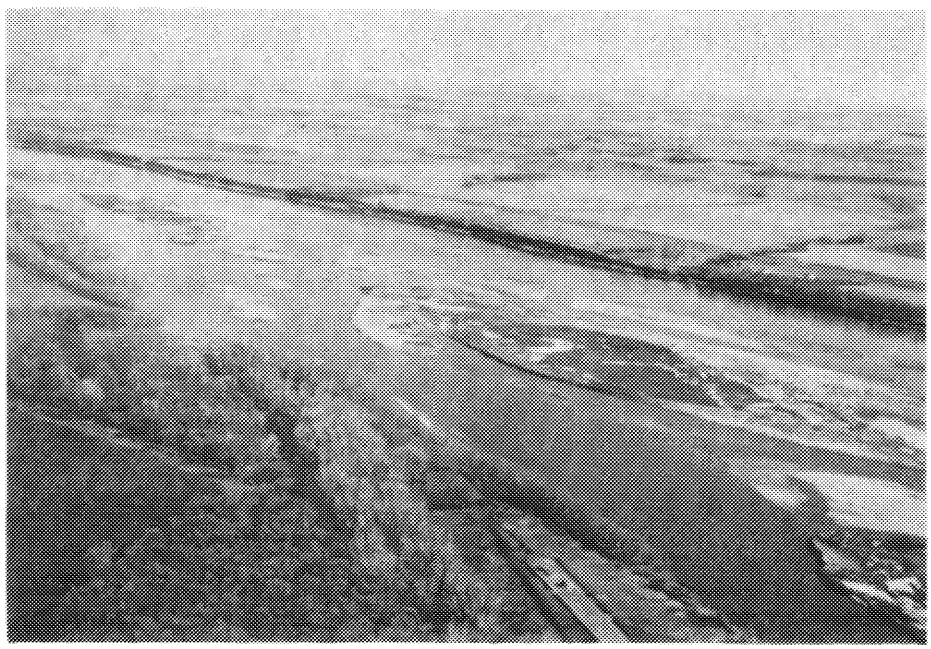
Photo No. 1. Wilton Area
(Note the woodland pattern)
