FINAL REPORT TO CONGRESS

THE STREAMBANK EROSION CONTROL EVALUATION AND DEMONSTRATION ACT OF 1974 SECTION 32, PUBLIC LAW 93-251

Appendix E - Missouri River Demonstration Projects

Volume 1 of 2

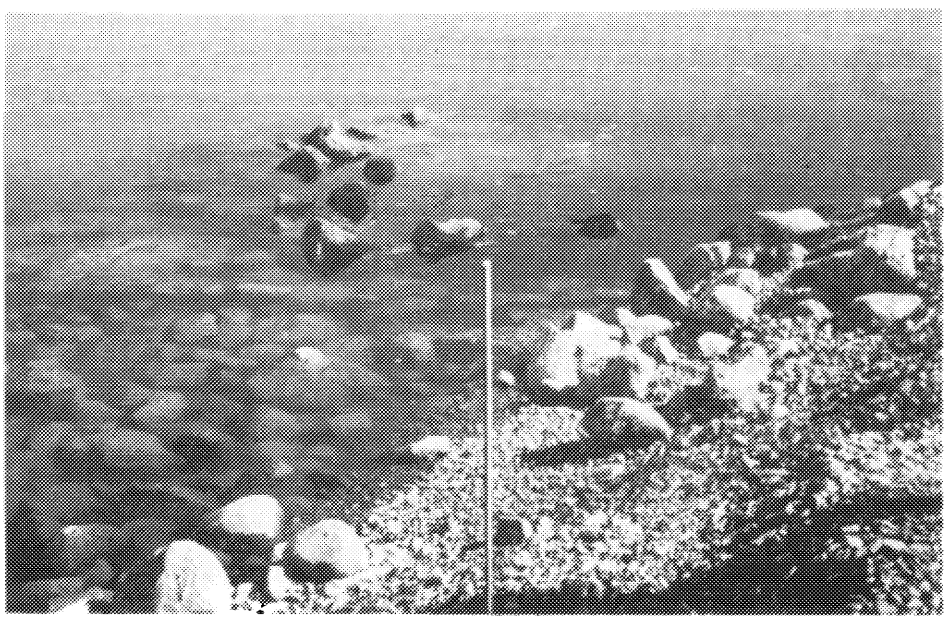
Effects on Fish and Wildlife Resources - Fish. Adverse impacts to the aquatic ecosystem have been minimal. In fact, there could be some minor positive effects. The rock used in many of the revetments provides a suitable substrate for invertebrates (Photo. 3). At the I-94 site, colonization by mayflies (Ephemeroptera) and caddis flies (Trichoptera), as well as other invetebrates, were noted. These invertebrates help to increase the food base for many river fishes. It should be recognized, however, that the overall contribution to the food base is very small. With 160 miles of shoreline of the free flowing Missouri River in North Dakota, a few hundred or few thousand feet of submerged rock will not significantly increase the food base of the river.

Photo No. 3. Rock Substrate, I-94 Area

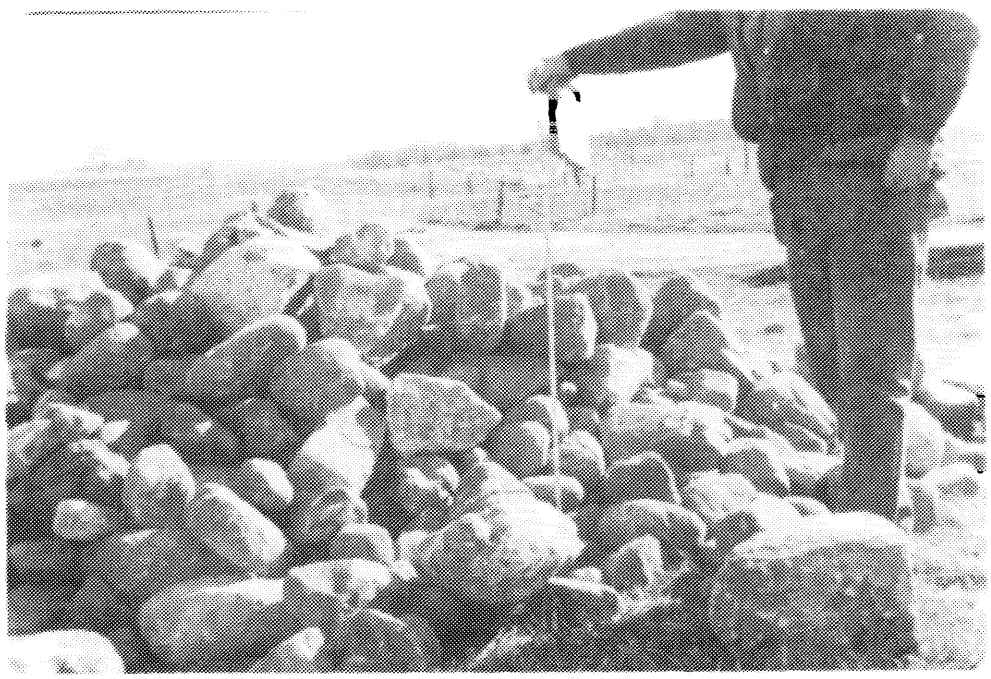
White Swan Area
Photos 1 and 2

PHOTO 2. 500 LB. GRADATION STONE
(Photo Taken September 1980)

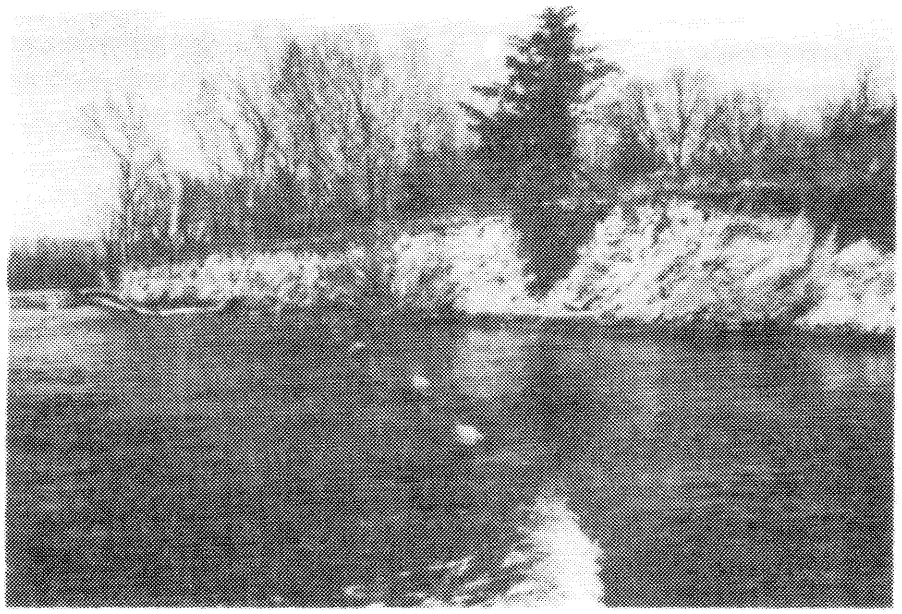
PHOTO 3. TYPICAL SEVERE EROSION CONDITIONS ALONG UPSTREAM PORTION OF THE PROJECT AREA. (Photo Taken 15 April 1980)

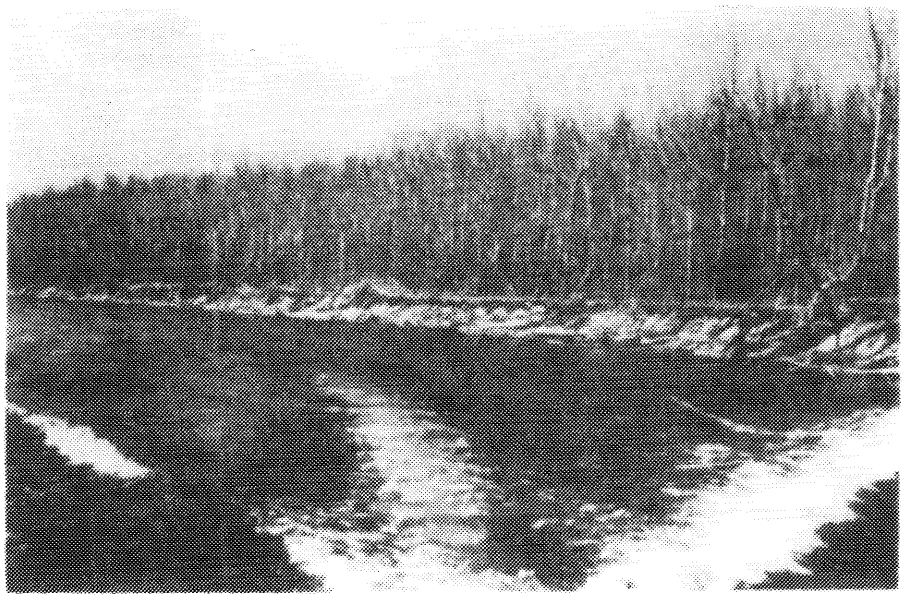
PHOTO 4. TYPICAL SEVERE EROSION CONDITIONS ALONG THE DOWNSTREAM PORTION OF THE PROJECT AREA. THIS BANKLINE WILL CONTAIN HARDPOINTS. (Photo Taken 15 April 1980)

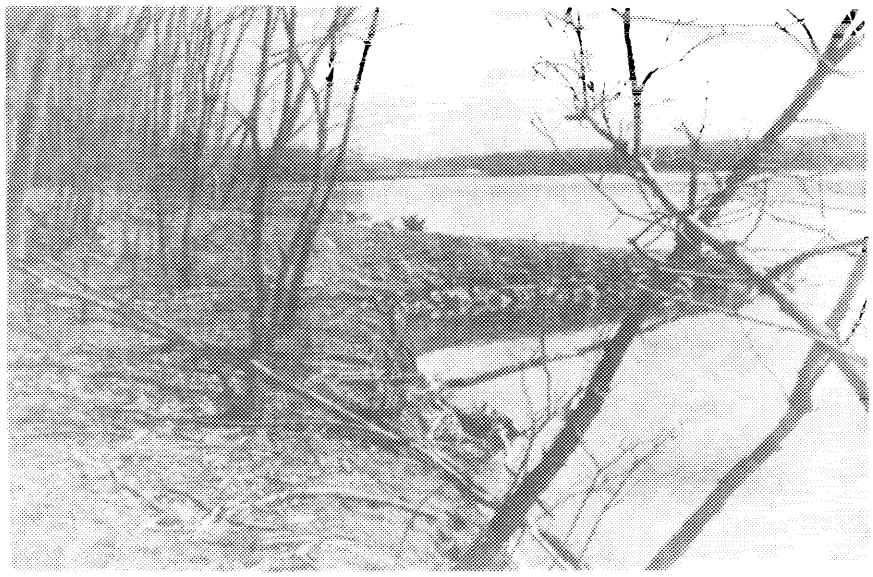
PHOTO 5. HARDPOINT 869.24, LOOKING UPSTREAM ALONG THE MIDDLE AND DOWNSTREAM PORTION OF THE PROJECT AREA. (Photo Taken 6 April 1981)

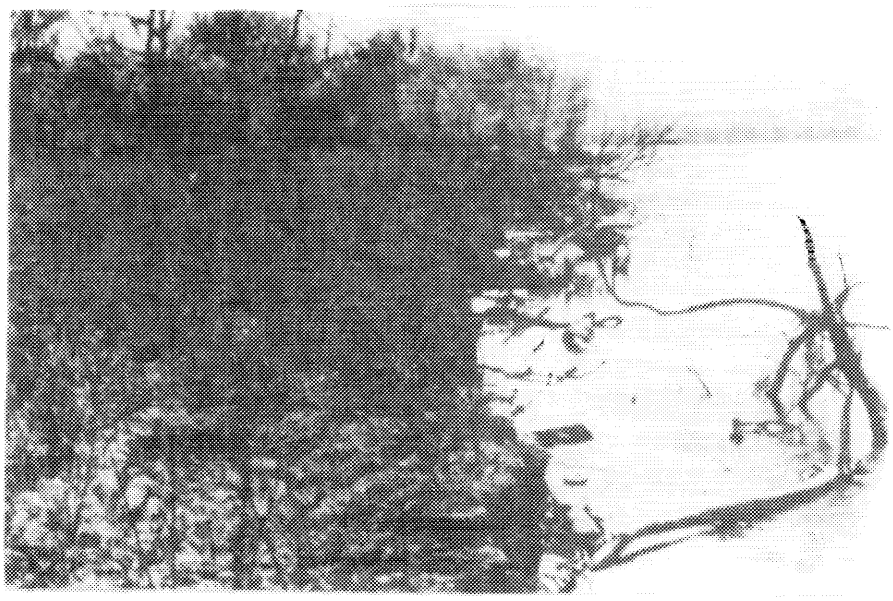
White Swan Area
Photos 7 and 8

PHOTO 7. SITE OF WINDROW REVETMENT 870.0, STATION 15+50 PRIOR TO CONSTRUCTION. (Photo Taken 19 September 1980)

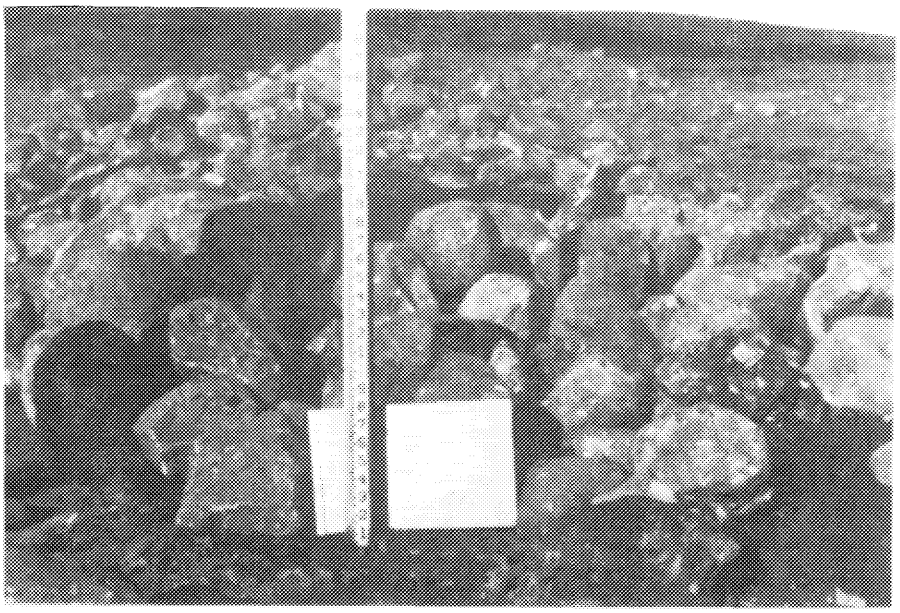
PHOTO 9. 200 LB. GRADATION TEST
(Photo Taken 19 April 1979)

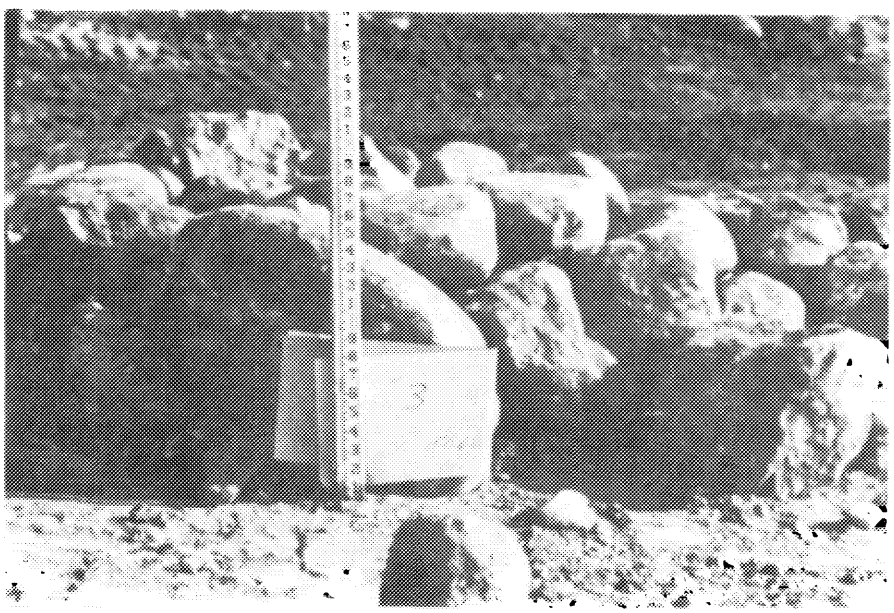
PHOTO 10. 500 LB. GRADATION TEST
(Photo Taken 10 March 1979)

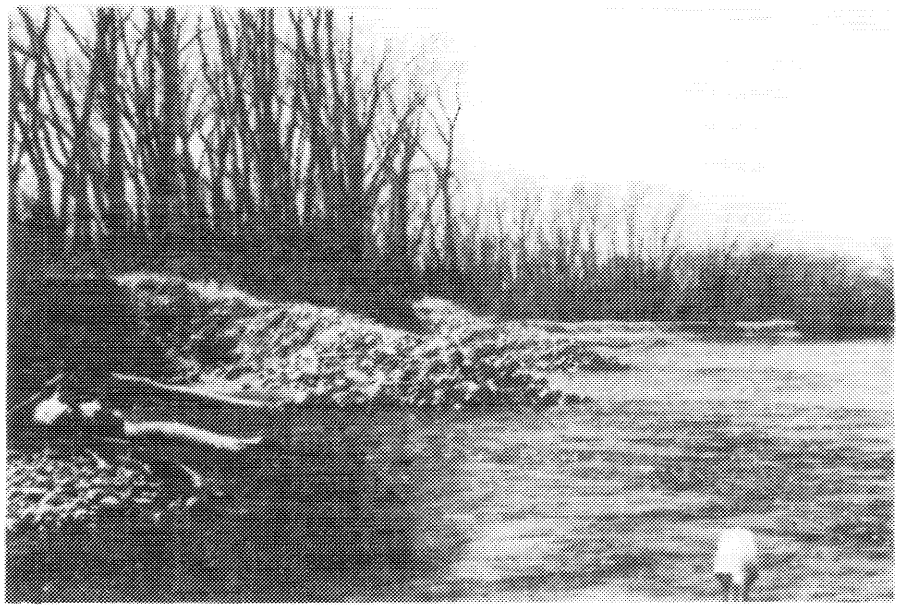
SUNSHINE BOTTOM PROJECT AREA
Photos 11 and 12

PHOTO 11. HARDPOINTS 866.9 AND 866.8, APPROXIMATELY 1 YEAR AFTER COMPLETION. (Photo Taken 15 April 1980)

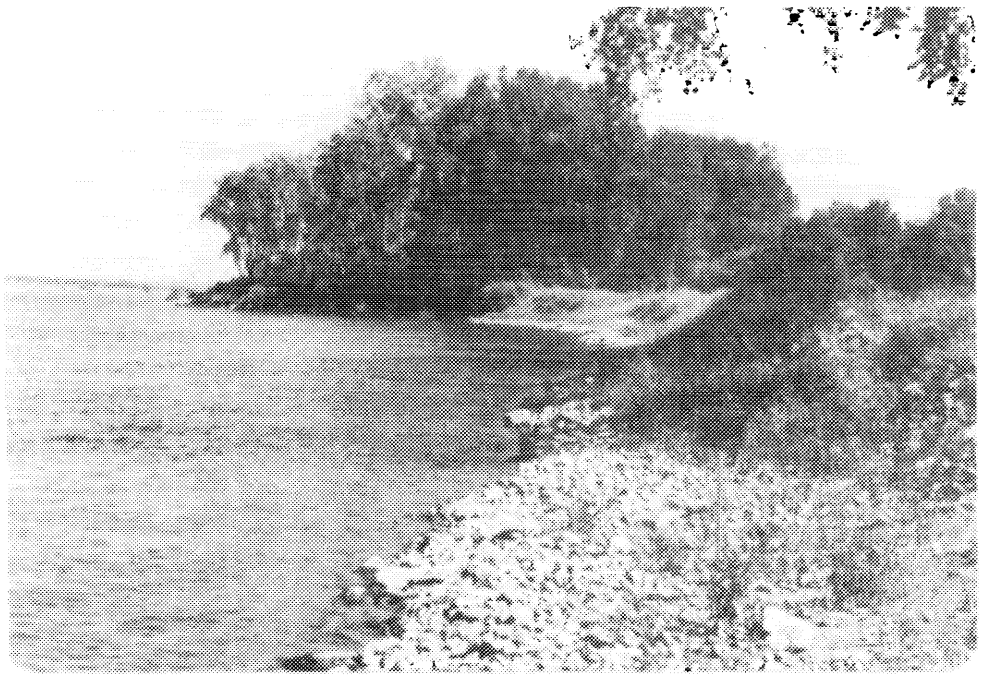
PHOTO 15. REINFORCED REVETMENT 867.0, STATION 0+00, APPROXIMATELY 15 MONTHS AFTER COMPLETION. (Photo Taken August 1980)

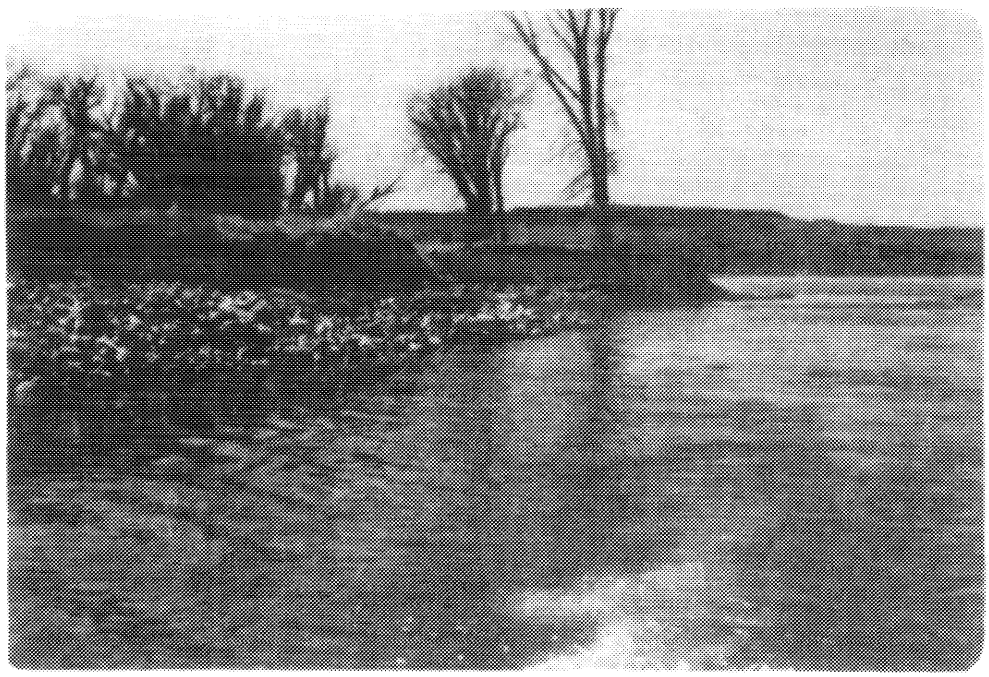
PHOTO 16. COMPOSITE REVETMENT 868.0, STA. 17+00, APPROXIMATELY 11 MONTHS AFTER COMPLETION. (Photo Taken 15 April 1980)

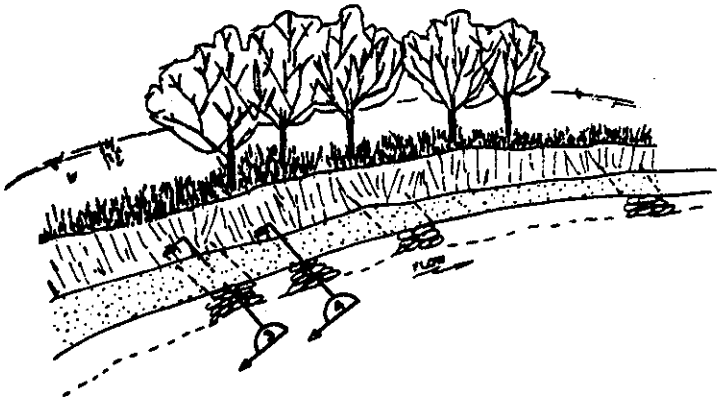
PLATE 0-7

c. **Reinforced Revetment.** The Reinforced Revetment structure, shown on Plate 0-7, consists of a toe of erosion-resistant material placed somewhat riverward of the bankline. The toe is then reinforced by intermittent stone-filled tiebacks, which are placed on the riverbank or in an excavated trench and extend landward from the toe to or into the riverbank. The toe fill material may either be high quality stone, low grade material, or both. The fill material used in the tieback is generally stone. The toe material is placed on the riverbed generally parallel to the natural bankline. The toe fill crown is generally constructed to the normal water surface elevation but may be lower. The stone tiebacks slope upward from the crown of the toe to several feet above the normal water surface elevation at the existing bankline. Between tiebacks, the upper bank may be graded to fill in the voids between tiebacks, the bank, and the toe. The upper bank surfaces of the reinforced revetment may be generally covered with either gravel or topsoil and seeded to satisfy aesthetic and environmental considerations.

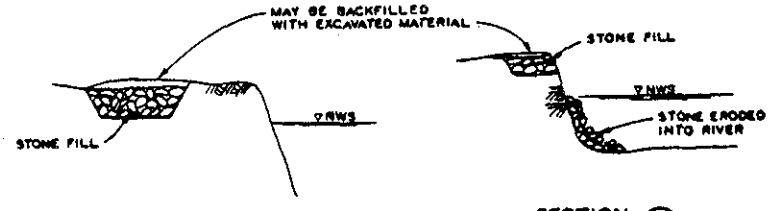
PLATE 0-8

a. **Windrow Revetment.** The Windrow Revetment structure, shown on Plate 0-8, consists of a mound of stone placed either on the overbank, or partially or totally buried, immediately adjacent and parallel to the general alignment of the eroding bankline. In theory, a minimum windrow is placed first and then as the bank erodes, the stone sloughs and blankets the new bank at a naturally established slope. Then stone material is added on an as-needed basis until equilibrium (i.e., a stable bank) is established. This provides a structure containing the least possible amount of stone, and accordingly, the least cost for a revetment-type structure. Variable factors that require evaluation include stone gradation, mound size and shape, minimum initial application rate, size and shape of the excavated trench, and structural segment lengths and spacing. The Windrow Revetment is an excellent technique in areas where river flows are unusually deep and swift along the toe of the bankline. This technique avoids the excessive quantity of material needed to construct a fill within the water area in such situations. However, the presence of improvements or heavy timber usually necessitates substitution of alternate techniques in areas otherwise suited to windrow revetment.

2. **HARDPOINTS.** The Hardpoint structure, shown on Plate 0-8, are used when possible in lieu of revetment systems as a more economical measure and also to develop diversity in the aquatic and near-bank environment. They are best utilized along relatively long, convex-shaped or straight bankline increments having water depths of 5 to 10 feet. A hardpoint consists of two components: a short spur 30 to 50 feet long of erosion resistant material extending from the bank into the river; and a root of erosion-resistant material 30 to 50 feet long placed in a trench excavated landward from the bankline. The upstreammost hardpoint in multi-hardpoint systems may be of heavier section than the "shaded" downstream hardpoints. The crown width of the spur varies up to 10 feet maximum and is generally inversely proportional to water depth. This width may also reflect maintenance and access considerations. The crown elevation is generally at the normal water surface at the riverward end, and slopes up to varying elevations at the bankline, depending on bank height and root type. There are two basic root types; a deep "V" trench excavation for high banks and a wide, shallow trench for low banks. Spurs are angled 10°-20° downstream of the normal to the bankline and are designed to provide an adequate amount of material to withstand anticipated scour conditions.
