**Periodic Inspection Report No. 5
Hancock Brook
Plymouth, Connecticut**

Hancock Brook Lake

November 1995

**US Army Corps
of Engineers**

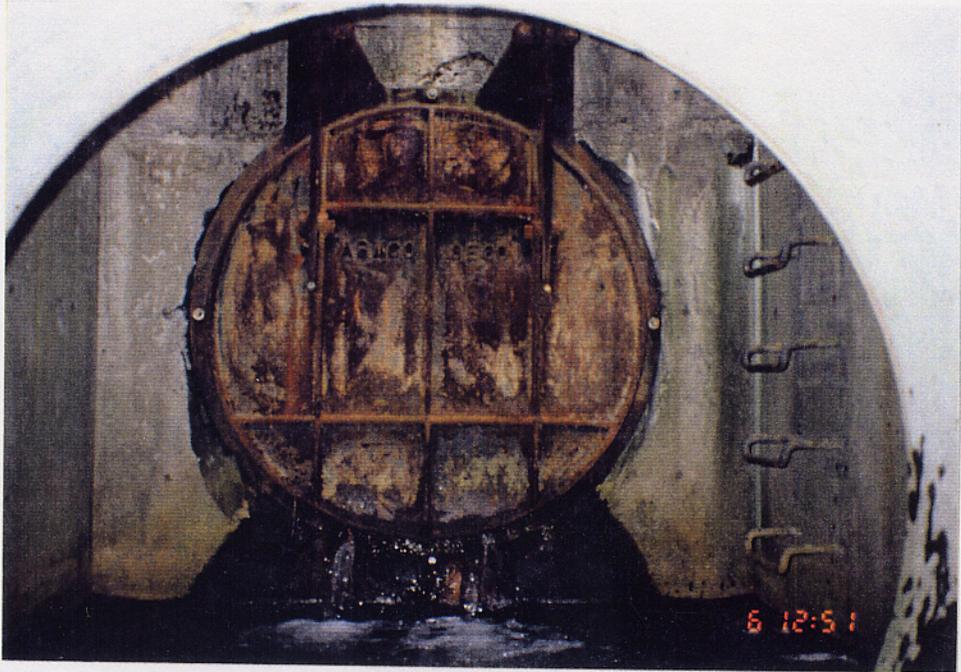
Photo B-1: Diversion Dike 1 Flap Valve

(1) Diversion Dike 1 Flap Valve. The 60 inch diameter flap valve was visually inspected and no mechanical deficiencies were noted (see photo 1). See the structural comments for the condition of the reinforced concrete pipe at the valve and the valve frame.

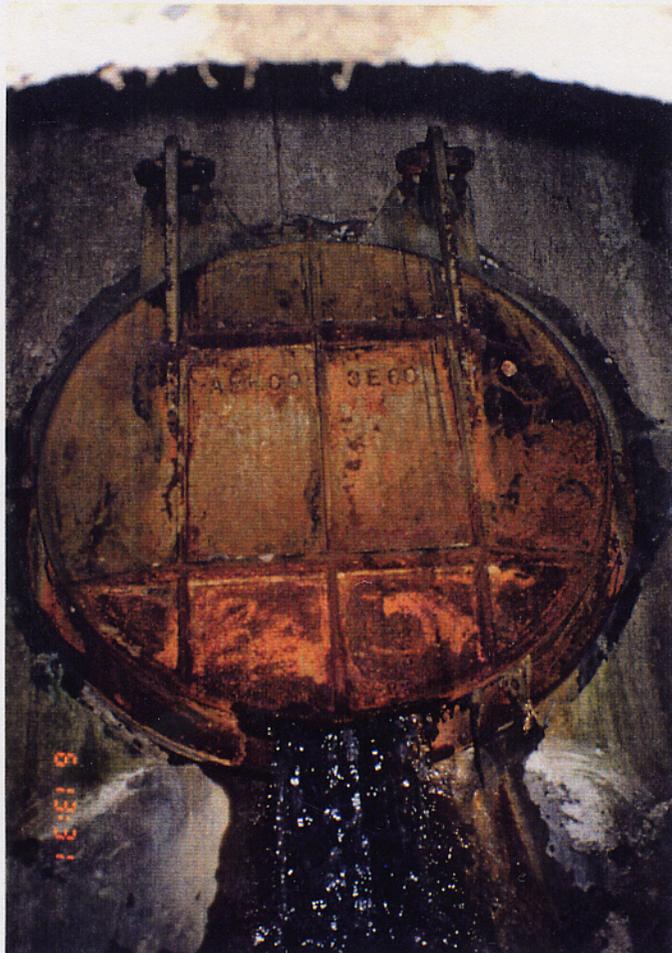
Photo B-2: Diversion Dike 2 Flap Valve

(2) Diversion Dike 2 Flap Valve. The 60 inch diameter flap valve was visually inspected and no mechanical deficiencies were noted (see photo 2). See the structural comments for the condition of the reinforced concrete pipe at the valve and the valve frame.

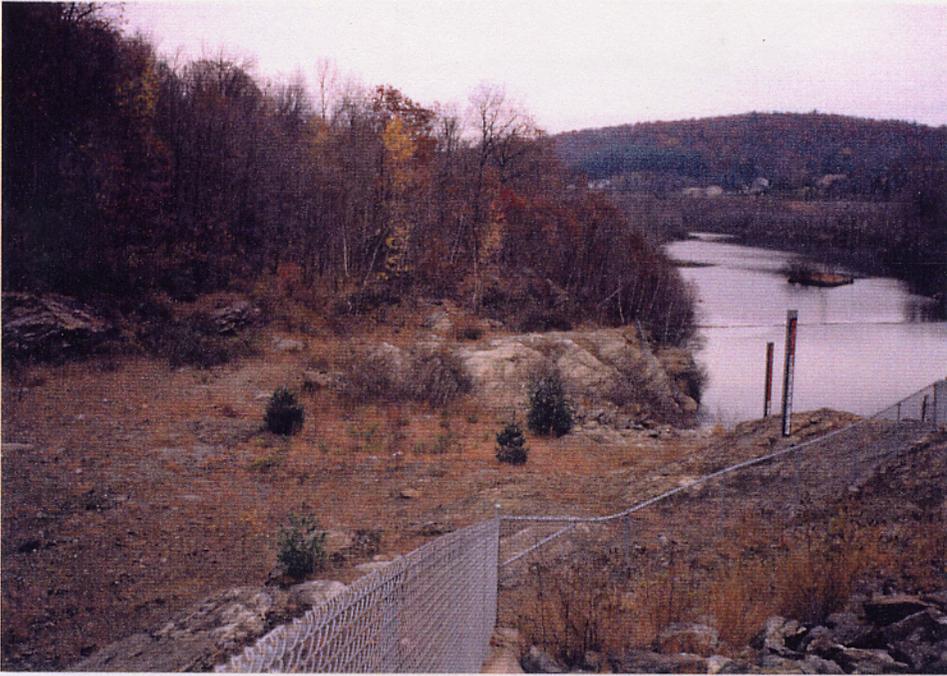
Photo D-1. Spillway approach channel.

a. Approach. The overall condition of the approach channel is good with no major obstructions (photo 1). There are a few small pine trees near the junction of the channel and reservoir.

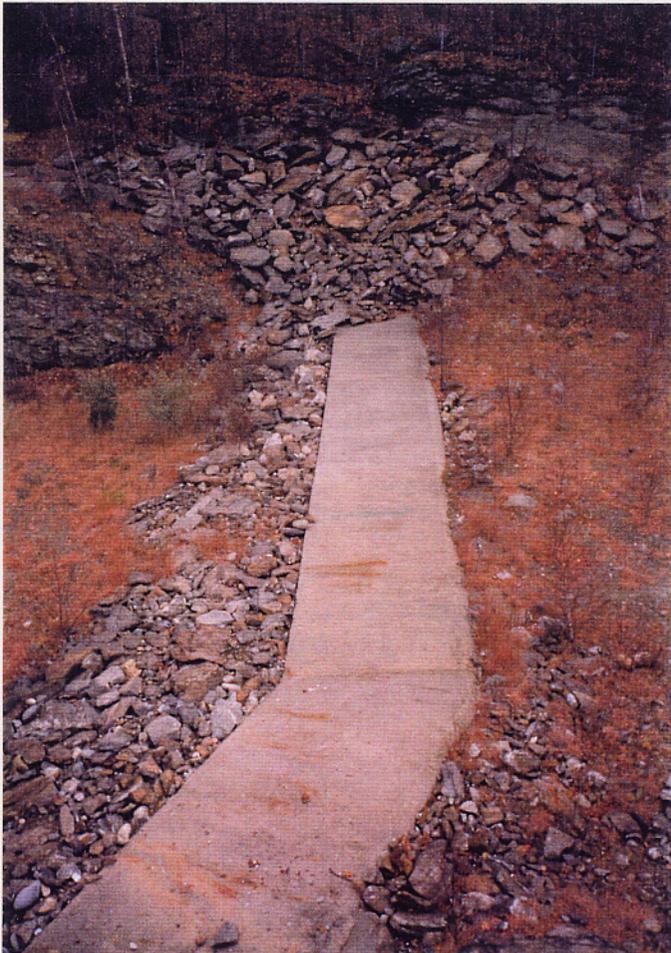
Photo D-2. Spillway weir.

b. Control. The concrete spillway weir is in good condition with no major cracks or spalls that would affect hydraulic capacity (photo 2).

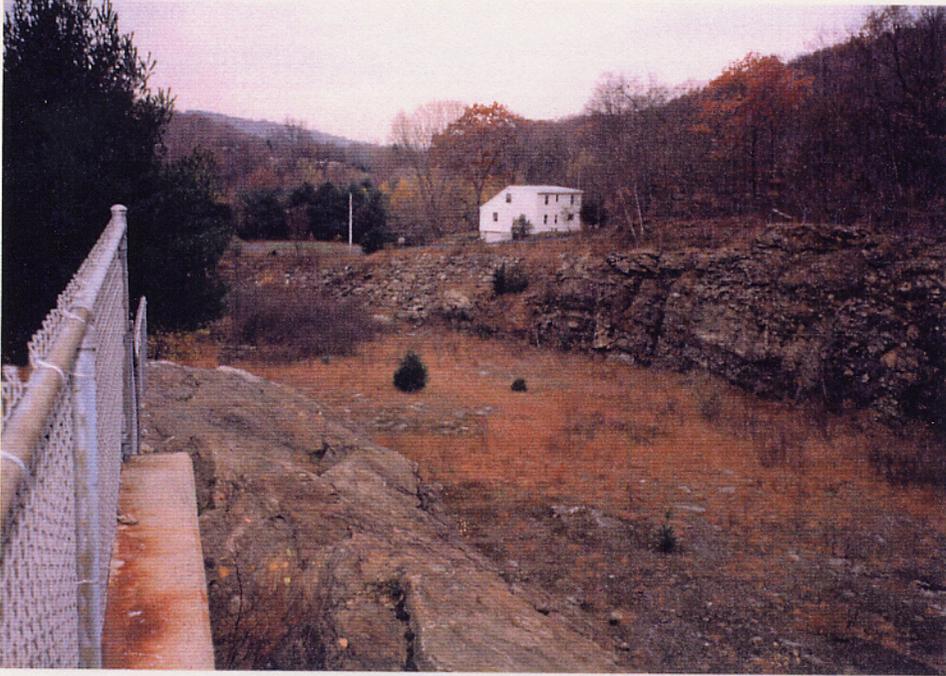
Photo D-3. Spillway exit channel.

c. Exit. The spillway exit channel is in good condition with no major outgrowth of trees or vegetation which would obstruct flow (photo 3).

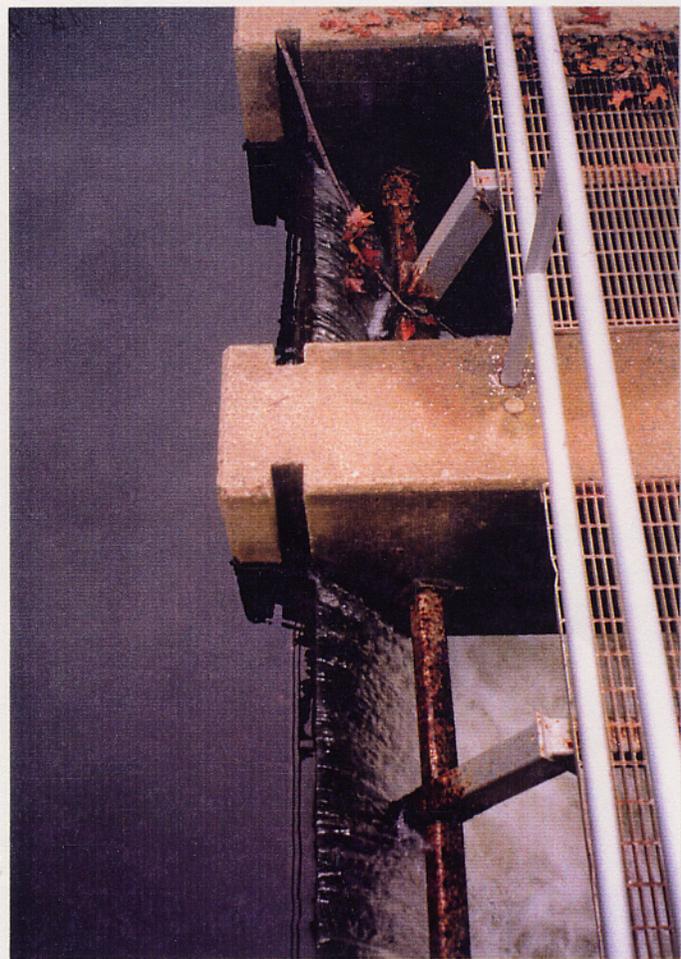
Photo D-6. West side of intake weir.

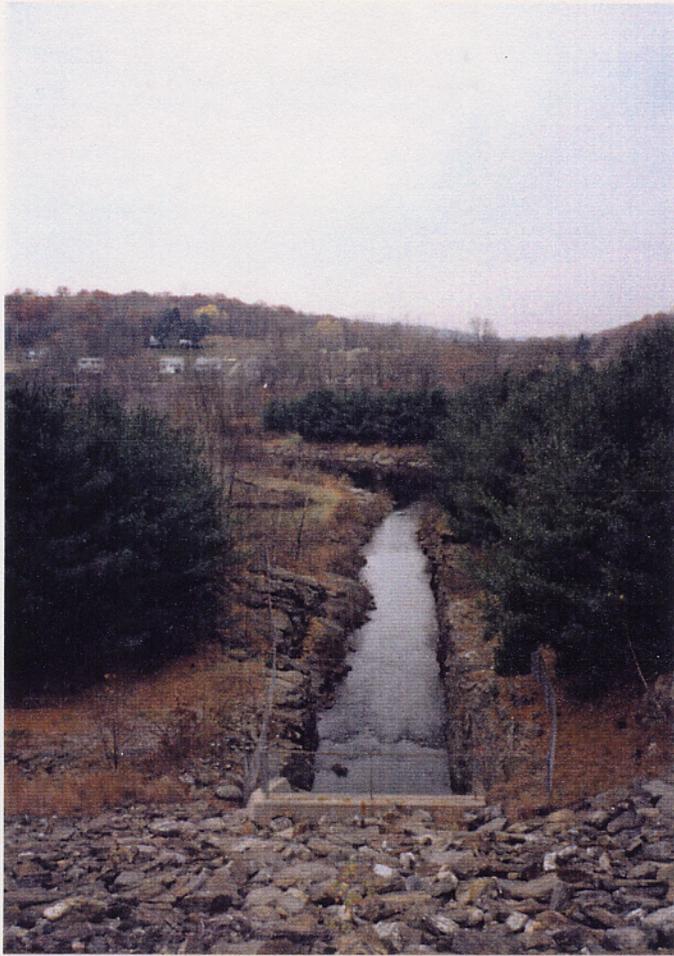
Photo D-7. Looking downstream at exit channel.

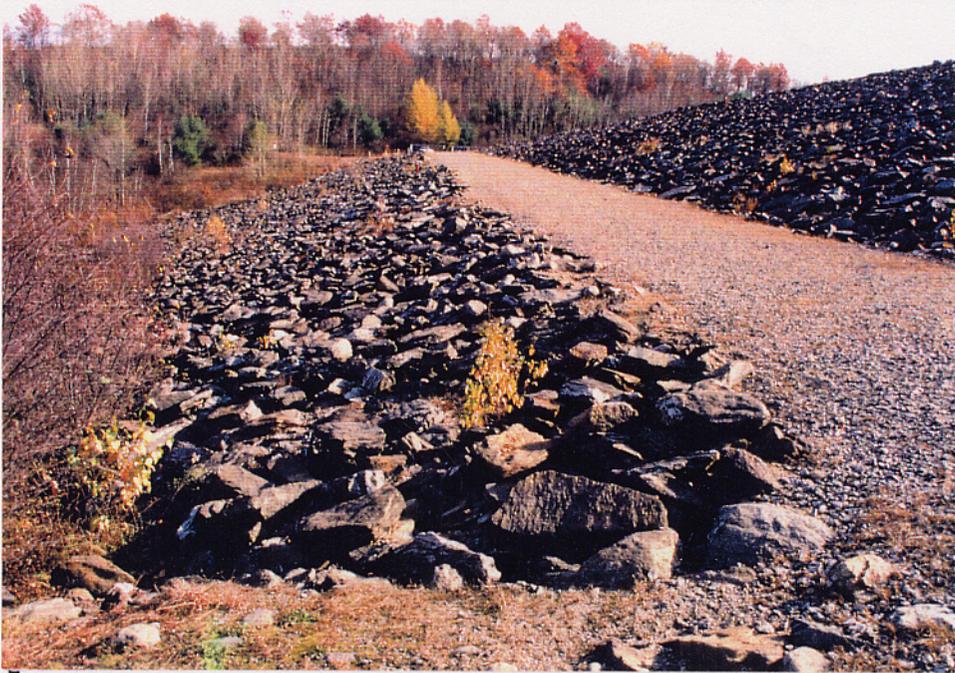
▲PHOTO E-1: Upstream slope and toe access road.

(2) Upstream Slope. The slope is in good condition and appears stable with no indication of movement or sloughing (Photo 1). Stone quality is good but the size varies with an occasional weathered piece of schist

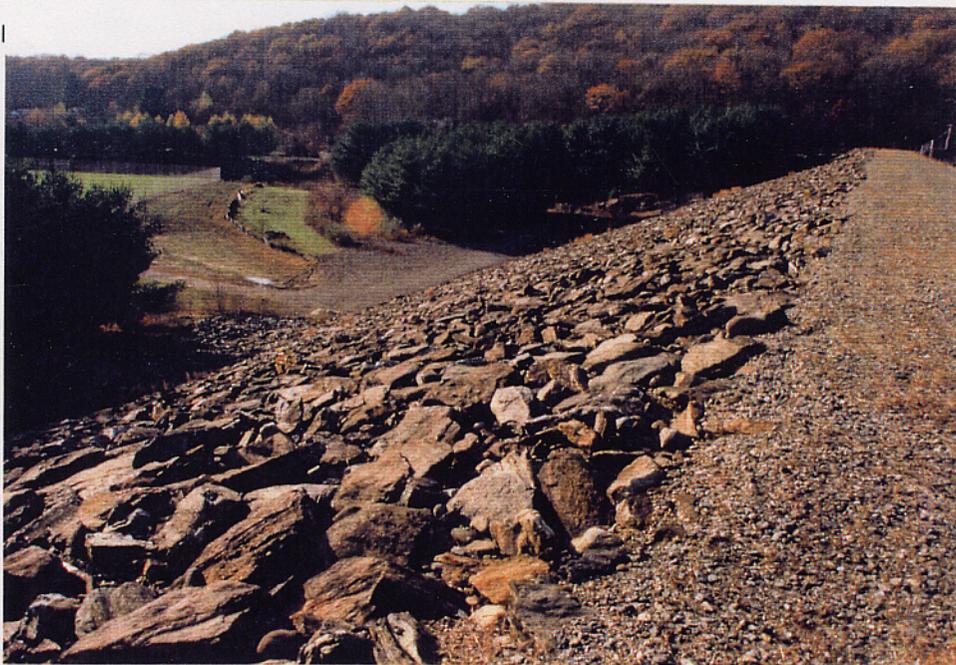
▲PHOTO E-2: Downstream slope and toe.

(3) Downstream Slope. The downstream slope appears stable. The stone protection material on the surface is highly variable in size (Photo 2). There are numerous scattered schist blocks on the surface that have weathered to fines. There is no significant erosion of these fines at this time.

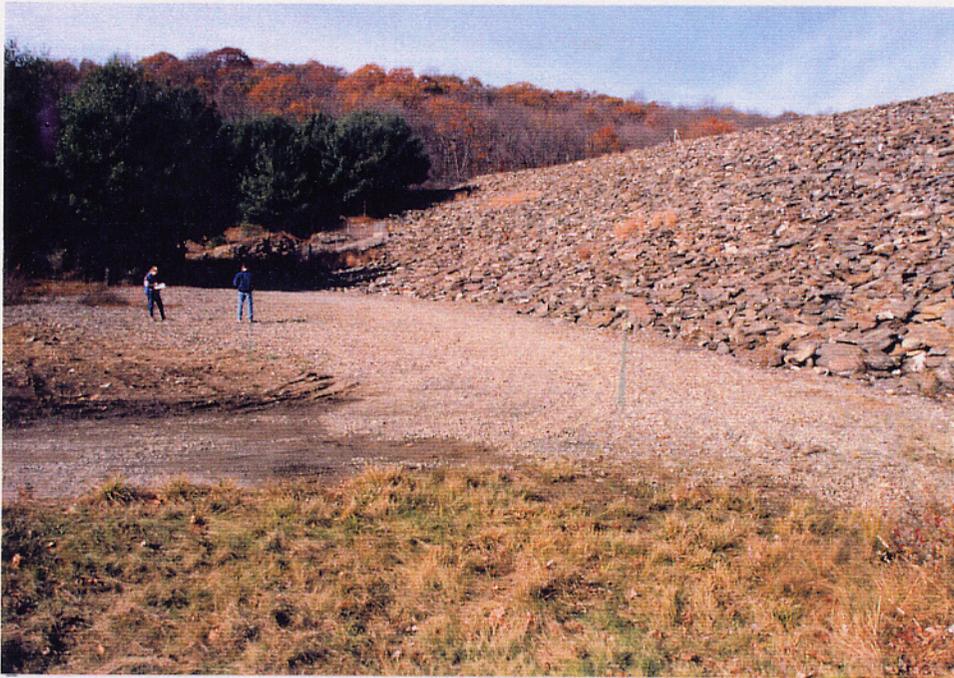
▲PHOTO E-3: Downstream toe - crushed stone fill area.

(4) Seepage. No piping, boils or sink holes were observed during the inspection or reported by the Project Manager. A small amount of standing water (1-2 inches) was noted in the crushed stone fill between the diversion drainage ditch and the downstream toe of the slope. Historically, there has been water accumulated in this area as it is surrounded by higher ground (Photo 3). The drainage ditch constructed to drain this area appears to have too flat a gradient or it may slope towards the dam.

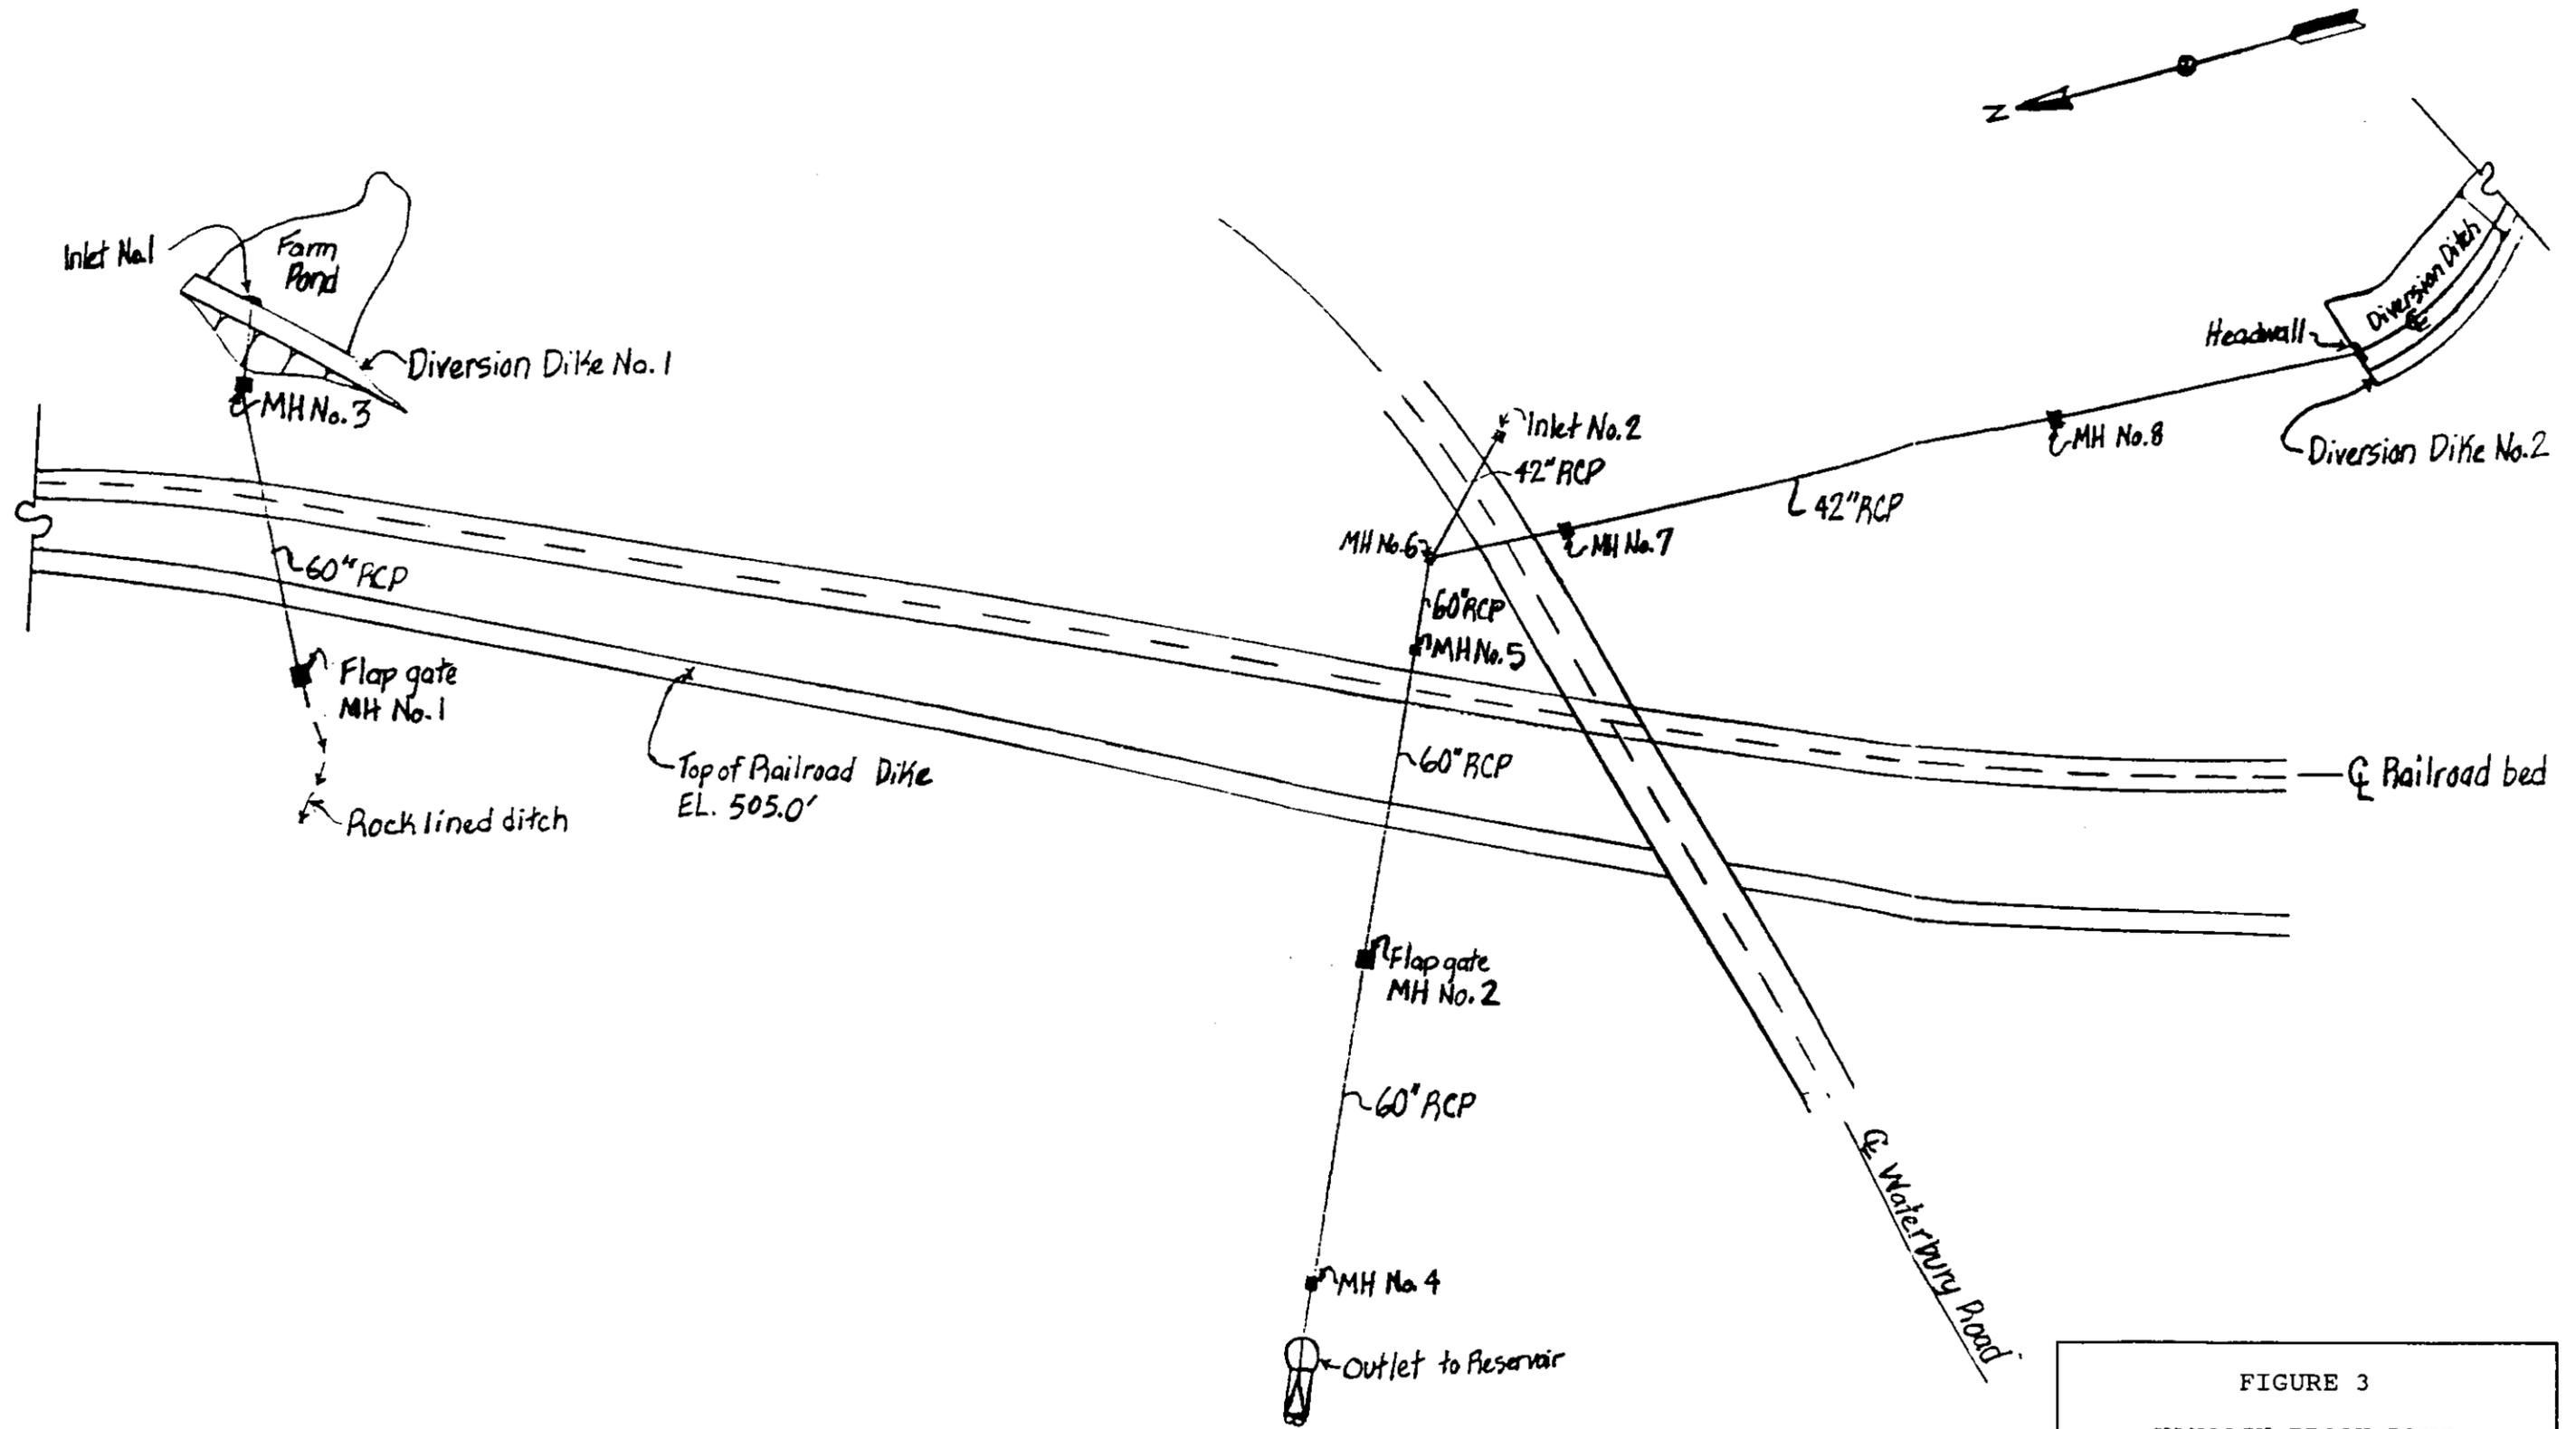
FIGURE 3
HANCOCK BROOK LAKE
CONFIGURATION OF DIKES

(2) Dikes. There are three dikes associated with Hancock Brook Lake. A main dike runs parallel and west of the Penn Central railroad tracks. It crosses Waterbury Road about 2,000 feet from the dam along the east bank of the reservoir. In addition, two small diversion dikes are located on private property upland of the railroad tracks. Two 60-inch diameter reinforced concrete pipes (RCP) run from the diversion dikes under the main dike and into the reservoir (figure 3). The Corps' legal responsibility is limited to maintenance of the main dike. In September 1991, a determination was made by Real Estate Directorate that the Corps was not legally responsible for maintenance of either the diversion dikes or conduits, which are owned by Penn Central Transportation Corporation. However, NED has adopted the policy of maintaining the two 60-inch diameter RCPs from the point where they cross under the main dike onto Corps' property. As a result, the two diversion dikes were not inspected, while portions of the 60-inch RCPs, which lie under the main dike, were inspected.
