Report on the Dam of the Holyoke Water Power Company  
Holyoke, Massachusetts

1945

War Department  
United States Engineer Office  
Providence, Rhode Island

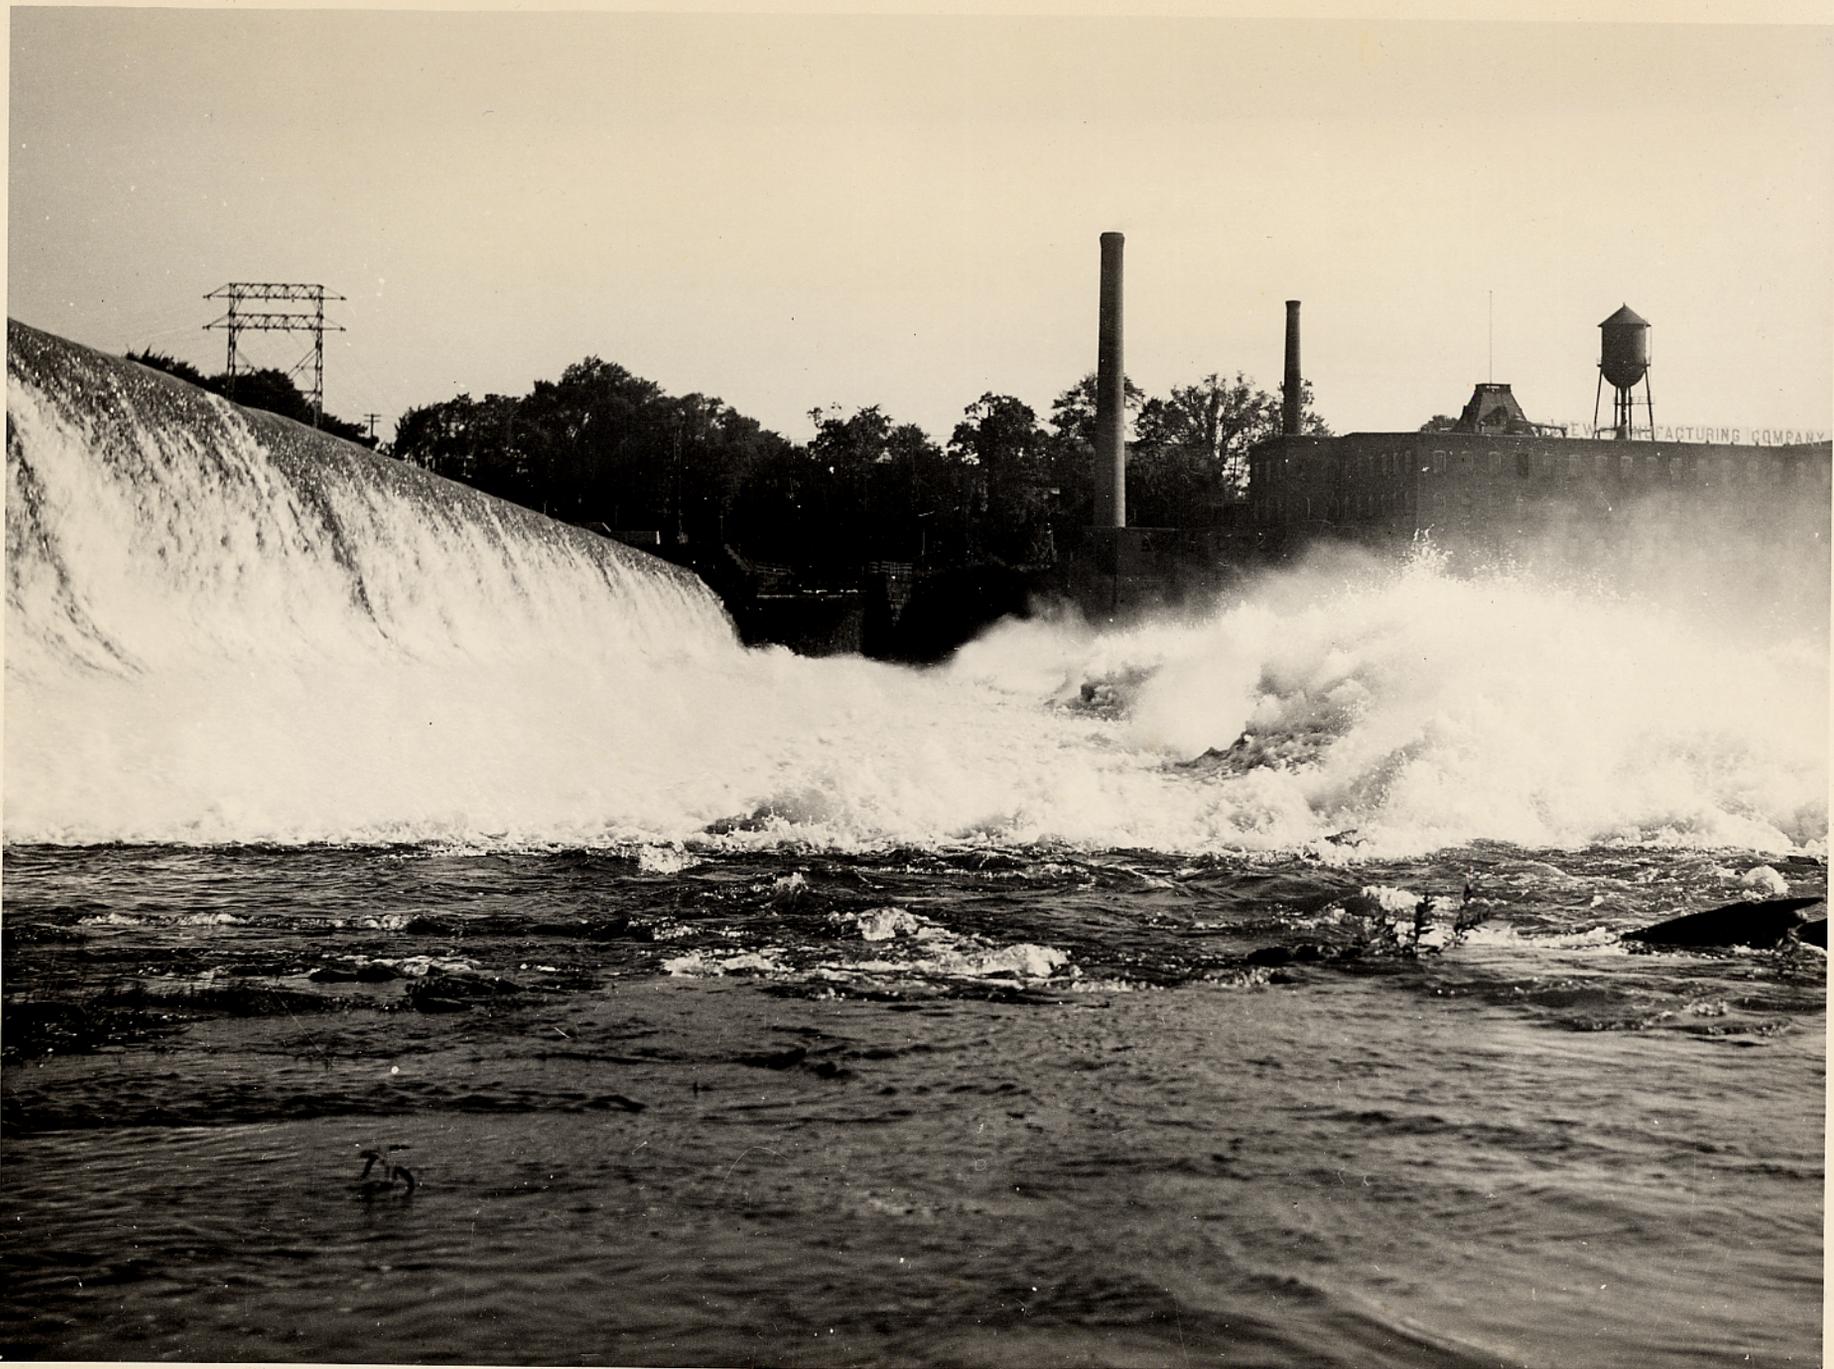
c. Damage to the Masonry Dam in 1936 - The 1936 floods resulted in the displacement of the capstones at the crest of the dam to a depth of 5 feet. The exact time of the accident is not known but is believed to have occurred during a minor crest, accompanied by ice passage, which occurred about one week in advance of the record-breaking March 21, 1936 flood. It has been reported that the amount of material which it was necessary to replace is as shown on Plate No. 3. Concrete was used to replace the lost capstones. The section shown is typical for the full length of the dam with the exception of 28 feet at the left abutment and 6 feet at the right abutment, where no damage occurred, and also with the exception of 213 feet where the stone indicated in dotted lines on Plate No. 3 withstood the water pressure. Those capstones which did not carry away were permitted to remain in place. The structural members indicated on Plate No. 3 were for the purpose of supporting the concrete forms and the coffer dam, and were left in place in the concrete.

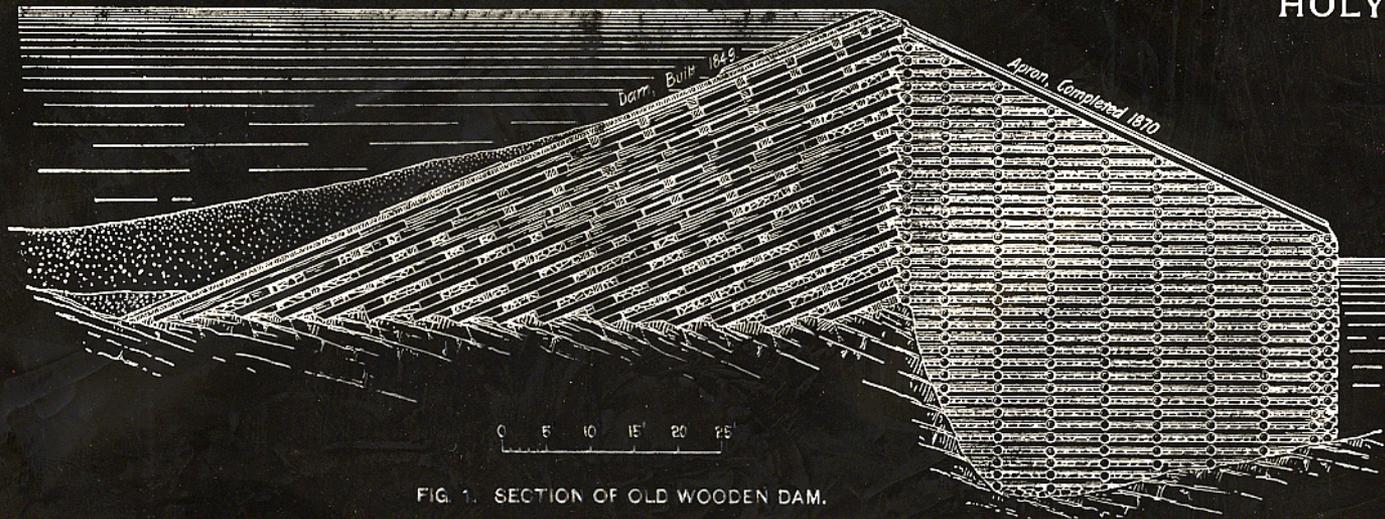
FIG. 1. SECTION OF OLD WOODEN DAM.

"The permanent dam shown in Fig. 1, Plate No. 1, was begun the following year and finished in the summer. This dam is still standing, but will soon be replaced by a masonry dam below it. It is 1017 feet long and has a maximum height of about 30 feet. The down-stream face of the dam was originally made vertical, but in 1870 a sloping apron was built in front of the dam, as shown in Plate No. 1.

"The water, ice, logs, etc., passing over it rapidly wore away the rock in front of it. By 1868 the ledge had been eroded to a depth of 20 to 25 feet, and the dam had become undermined in some places. Besides the wearing out of the rock, the front timbers had become injured by logs and ice which, after passing over the dam, were forced against the front face by the eddies caused by the falling water. In some cases logs having become wedged among the front timbers and being struck by the falling water forced the timbers apart, acting like large levers. In order to protect the dam against such injuries and to reduce the fall of the water, a large inclined apron of cribwork was built in front of the dam during the years 1868, 1869, and 1870 (Plate No. 1.). This crib, which exceeds the original dam in volume, was built of round logs laid so as to form pockets 6 by 6 feet, which were filled with stone to the top before the covering, consisting of 6-inch planks of hard wood, was put on. The cost of the apron is given variously as \$263,000 to \$350,000--about double the cost of the original dam.

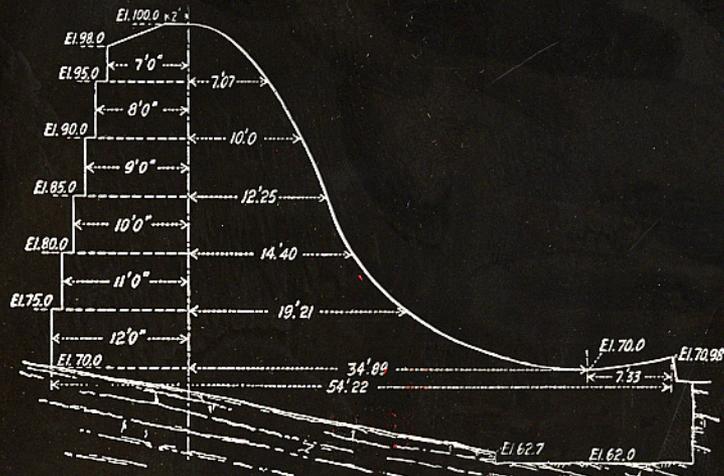
FIG. 2. OUTLINE SECTION OF DAM.

"Figs 2 and 3, Plate No. 1, show the profile adopted for the masonry dam. The upper part of the down-stream face is the parabola, which a sheet of water 4 feet in depth over the crest would describe in falling freely. The parabola continues to the point of reversing below which a cycloid (the curve of "quickest descent") is adopted for the face. At the extreme toe the face is turned somewhat upwards to break the force of the water and to prevent it from cutting the ledge beyond. The back slope forms a series of steps, 5 feet high, equivalent to a batter of 1 foot in 5 feet. The length of the rollway of the new dam will be 1020 feet. The plans for the masonry dam were prepared by Mr. E. S. Waters, Chief Engineer of the Holyoke Water Power Company."
