Access Study to all Pertinent Parts of  
Dam Projects During High Reservoir  
Conditions

# **Upper Connecticut Basin New Hampshire and Vermont**

JULY 1992

**US Army Corps  
of Engineers**  
New England Division

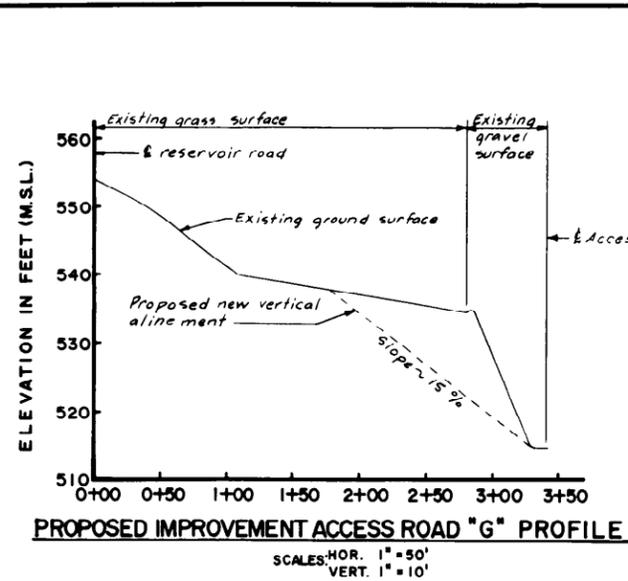
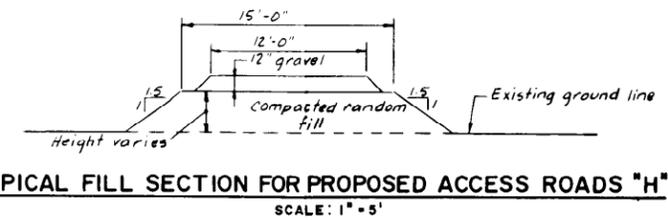
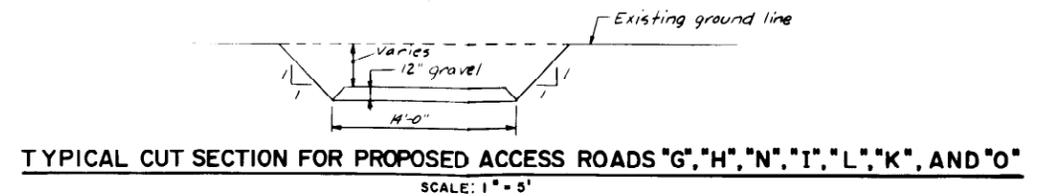
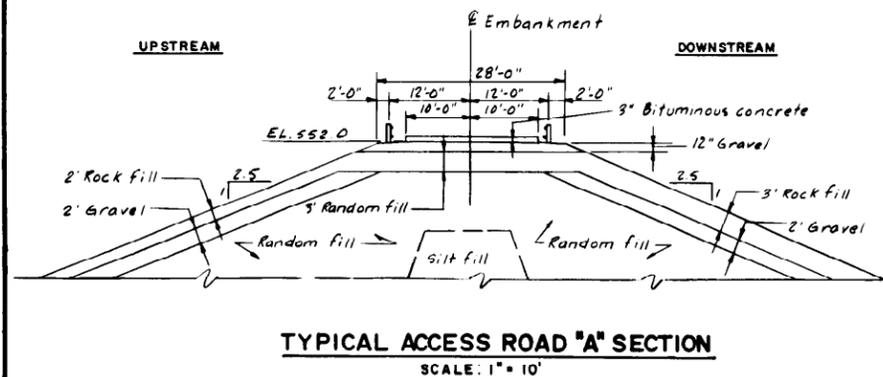
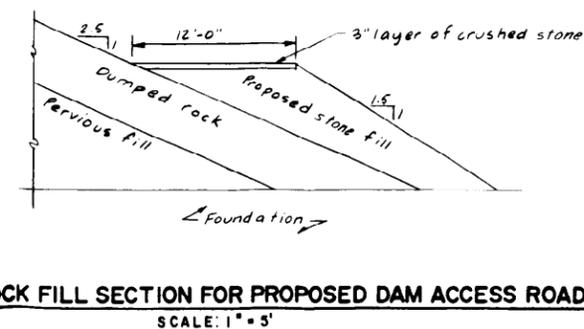
DEPARTMENT OF THE ARMY NEW ENGLAND DIVISION CORPS OF ENGINEERS WALTHAM, MASS.	
DES. BY: _____	<b>EMERGENCY ACCESS STUDY UPPER CONNECTICUT RIVER BASIN</b>
DR. BY: _____	
CK. BY: _____	
NORTH SPRINGFIELD LAKE PROFILES AND SECTIONS	
GEOTECH. ENG. DIV. PLATE C-2	SCALE: AS SHOWN DATE: SEPT. 1990

3. Adequacy of Access. The access to the downstream toe of North Springfield Dam is adequate except for Access Road "K" which has a grass surface. It appears Access Road "K" might soften during high water conditions. Then it would become difficult to operate heavy equipment on it.

The outlet channel and structure are very difficult to reach during both low and high water conditions. Stone slopes completely surround the outlet channel and structure. Only light weight equipment can be lowered from Access Roads "A" and "B" to the outlet channel and structure area.

9. Adequacy of Access. Access to the outlet works at North Springfield Dam is inadequate. The grass surface and steep slopes of Access Road "H" to the inlet channel and structure do not meet the design criteria. Only lightweight equipment can reach the outlet structure and channel under very difficult conditions.

4. Recommended Improvements. It is recommended that Access Road "K" be cleared, grubbed and surfaced with 12 inches of gravel to meet design criteria.

7. Recommended Improvements. Access Road "I" should be upgraded to allow heavy equipment to operate on it immediately after high water events. It should be extended to meet Access Road "H". The grass on the road (approximately thirty percent of the area) should be removed and grubbed. Soft materials under the grass or along the gravel portions of the road should be removed 12 inches of gravel shall be placed on former grass portions of the road, and six inches of gravel shall be placed on the existing gravel portions of the road. A small amount of gravel may be needed to use Access Roads "J" and "L" after heavy rain and high water events.
