WILSONVILLE, CONNECTICUT
FRENCH RIVER

LANGERS POND DAM
CT-00186

**NATIONAL DAM INSPECTION PROGRAM
CORPS OF ENGINEERS**

INSPECTION REPORT
LANGERS POND DAM
CT 00186

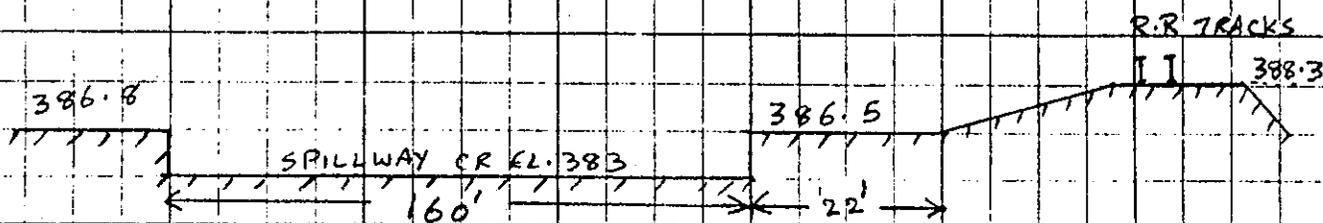
APPROXIMATE POTENTIAL OVERFLOW PROFILE
 (BASED UPON CAHN INC'S FIELD INFORMATION)

SPILLWAY CREST ELVD = 383 NGVD*
 TOP OF THE DAM EL = 386.5 (ELVN OF THE LEFT ABUTMENT - CONCRETE WALL)
 TOP OF THE DAM EL = 372.5
 HEIGHT OF THE DAM = 14 FT (4c)

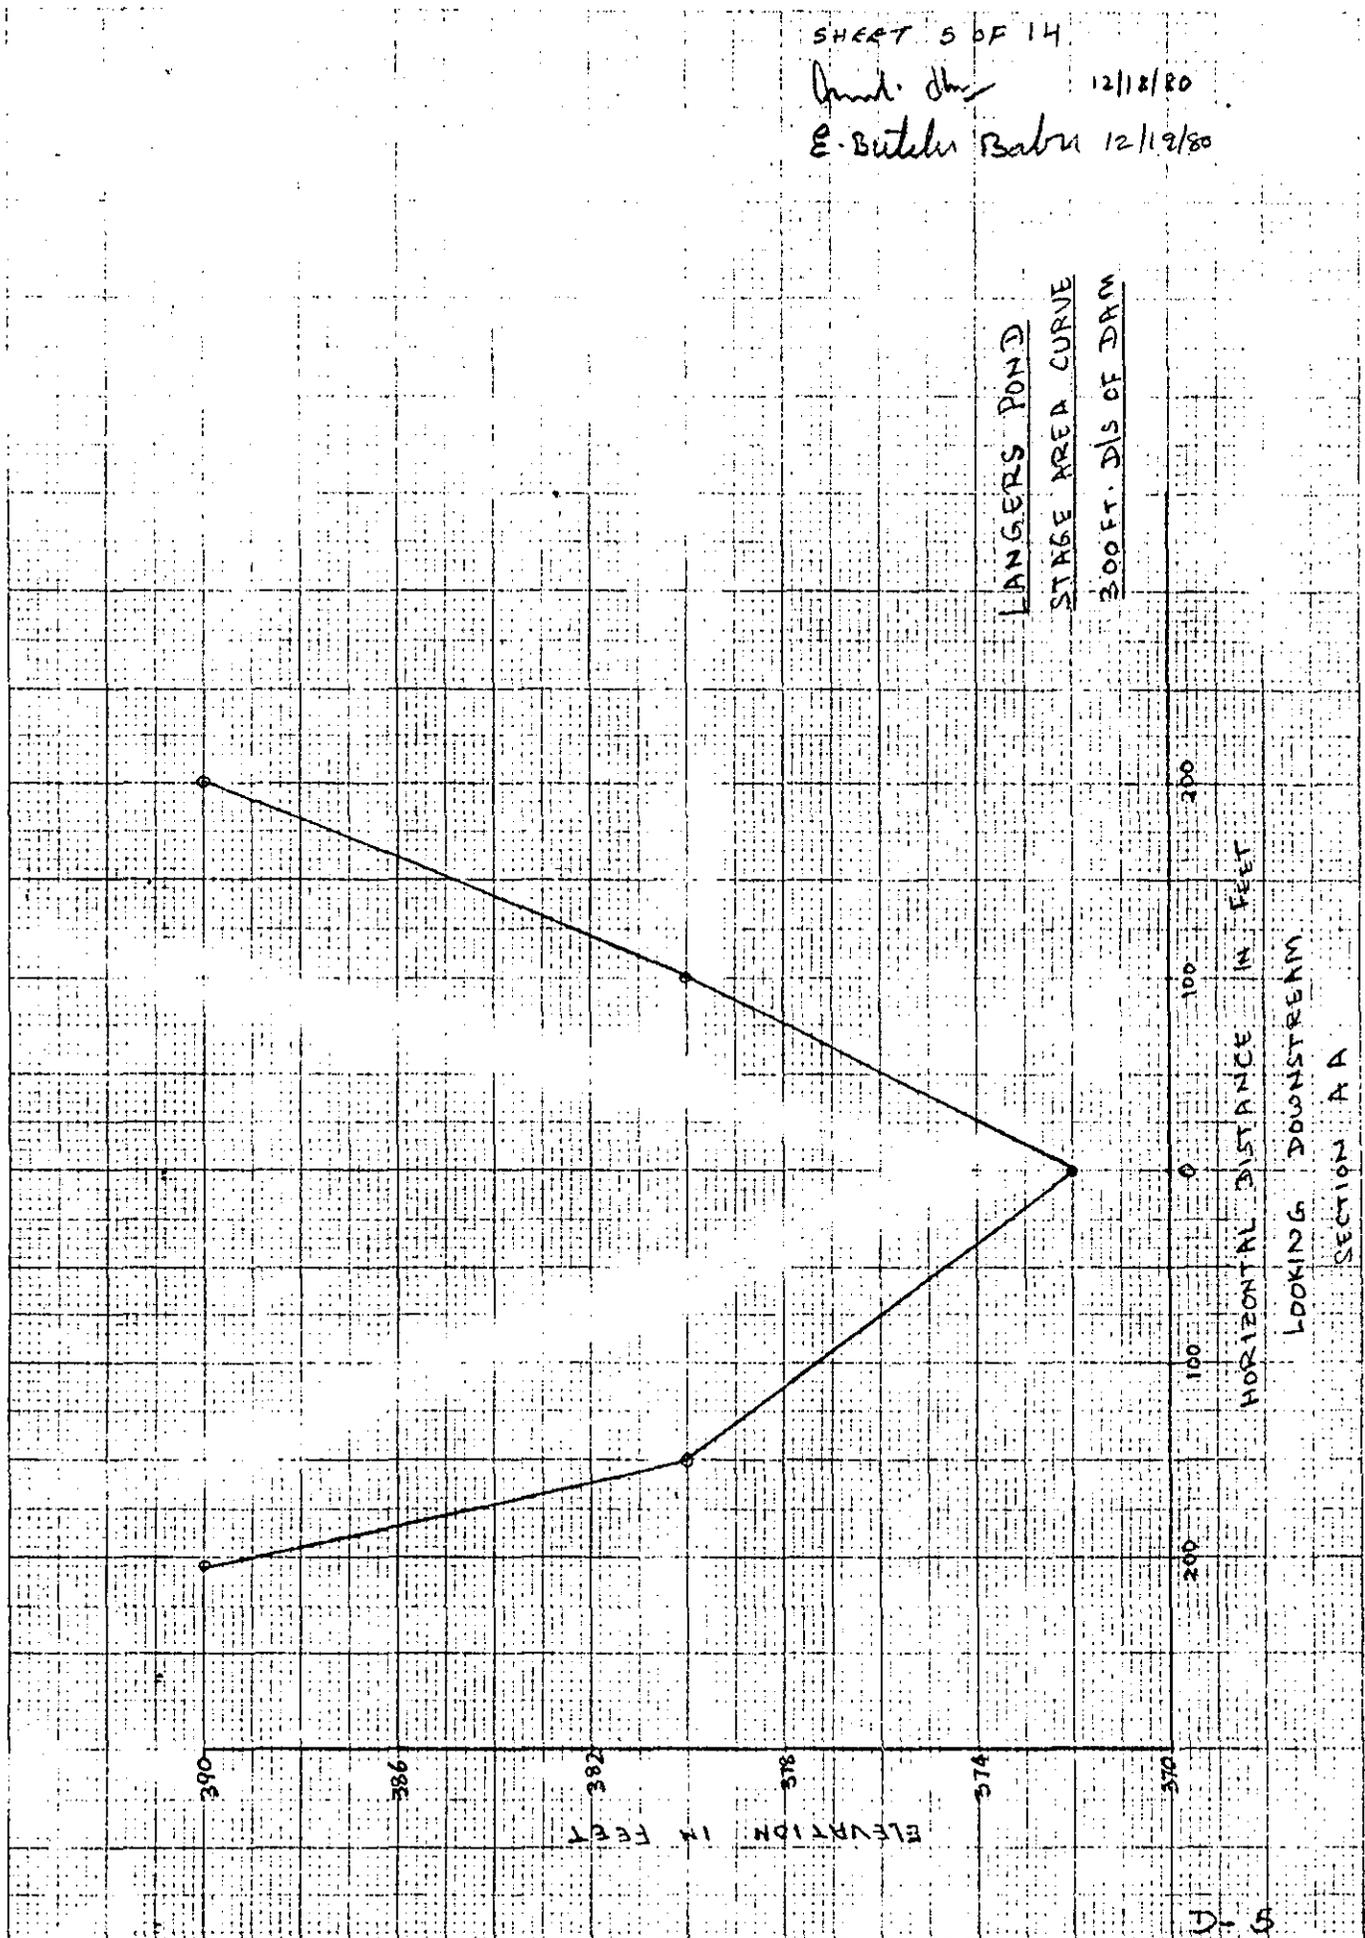
LANGERS POND
STAGE AREA CURVE
300 FT. D/S OF DAM

STAGE-AREA AND STAGE DISCHARGE CURVES ARE PLOTTED FOR SECTION AA
 FOR PEAK FAILURE OUTFLOW $Q_{P1} = 7840$ CFS,
 ELVN = 385.2 FROM STAGE DISCHARGE CURVE.
 FROM STAGE-AREA CURVE AREA = 2188 SQ. FT

LOOKING DOWNSTREAM
SECTION A-A

AT SECTION AA, THE FLOOD STAGE IS 384.6 WHEREAS THE 1ST FLOOR ELEVATION OF SIMONDS MANUFACTURING BUILDING IS 386.6. HOWEVER, THE LOWER FLOOR OF THE BUILDING ADJACENT TO THE RIVER COULD BE SUBJECT TO FLOOD DAMAGE. ALSO, THE RAILROAD TRACKS COULD BE INUNDATED IN THE VICINITY OF SECTION AA. BETWEEN SECTION AA AND CC, NO OTHER STRUCTURE IS LIKELY TO BE FLOODED.

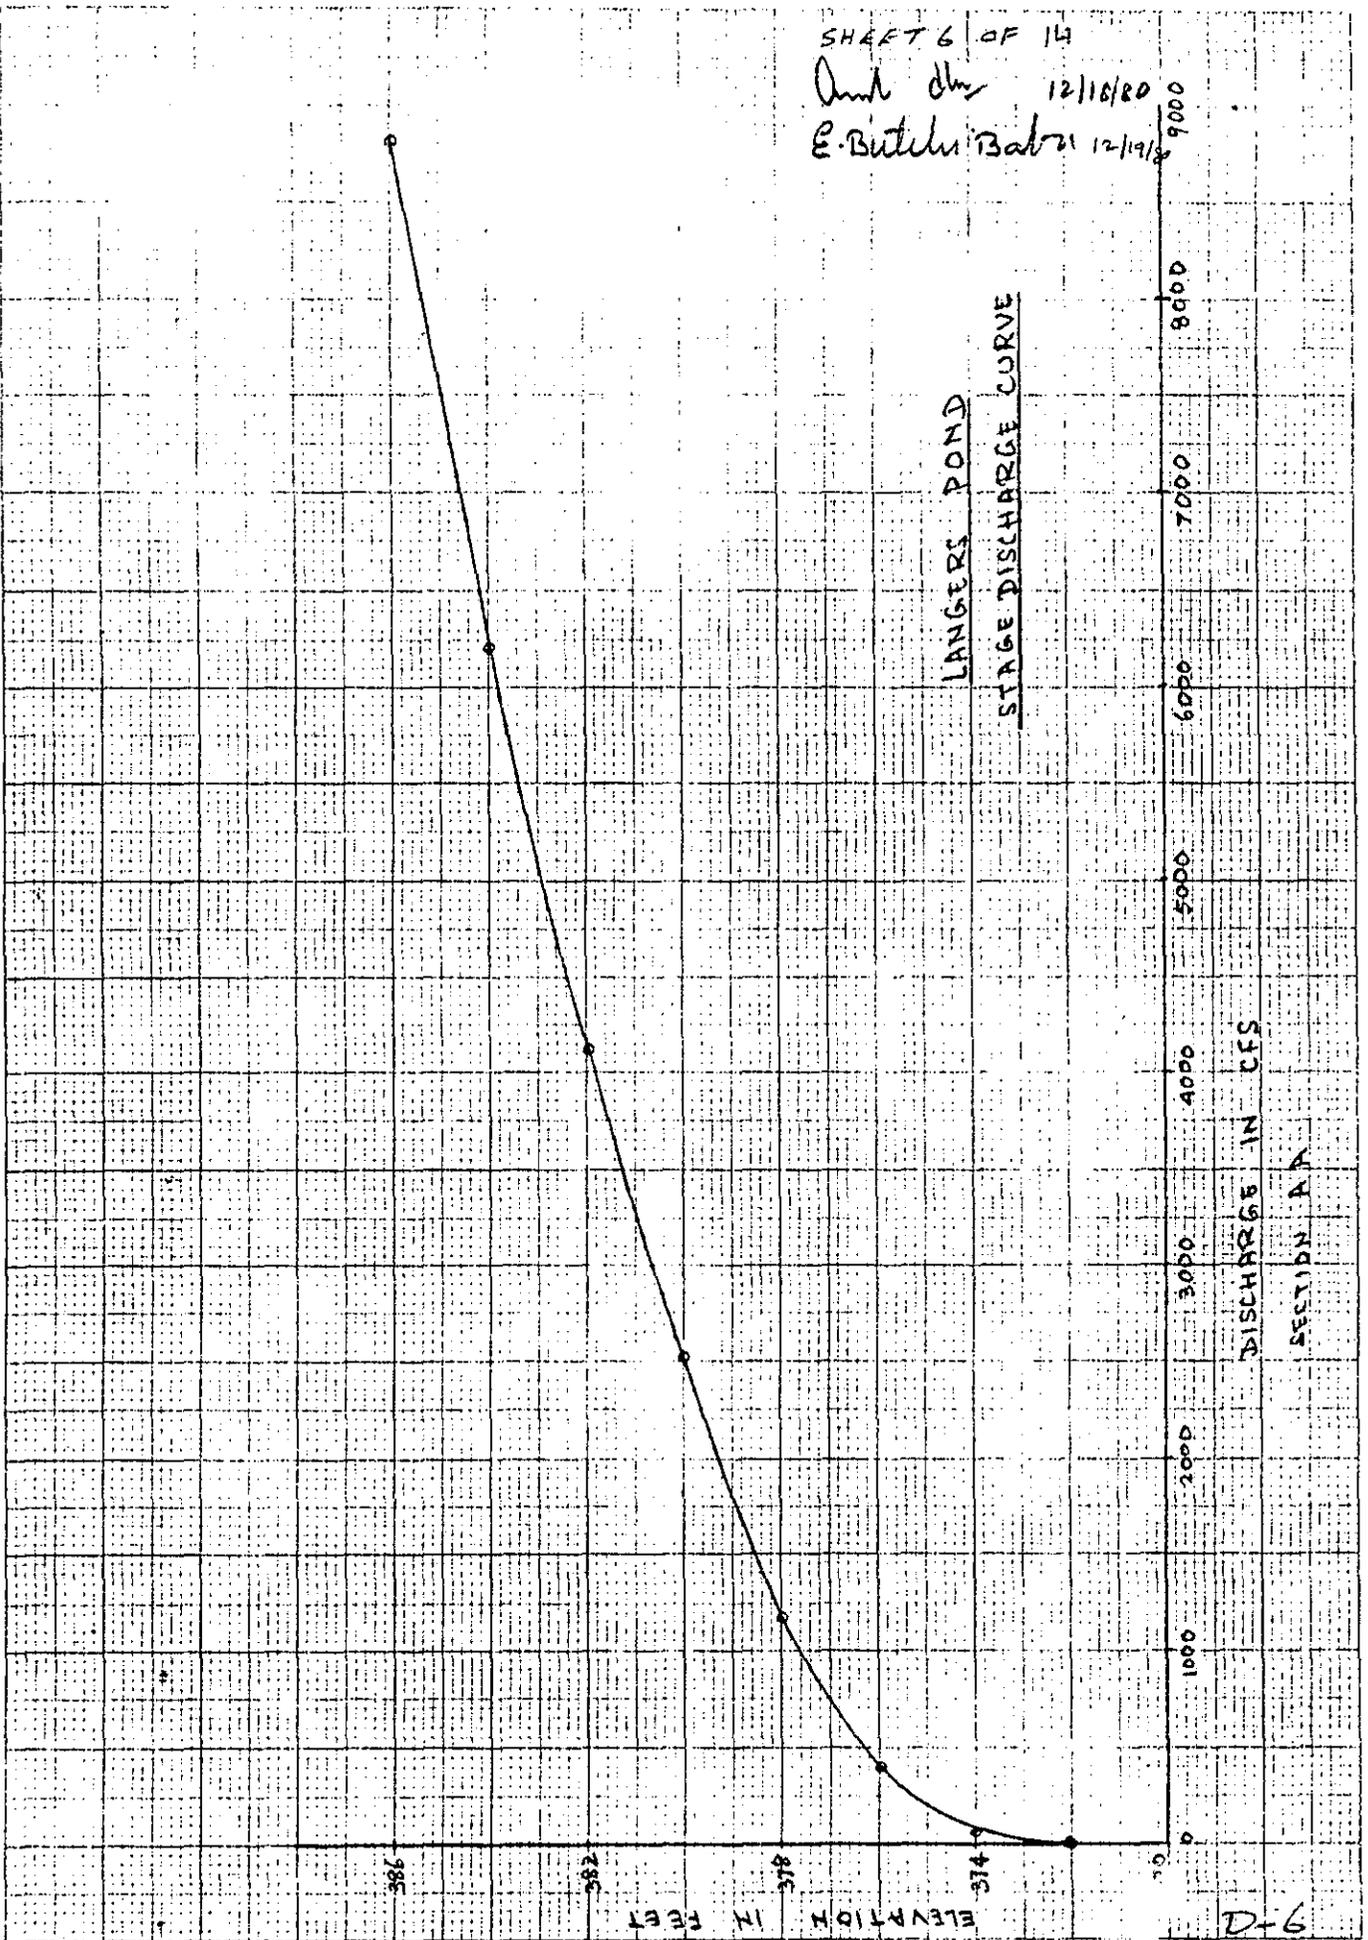
LANGERS POND
STAGE DISCHARGE CURVE

DISCHARGE IN CFS
SECTION AA

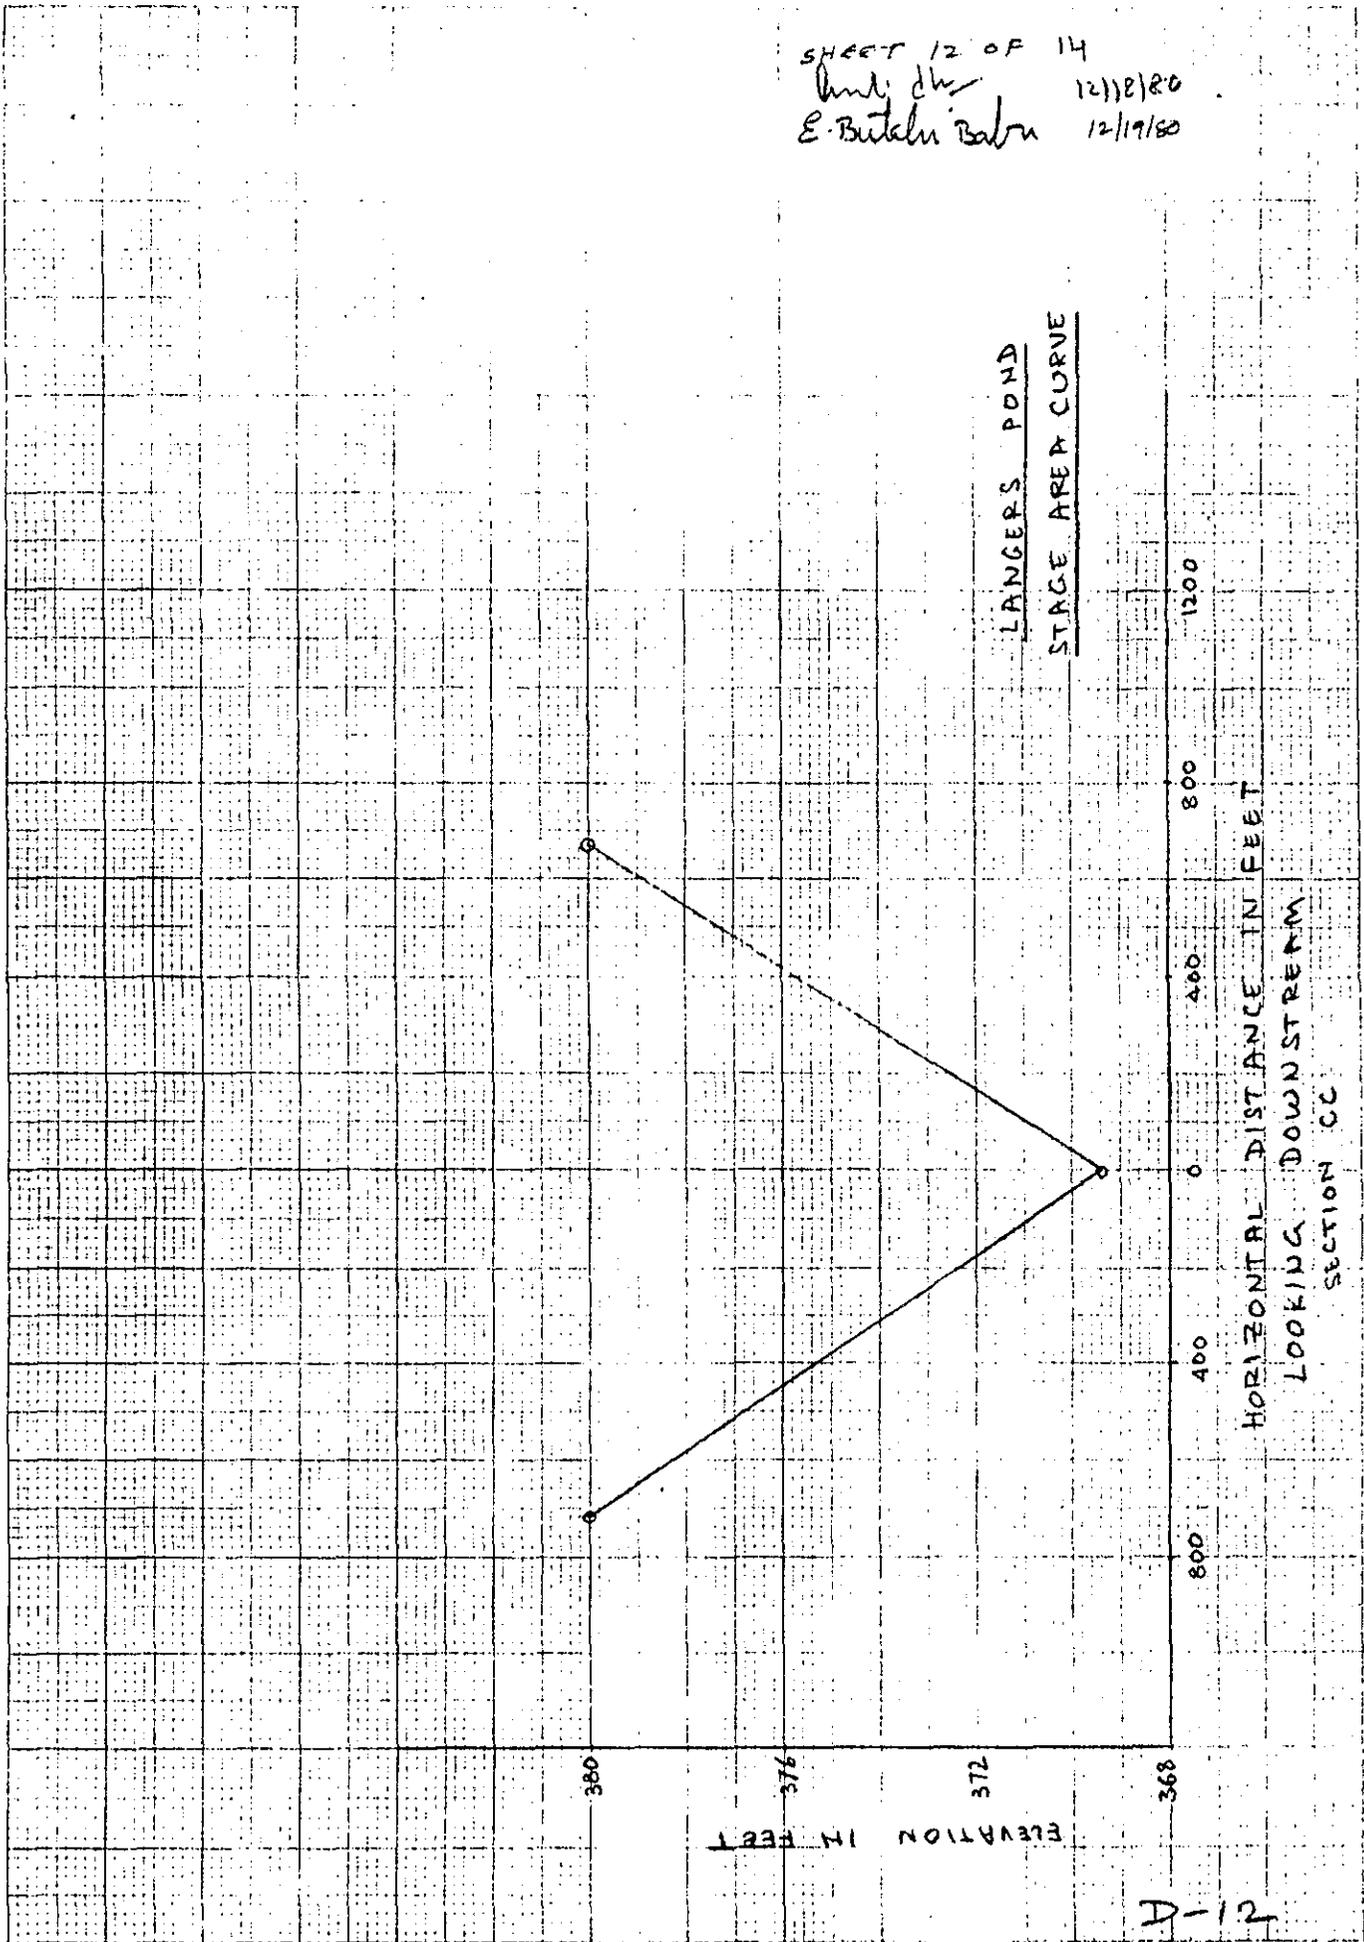
LANGERS POND
STAGE AREA CURVE

HORIZONTAL DISTANCE IN FEET
LOOKING DOWNSTREAM
SECTION CC
