HOUSATONIC RIVER BASIN
ANSONIA, CONNECTICUT
QUILLINAN RESERVOIR DAM
CT 00024

PHASE I INSPECTION REPORT
NATIONAL DAM INSPECTION PROGRAM

February 1980

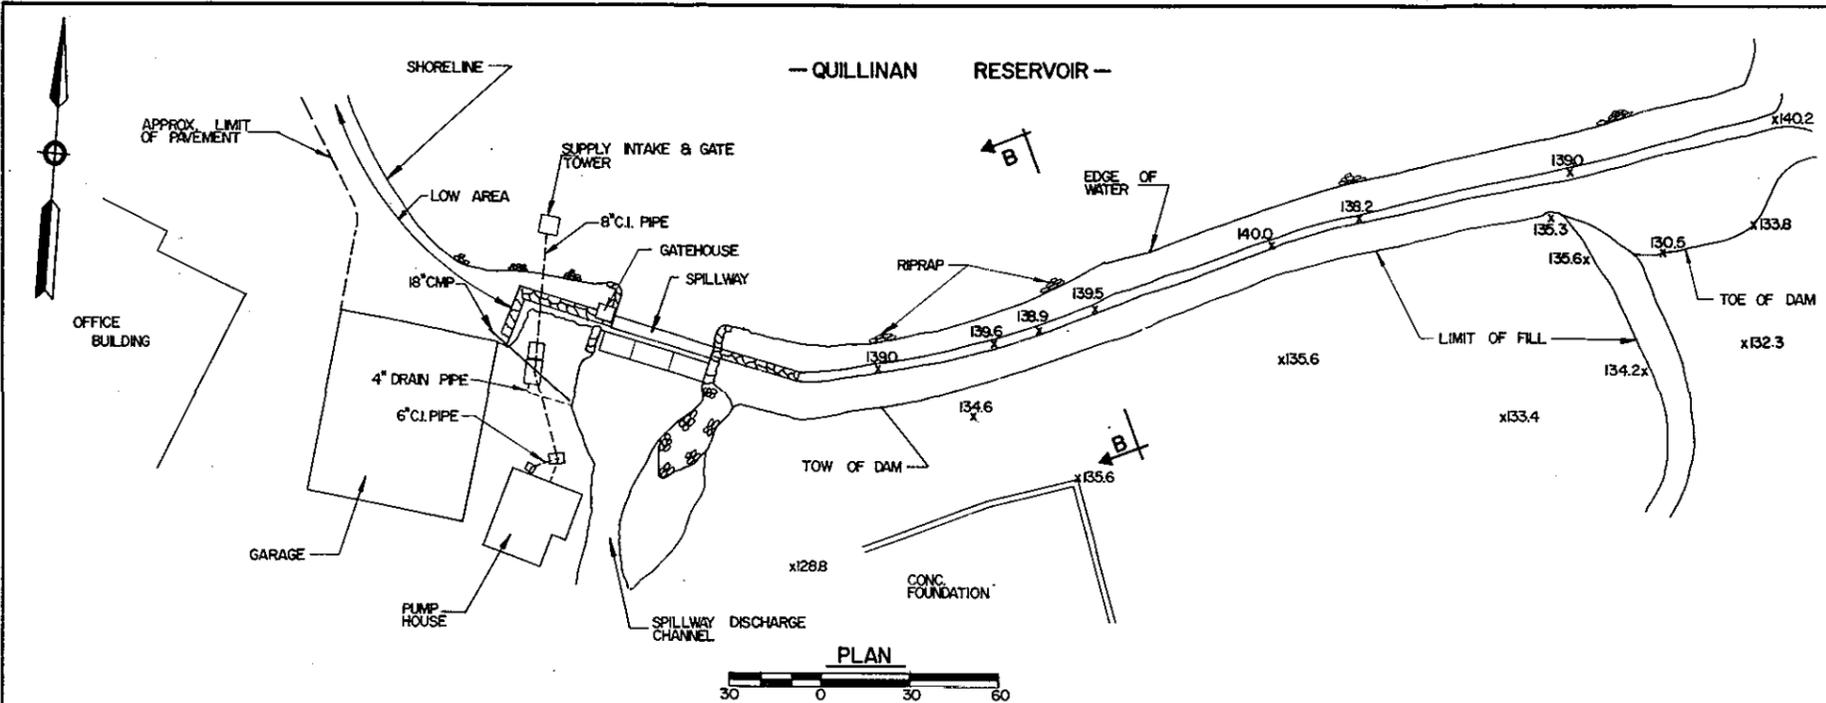
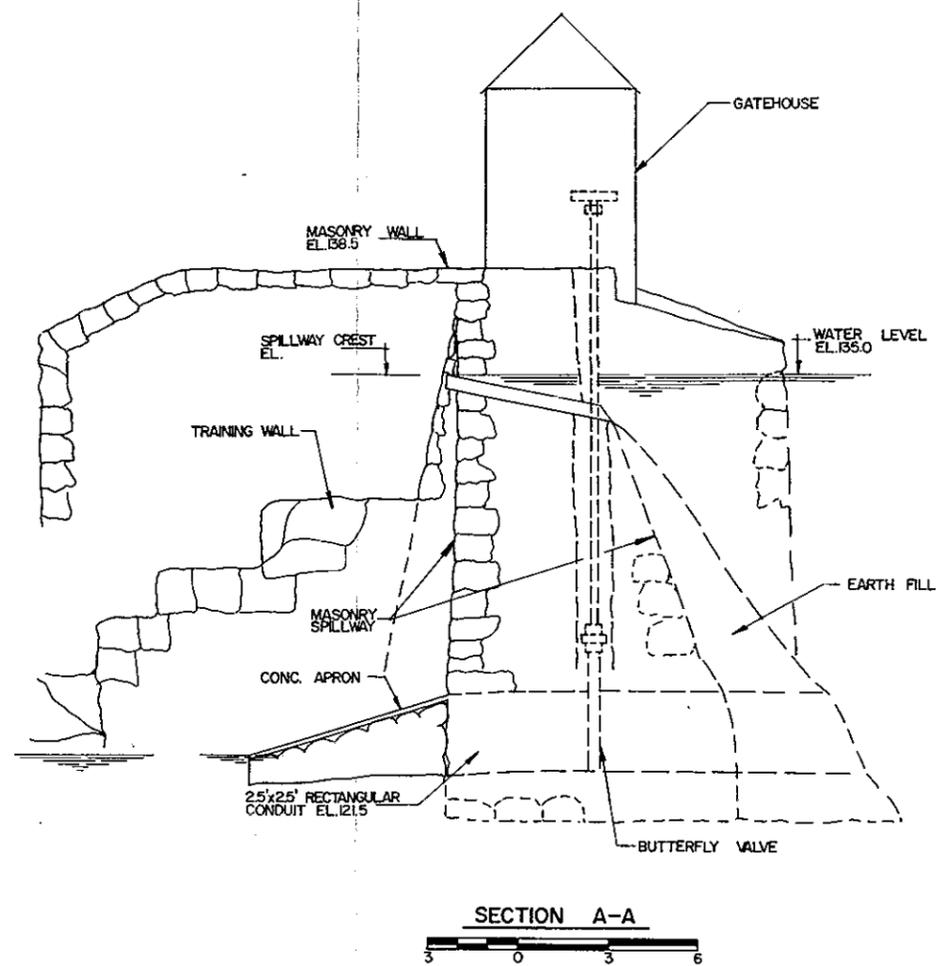
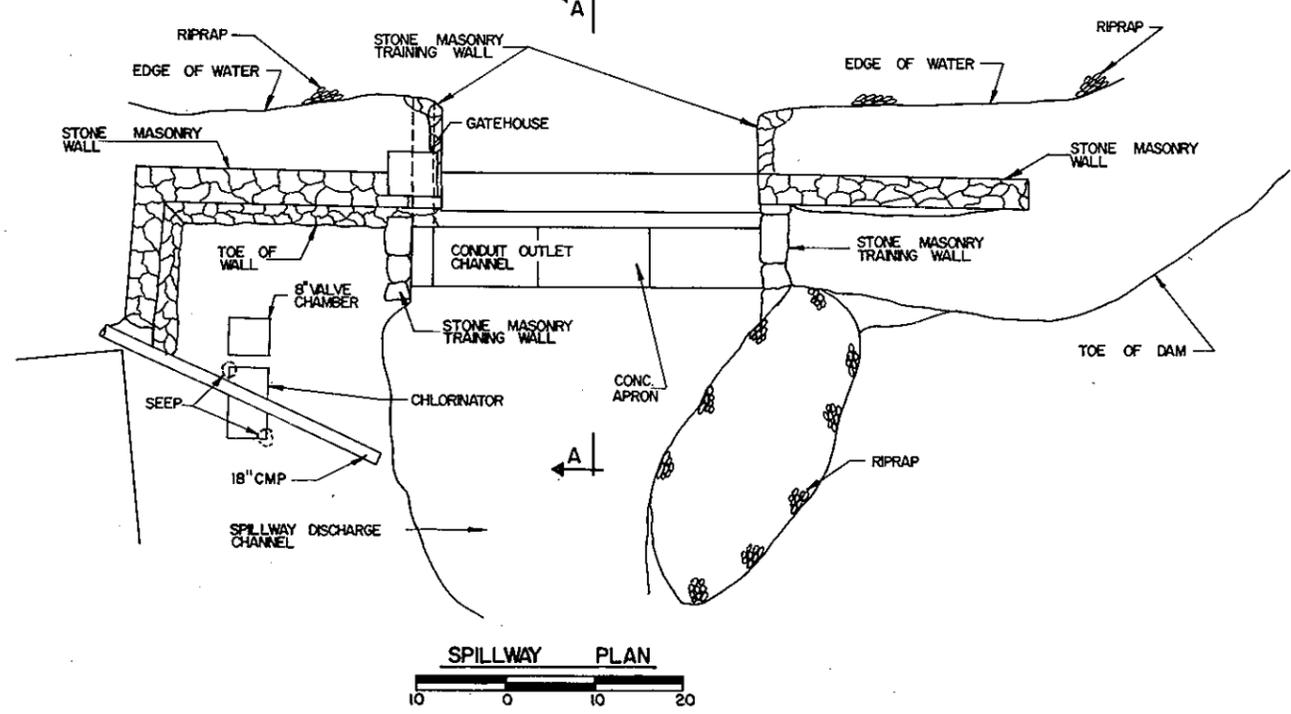
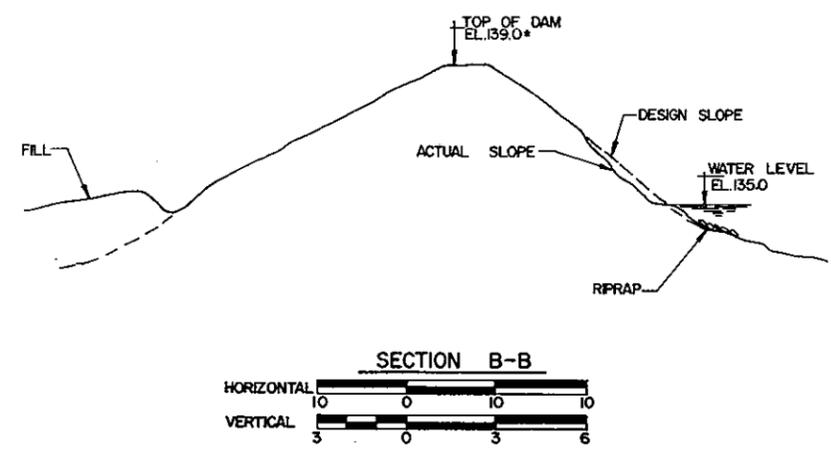
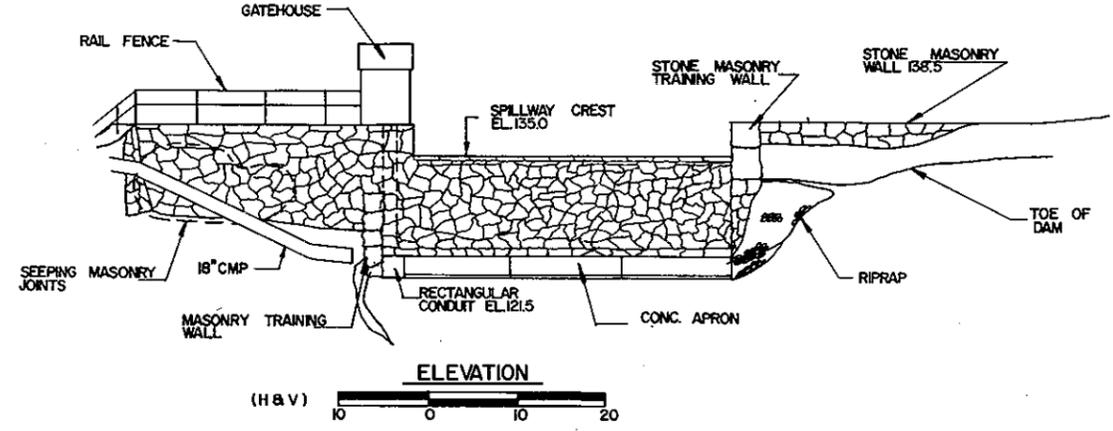
The fill at the toe of the left embankment has a weed cover on the top and terminates to the right at a concrete foundation (Photos 4 and 5, Sheet B-1). For 65+ feet at the left end of the dam, there is no fill dumped as yet. In this area the embankment is 8 to 10 feet in height with the downstream slope and toe covered with brush and trees.
