NEW CANAAN, CONNECTICUT

**GRUPES RESERVOIR DAM  
CT 00057**

PHASE I INSPECTION REPORT  
NATIONAL DAM INSPECTION PROGRAM

DECEMBER, 1979

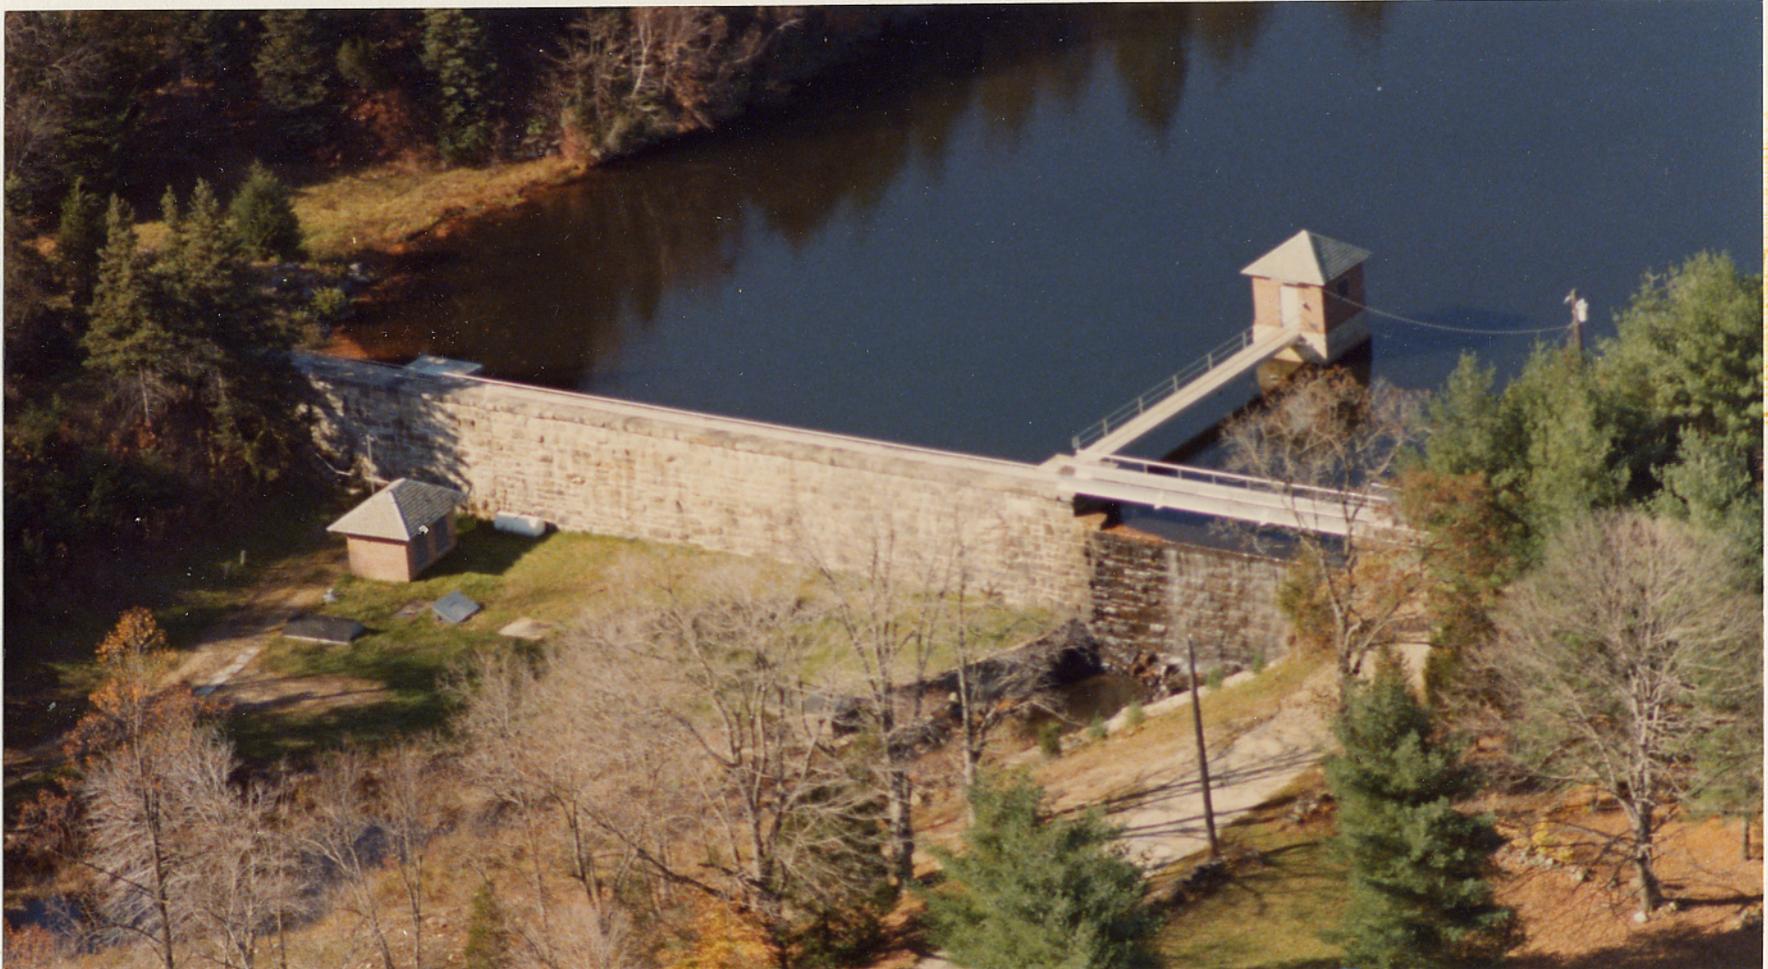
OVERVIEW PHOTO  
(November 1979)

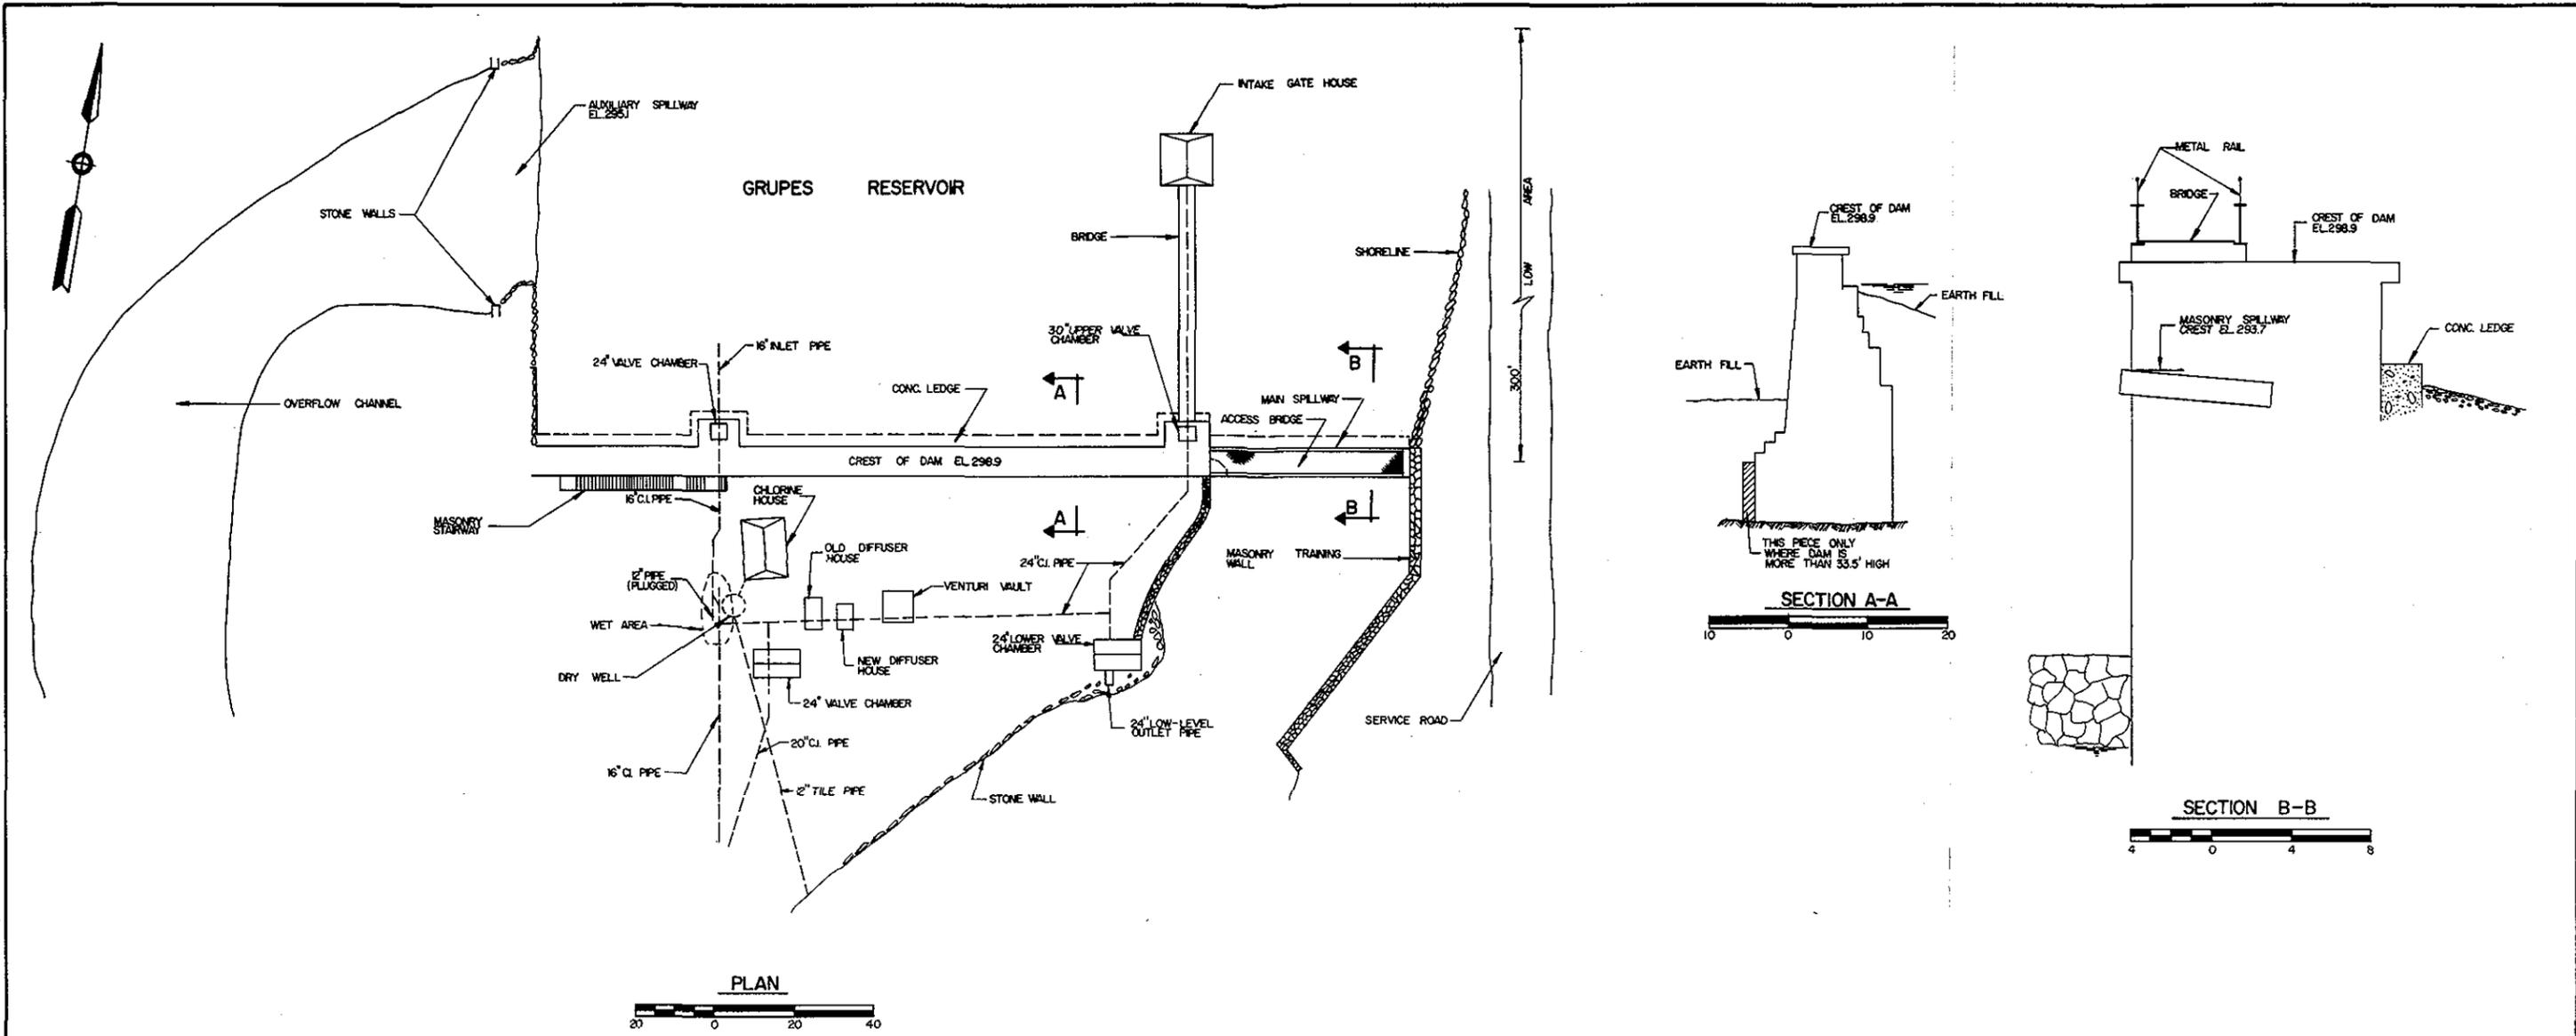
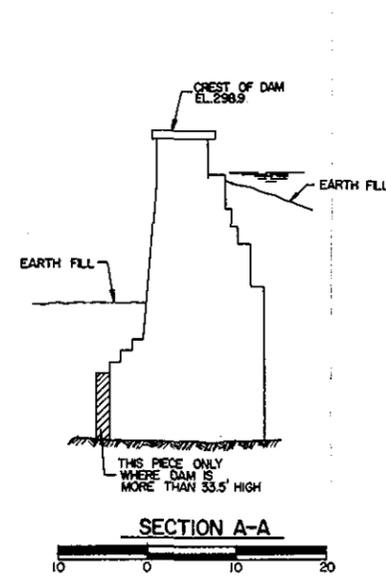
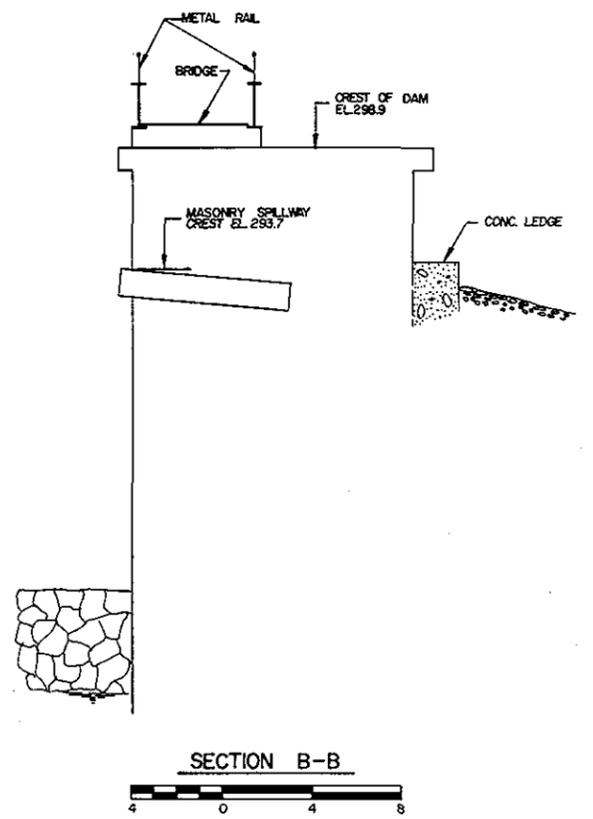
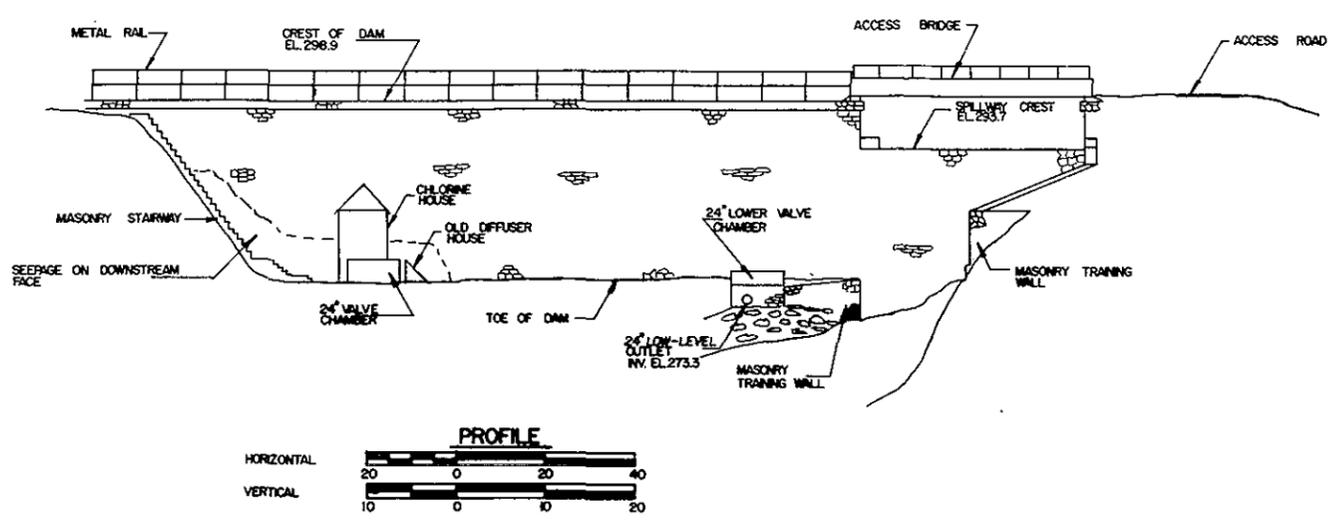
There is a 12 inch tile drain pipe which runs from a dry well, which is reported to be located to the right of the chlorine house, to the downstream river channel. (See Sheet B-1). Discharge from this pipe was approximately 10 gpm (Photo 4). A two inch thick deposit of siltation was observed on the bottom of the pipe outlet. The ground in the vicinity of the dry well is wet and according to the dam operator there is water in this area all year long (Photo 10).
