QUINNIPIAC RIVER BASIN
HAMDEN, CONNECTICUT

**LAKE WINTERGREEN DAM
CT 00118**

**PHASE I INSPECTION REPORT
NATIONAL DAM INSPECTION PROGRAM**

AUGUST 1978

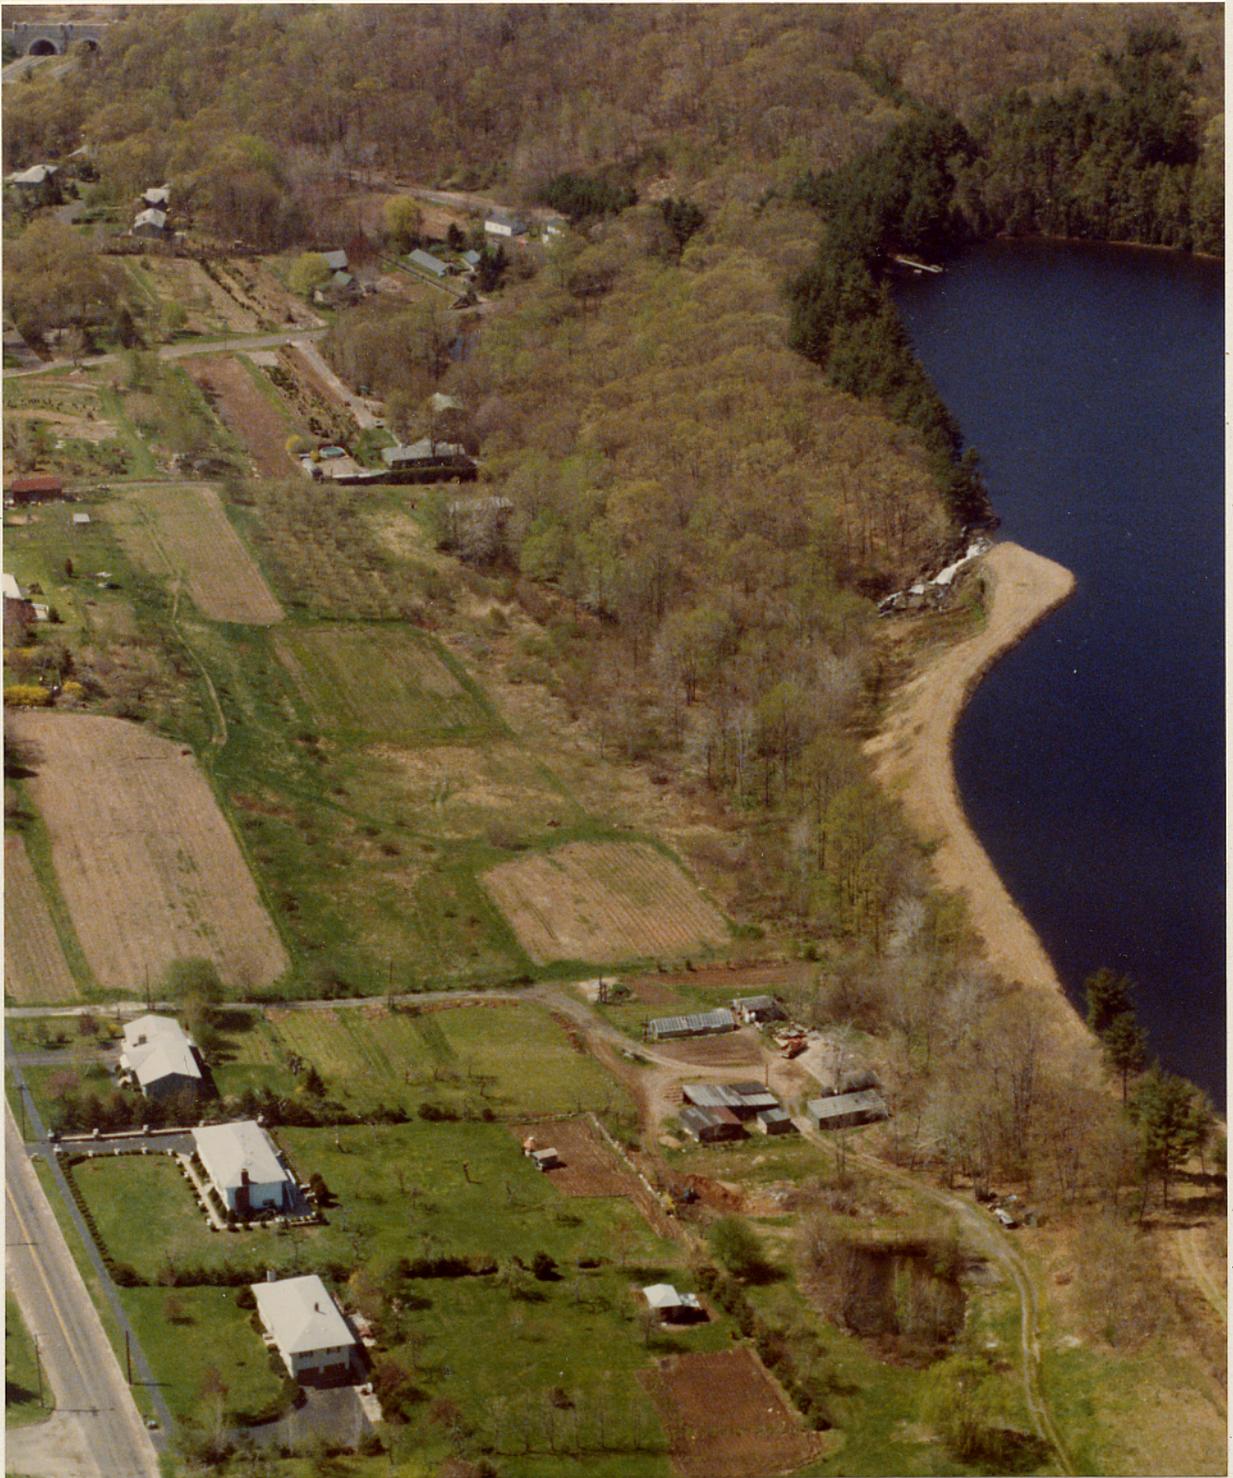
OVERVIEW PHOTO

d. Hazard Classification - HIGH - (Category I) Residential developments, some of which are visible in the overview photo, and the Wilbur Cross Parkway located downstream of the dam provide potential for severe loss of life should the dam breach.
