LOWER CONNECTICUT RIVER BASIN
MIDDLETOWN , CONNECTICUT

**CRYSTAL LAKE DAM
CT 00138**

**PHASE I INSPECTION REPORT
NATIONAL DAM INSPECTION PROGRAM**

JANUARY 1980

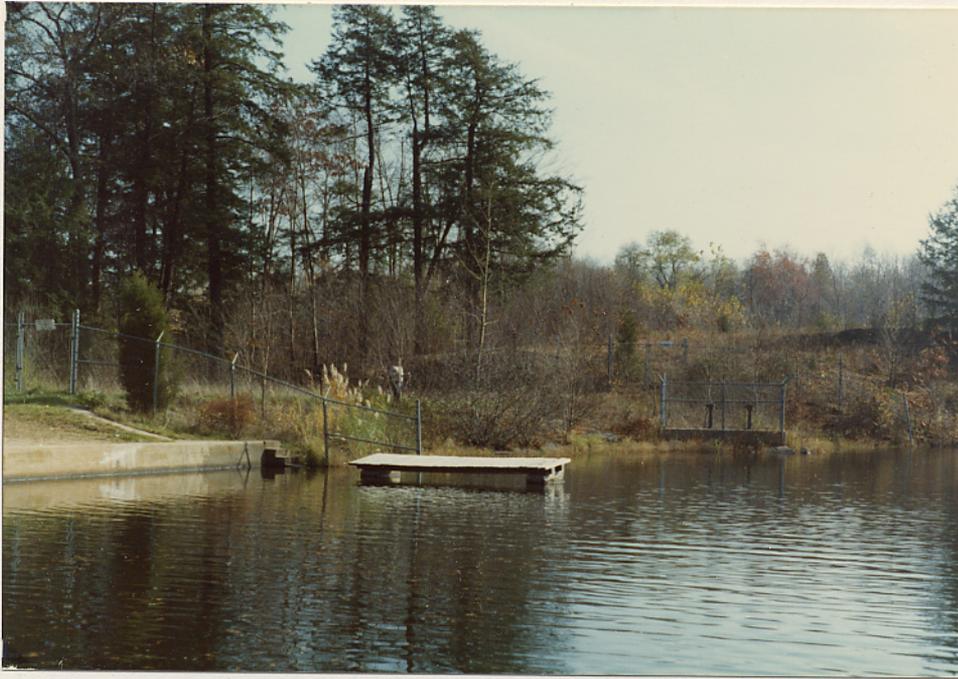
1) Upstream Slope - Most of the upstream side of the dam is covered by large flat riprap blocks. Brush and grass are growing between the riprap blocks as shown in Photos No. 1 and No. 2. A small concrete cutoff wall, 1-ft.-wide by 2-ft.-deep, is located on the crest of the upstream slope as indicated in Photo No. 3.

PHOTO #1: Upstream face of dam.

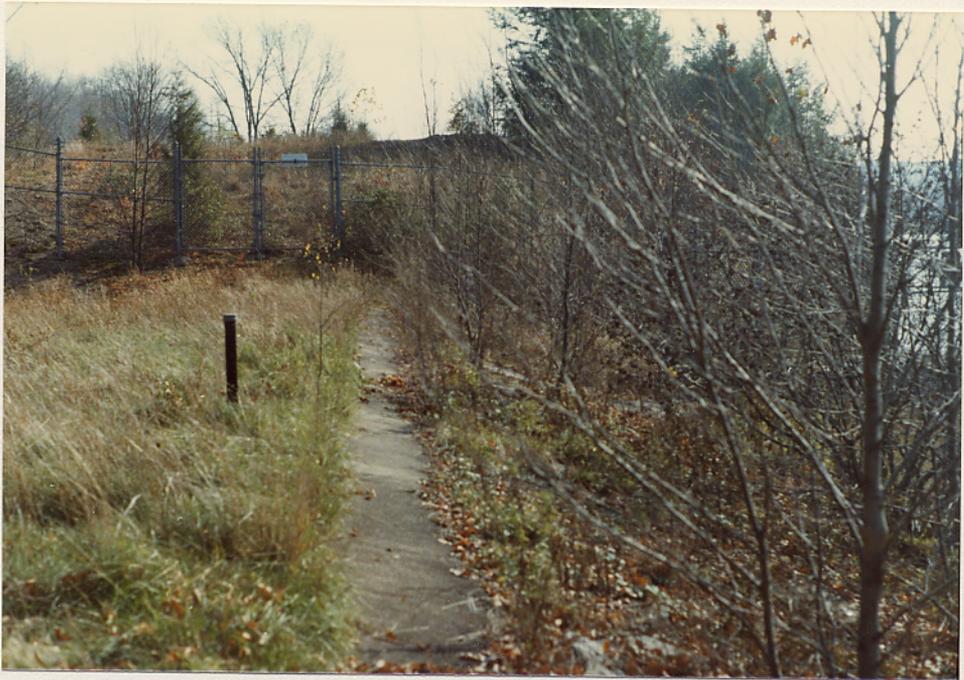
2) Crest - The crest of the dam is covered with grass over most of its length. The grass has not been mowed recently, but there is a footpath which is bare of vegetation near the downstream edge of the crest. The contact between the earthen embankment and the right abutment is not clearly defined (Photos No. 3 and No. 4). Three 2½-inch diameter pipe casings extend about 2 feet above the crest of the dam, the purpose of these pipes are unknown.

PHOTO #3: Crest of dam from left (North) abutment.

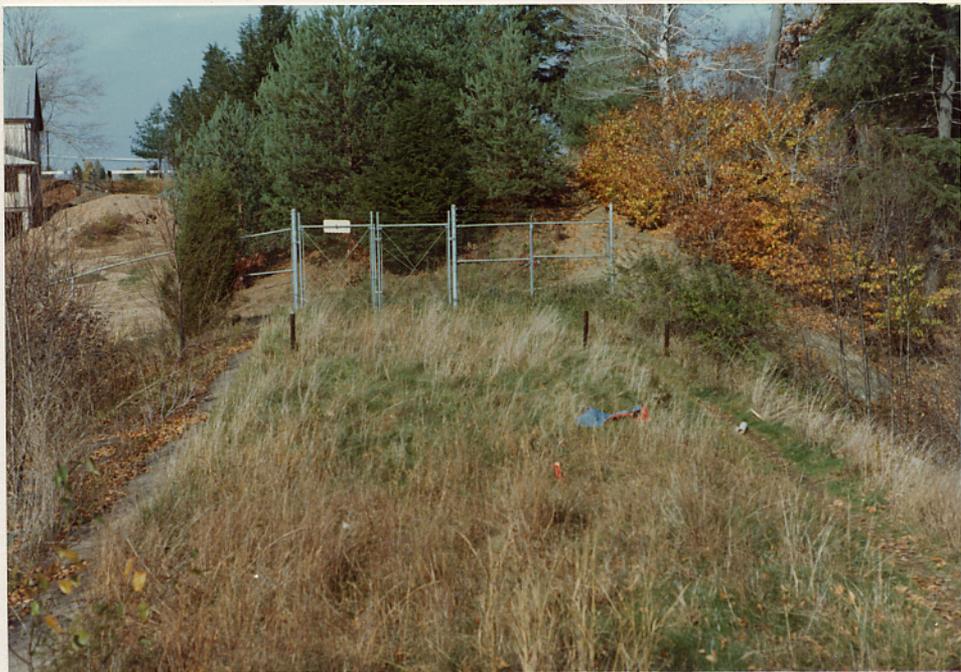
PHOTO #4: Crest of dam from right (South) abutment.

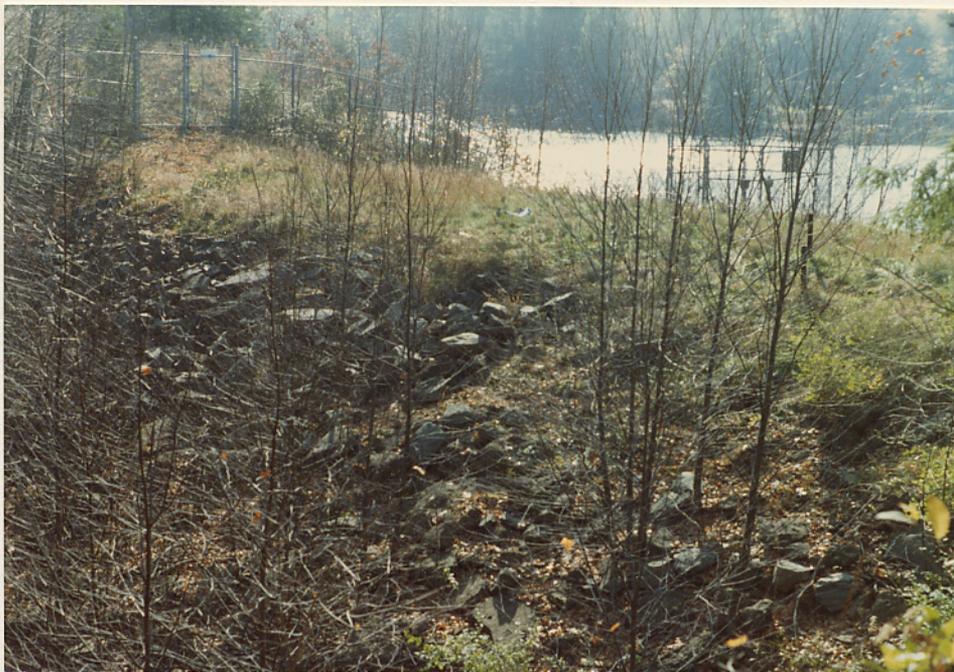
3) Downstream Slope - The downstream side of the dam consists of rockfill overlying the embankment section (Photos No. 5 and No. 6). The rockfill extends to the downstream toe of the dam and is covered by extensive small trees and fallen logs as indicated in Photo No. 7. A portion of the contact with the left abutment has been covered with trash and debris as shown in Photo No. 9. Bedrock is exposed at the contact with the right and left abutments.

PHOTO #5: Crest of dam and rockfill on downstream slope from left abutment.

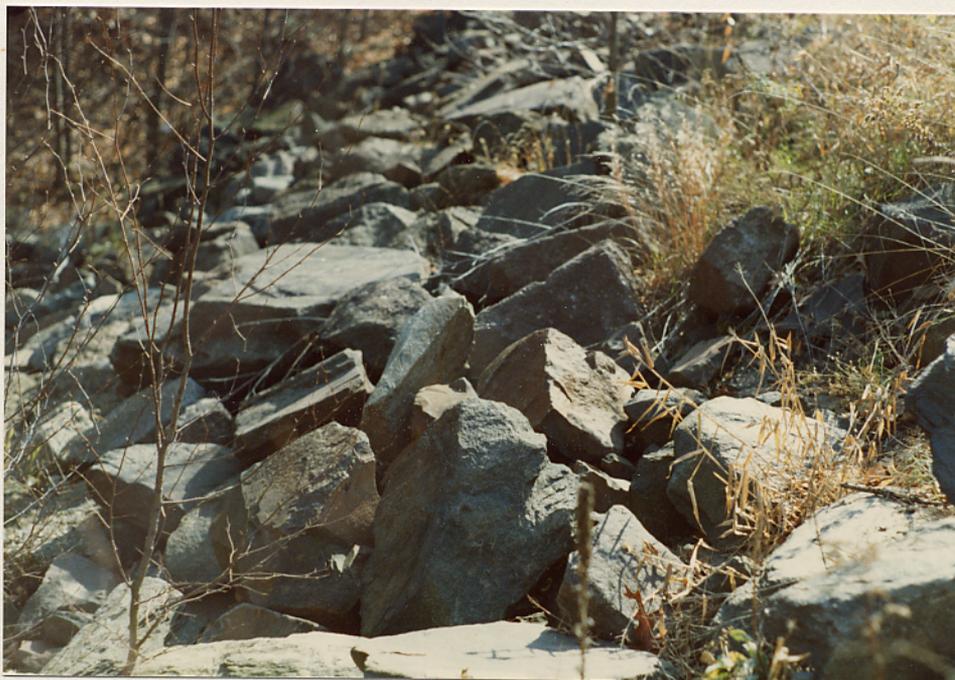
PHOTO #6: Rockfill on downstream slope of dam.

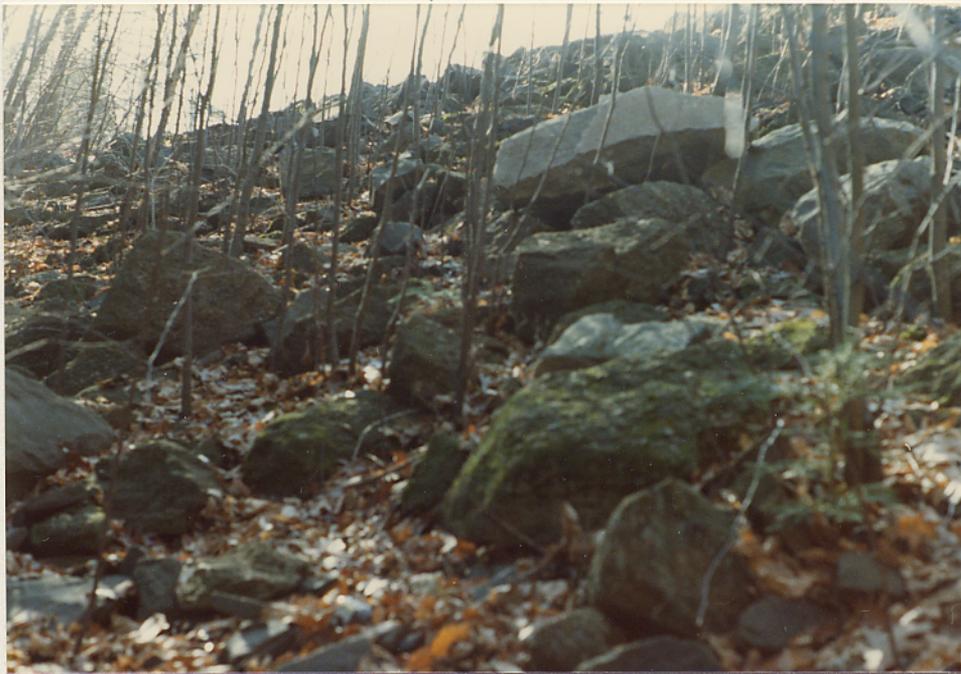
PHOTO #8: Downstream face of dam (looking upslope).

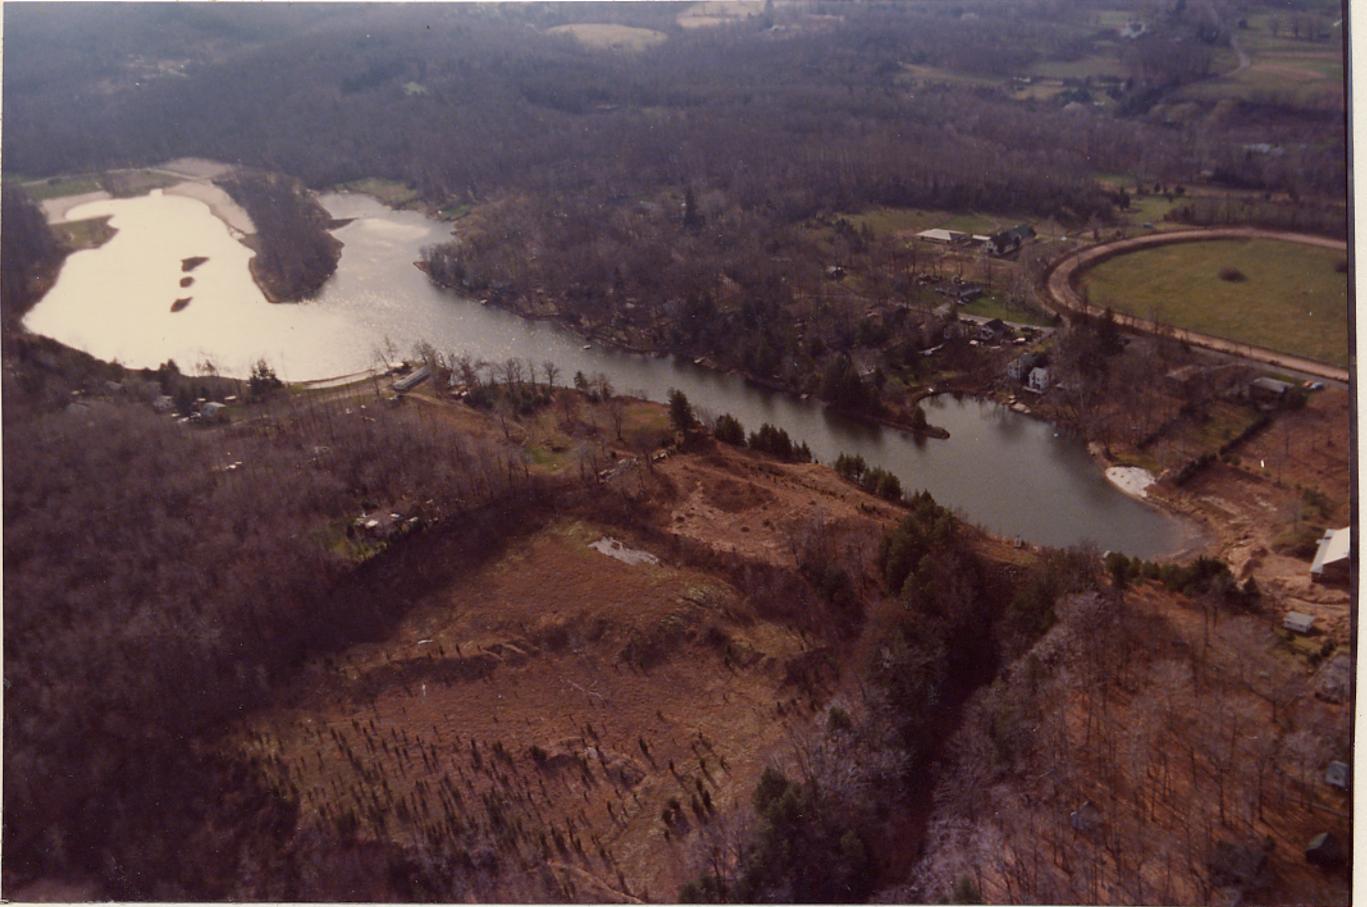
d. Reservoir Area. The reservoir has well vegetated banks at slight to moderate slopes. In addition, there are scattered residential homes located along the perimeter of the lake (see Photo No. 13).

PHOTO #13: Reservoir Area. Dam is at lower right of photograph.

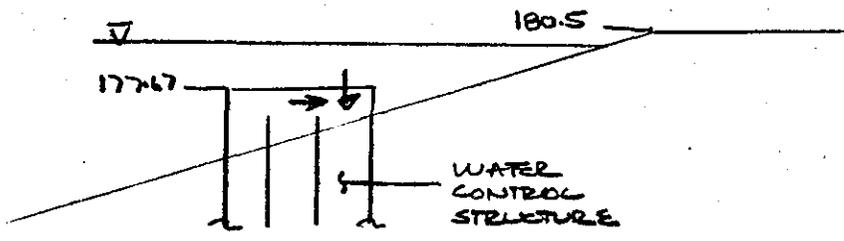
THIS GATE FUNCTIONS AS DROP INLET FOR WATER LEVELS GREATER THAN 177.67. THE OTHER GATES DO NOT FUNCTION AS OUTLET DISCHARGES, THEY ARE RESTRICTED TO CAPACITY OF STOPLOG SPILLWAY ACTING AS AN ORIFICE.
