**CONNECTICUT COASTAL BASIN  
EAST LYME, CONNECTICUT**

**GORTON POND DAM  
CT. 00157**

**PHASE I INSPECTION REPORT  
NATIONAL DAM INSPECTION PROGRAM**

**JANUARY, 1981**

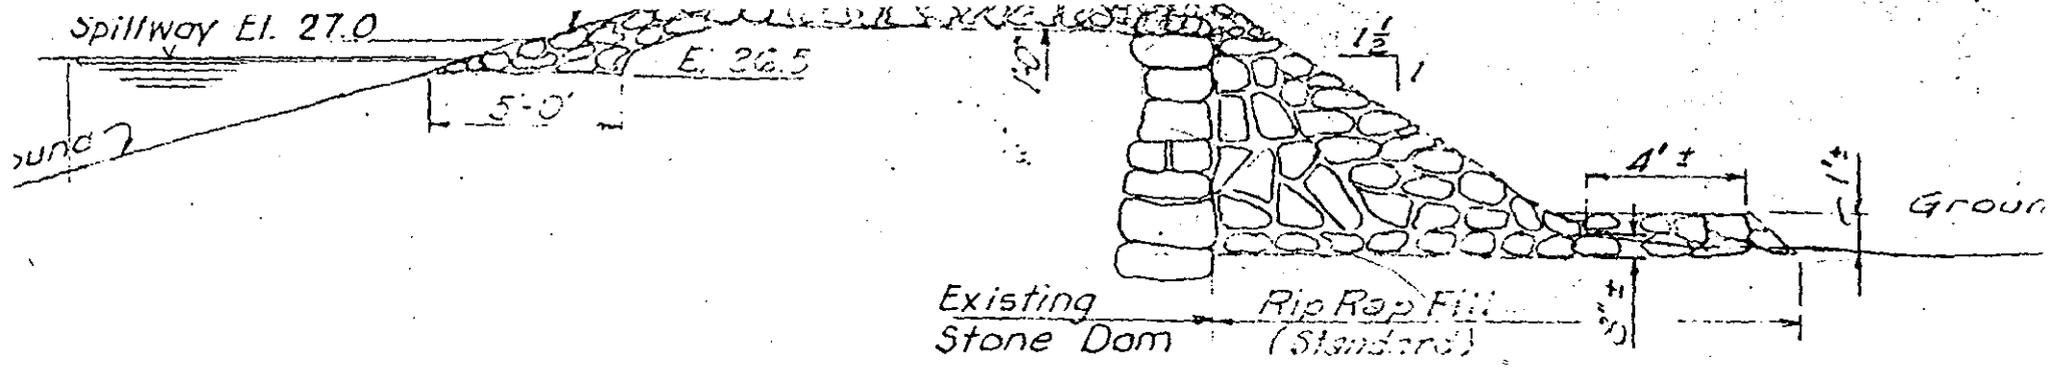
**SECTION A-A**  
SCALE 1" = 5'-0"

- b. Dam. The original dam was an earth embankment with a vertical stone wall on the downstream side. In 1974 a dumped riprap shell was added on the downstream side against the vertical stone wall (See Appendix B-3, Section A-A, and Photo C-2). As a part of the repairs in 1974, the crest and upstream slope were riprapped and crushed stone was used to fill the voids on the crest (Photo C-4).
