**QUINEBAUG RIVER BASIN  
KILLINGLY, CONNECTICUT**

**ACME POND DAM  
CT 00172**

**PHASE 1 INSPECTION REPORT  
NATIONAL DAM INSPECTION PROGRAM**

**MARCH 1981**

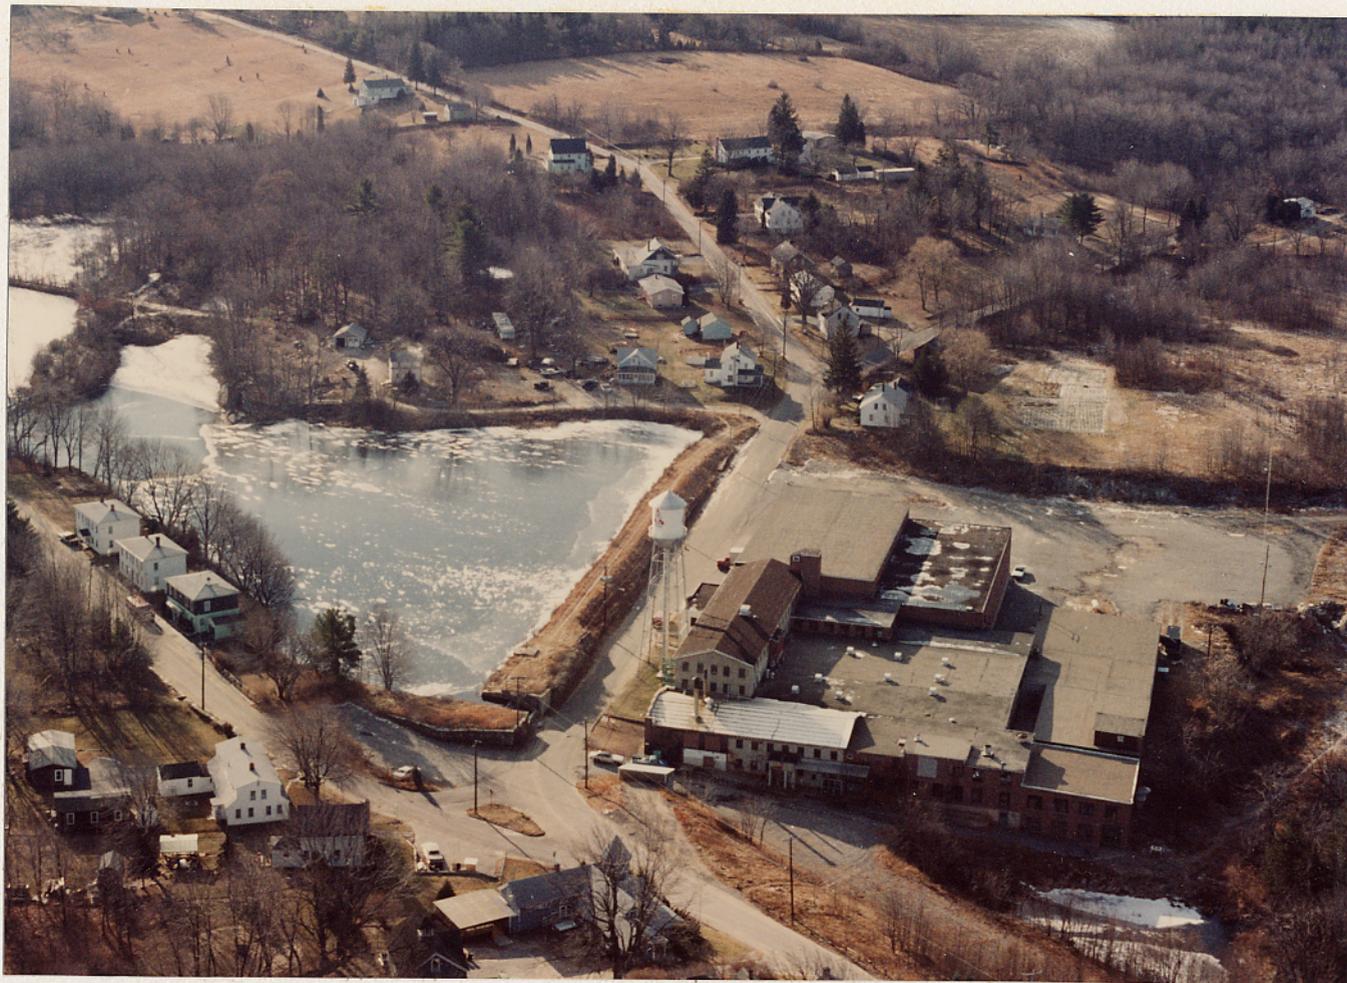
OVERVIEW PHOTO

As a result of the visual inspection, the dam at Acme Pond and its appurtenances are judged to be in fair condition. Saplings up to 3 inches in diameter and bushes are growing on the earth embankments. Riprap is sparse along the upstream slope and portions of a masonry wall on the upstream side have also collapsed. Various portions of the downstream stone masonry wall are bulging and out of alignment.

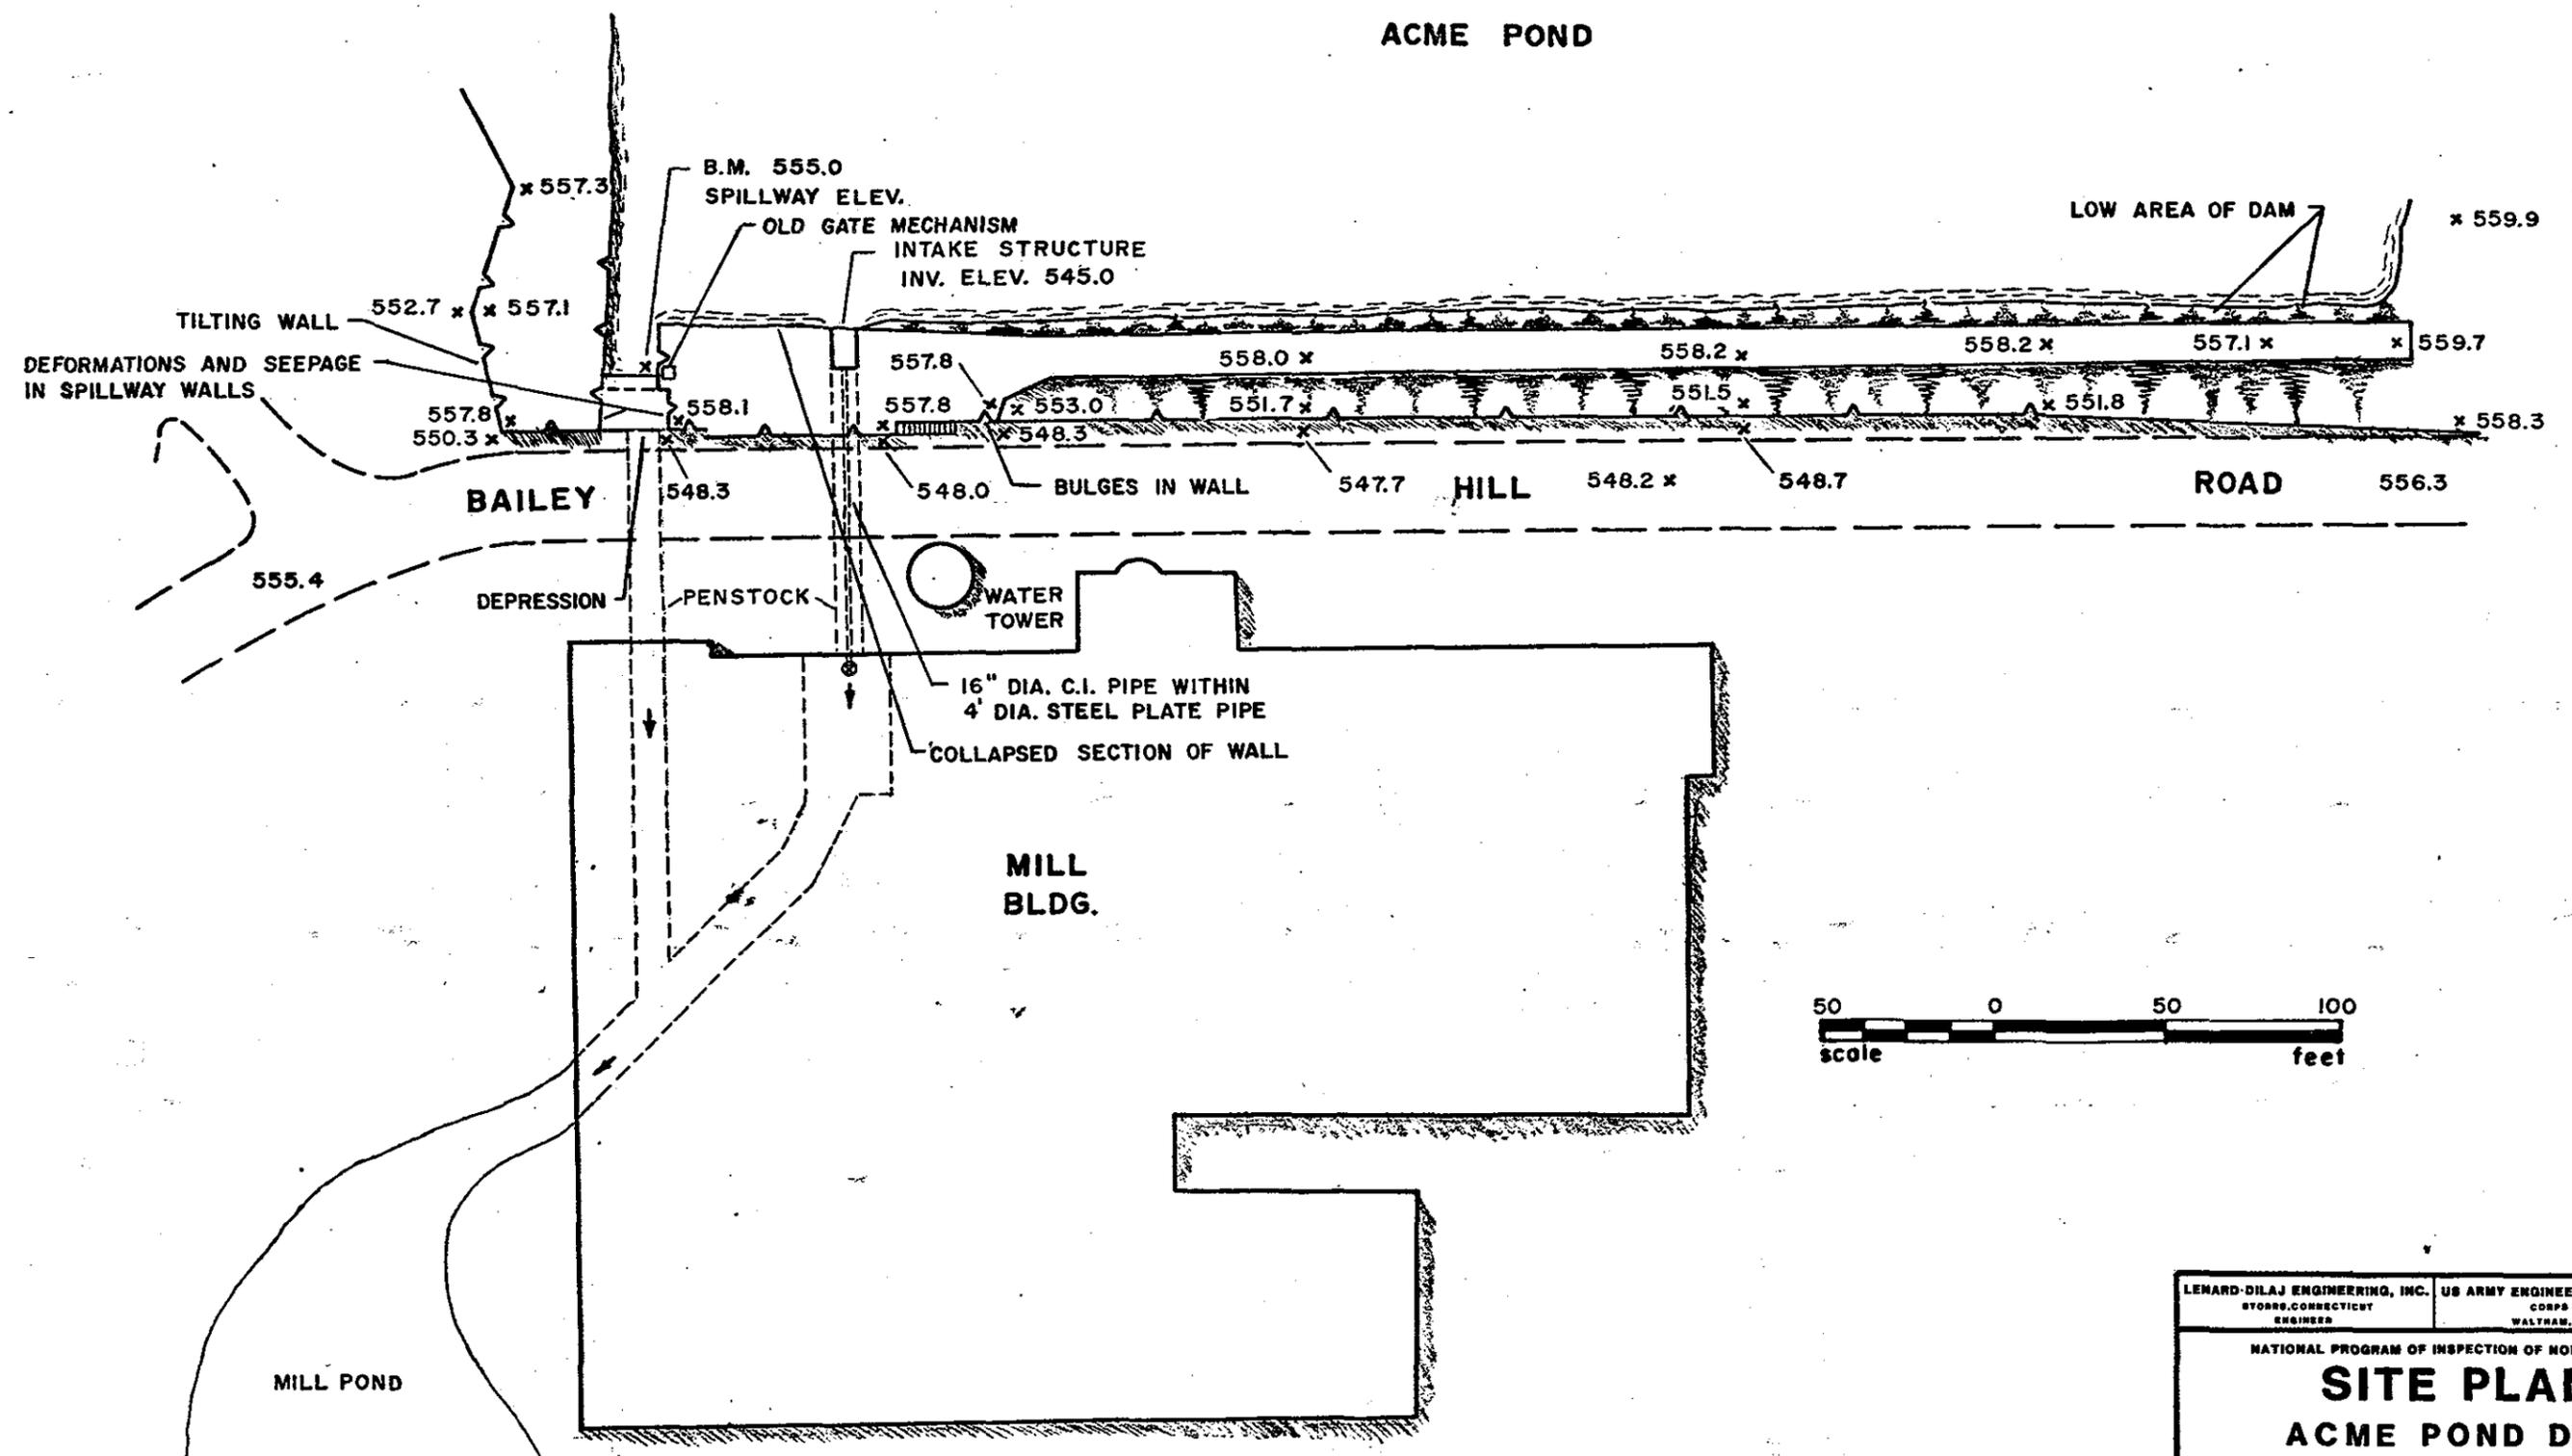
2. Outlet works: The outlet works include a concrete intake structure which is in good condition (Photo 9) and two upstream stone wingwalls which could be observed under water. There is a 16 inch pipe which passes beneath the road, installed inside an existing 4 foot diameter steel plate pipe which shows signs of corrosion and whose condition should be assessed along with a stability analysis. A brick arch could be observed over the downstream end of this pipe where it entered the basement of the mill building. The outlet continues through the building as a culvert. The bottom of the culvert was cut into bedrock with masonry of different types above. The outlet joins the spillway culvert immediately upstream of the point where the flow exits out of the building into an open channel (See Site Plan).
