**KENMERE RESERVOIR DAM**  
**CT - 00251**

**PHASE I INSPECTION REPORT**  
**NATIONAL DAM INSPECTION PROGRAM**

FEBRUARY 1980

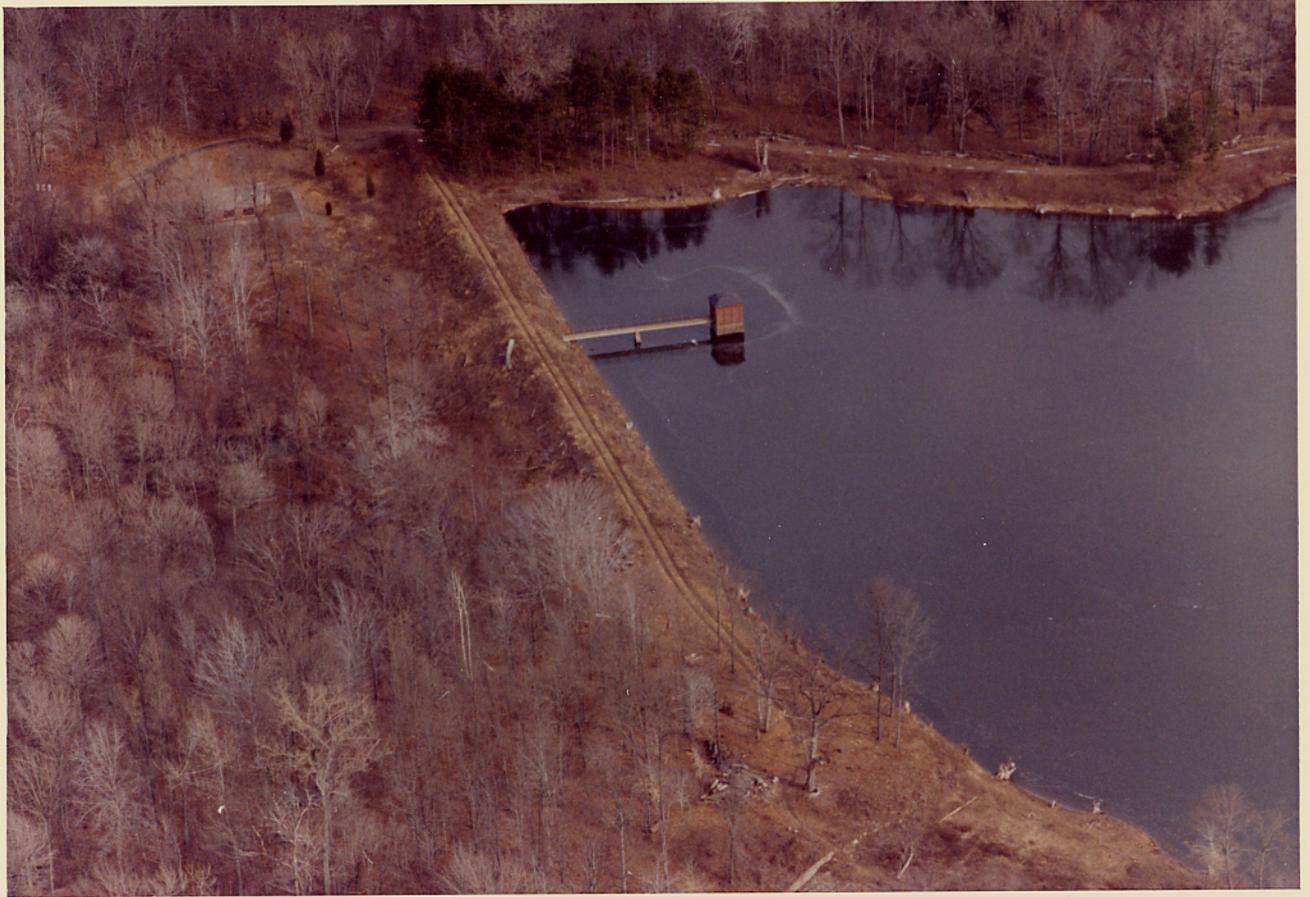
Overview Photo  
Kenmere Reservoir Dam

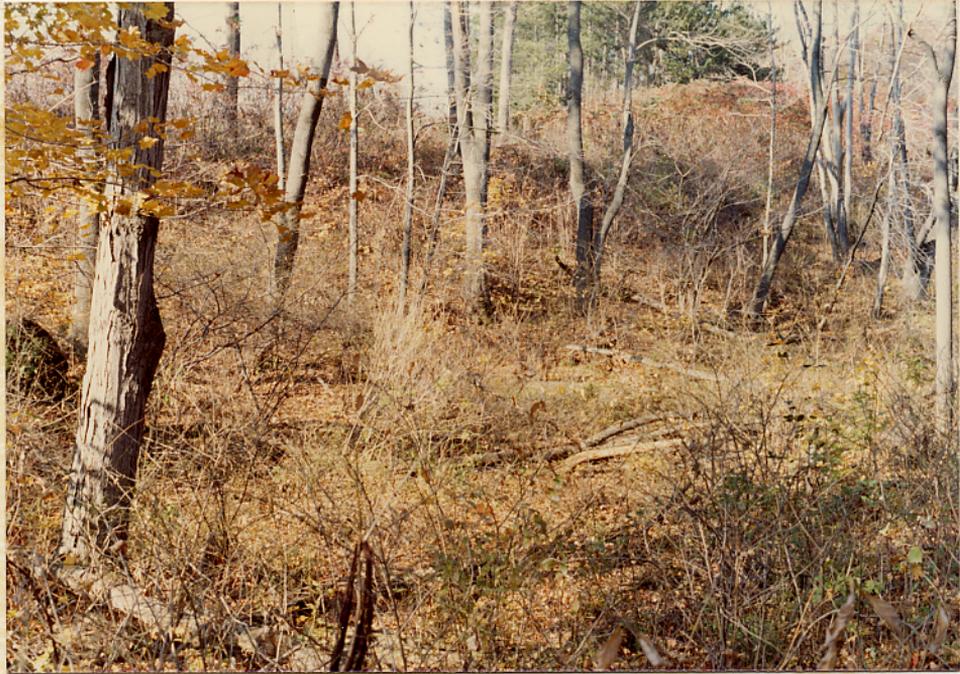
The downstream face is heavily overgrown with weeds, bushes and trees as indicated in Photo No. 15. The ground is wet and boil along a large portion of the toe. Near Sta. D3+25, a small spring was seen discharging approximately 20 ft. downstream of the toe. (Photo No. 17) A large erosion gully, approximately 12 ft. wide and 4 to 5 ft. deep, extends from the crest to the toe of the dike, at Sta. D2+85.

PHOTO #15: Downstream face of dike from right (east) side.
