**CONNECTICUT RIVER BASIN
PLYMOUTH , CONNECTICUT**

OLD MARSH POND DAM

CT 00285

**PHASE I INSPECTION REPORT
NATIONAL DAM INSPECTION PROGRAM**

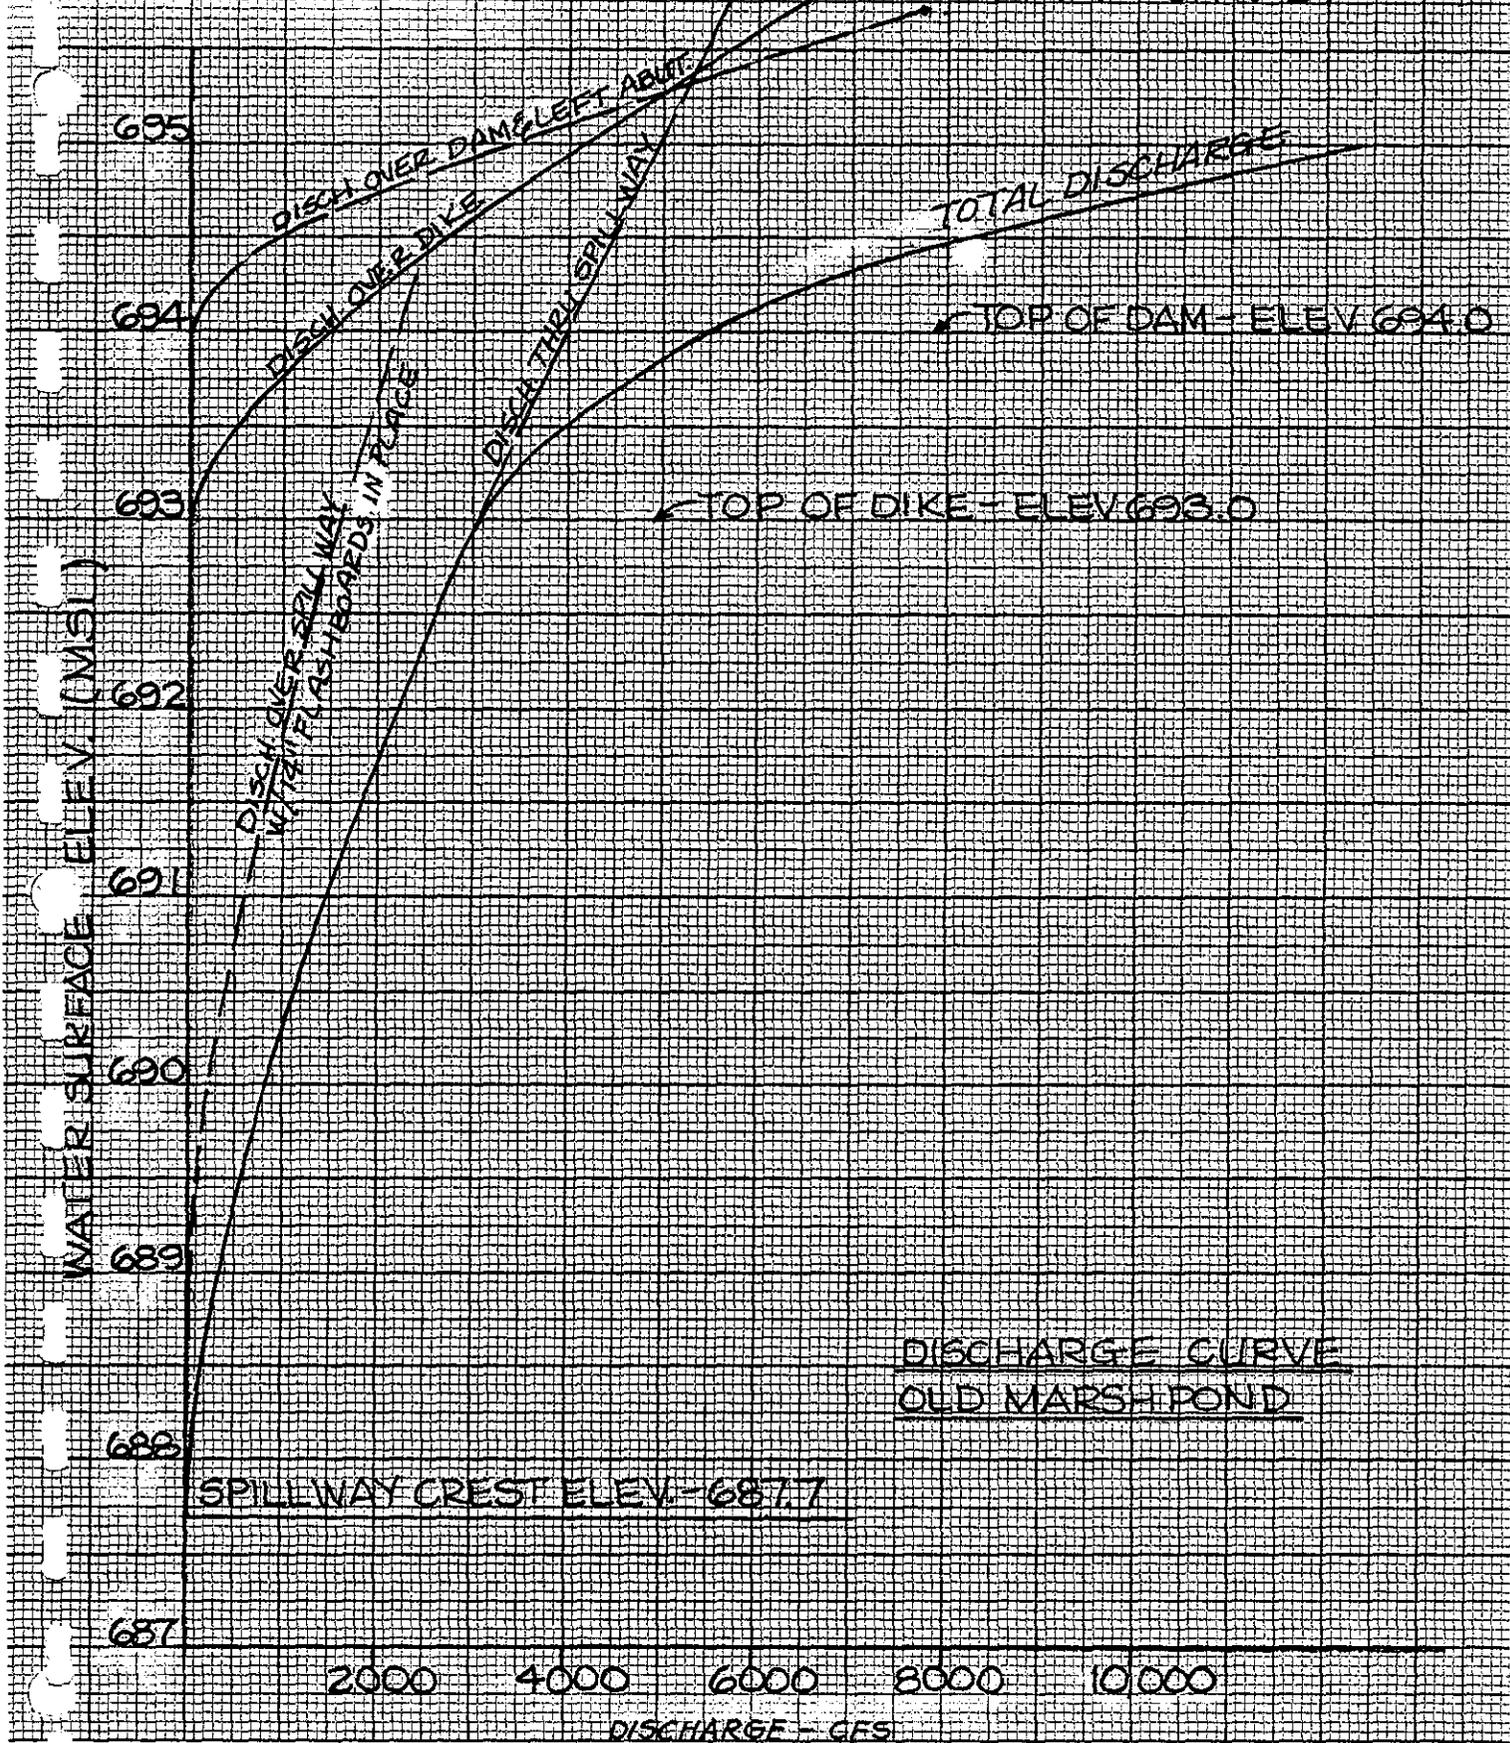
FIG. 1 - SHT. D-1

The spillway at Old Marsh Pond Dam is an ungated ogee overflow 60 ft. in length, which appears to have been designed for a capacity of about 900 cfs at 2.4 ft. surcharge head. The spillway control will be able to handle about 3,500 cfs with reservoir to top of dike, elevation 693; and about 4,000 cfs with reservoir to top of dam, elevation 694. Discharge curves and computations are shown on Figure 1 and sheets D-1 to D-3, Appendix D.

With the flashboards in place, the spillway capacity for heads up to reservoir level 692 will be reduced by more than half the capacity without the flashboards; for a head to reservoir level 694 the spillway capacity will be 55 percent of that of an unobstructed crest. A discharge curve for flow over the crest with the flashboards installed is shown on Fig. 1, Sheet D-1, Appendix D.

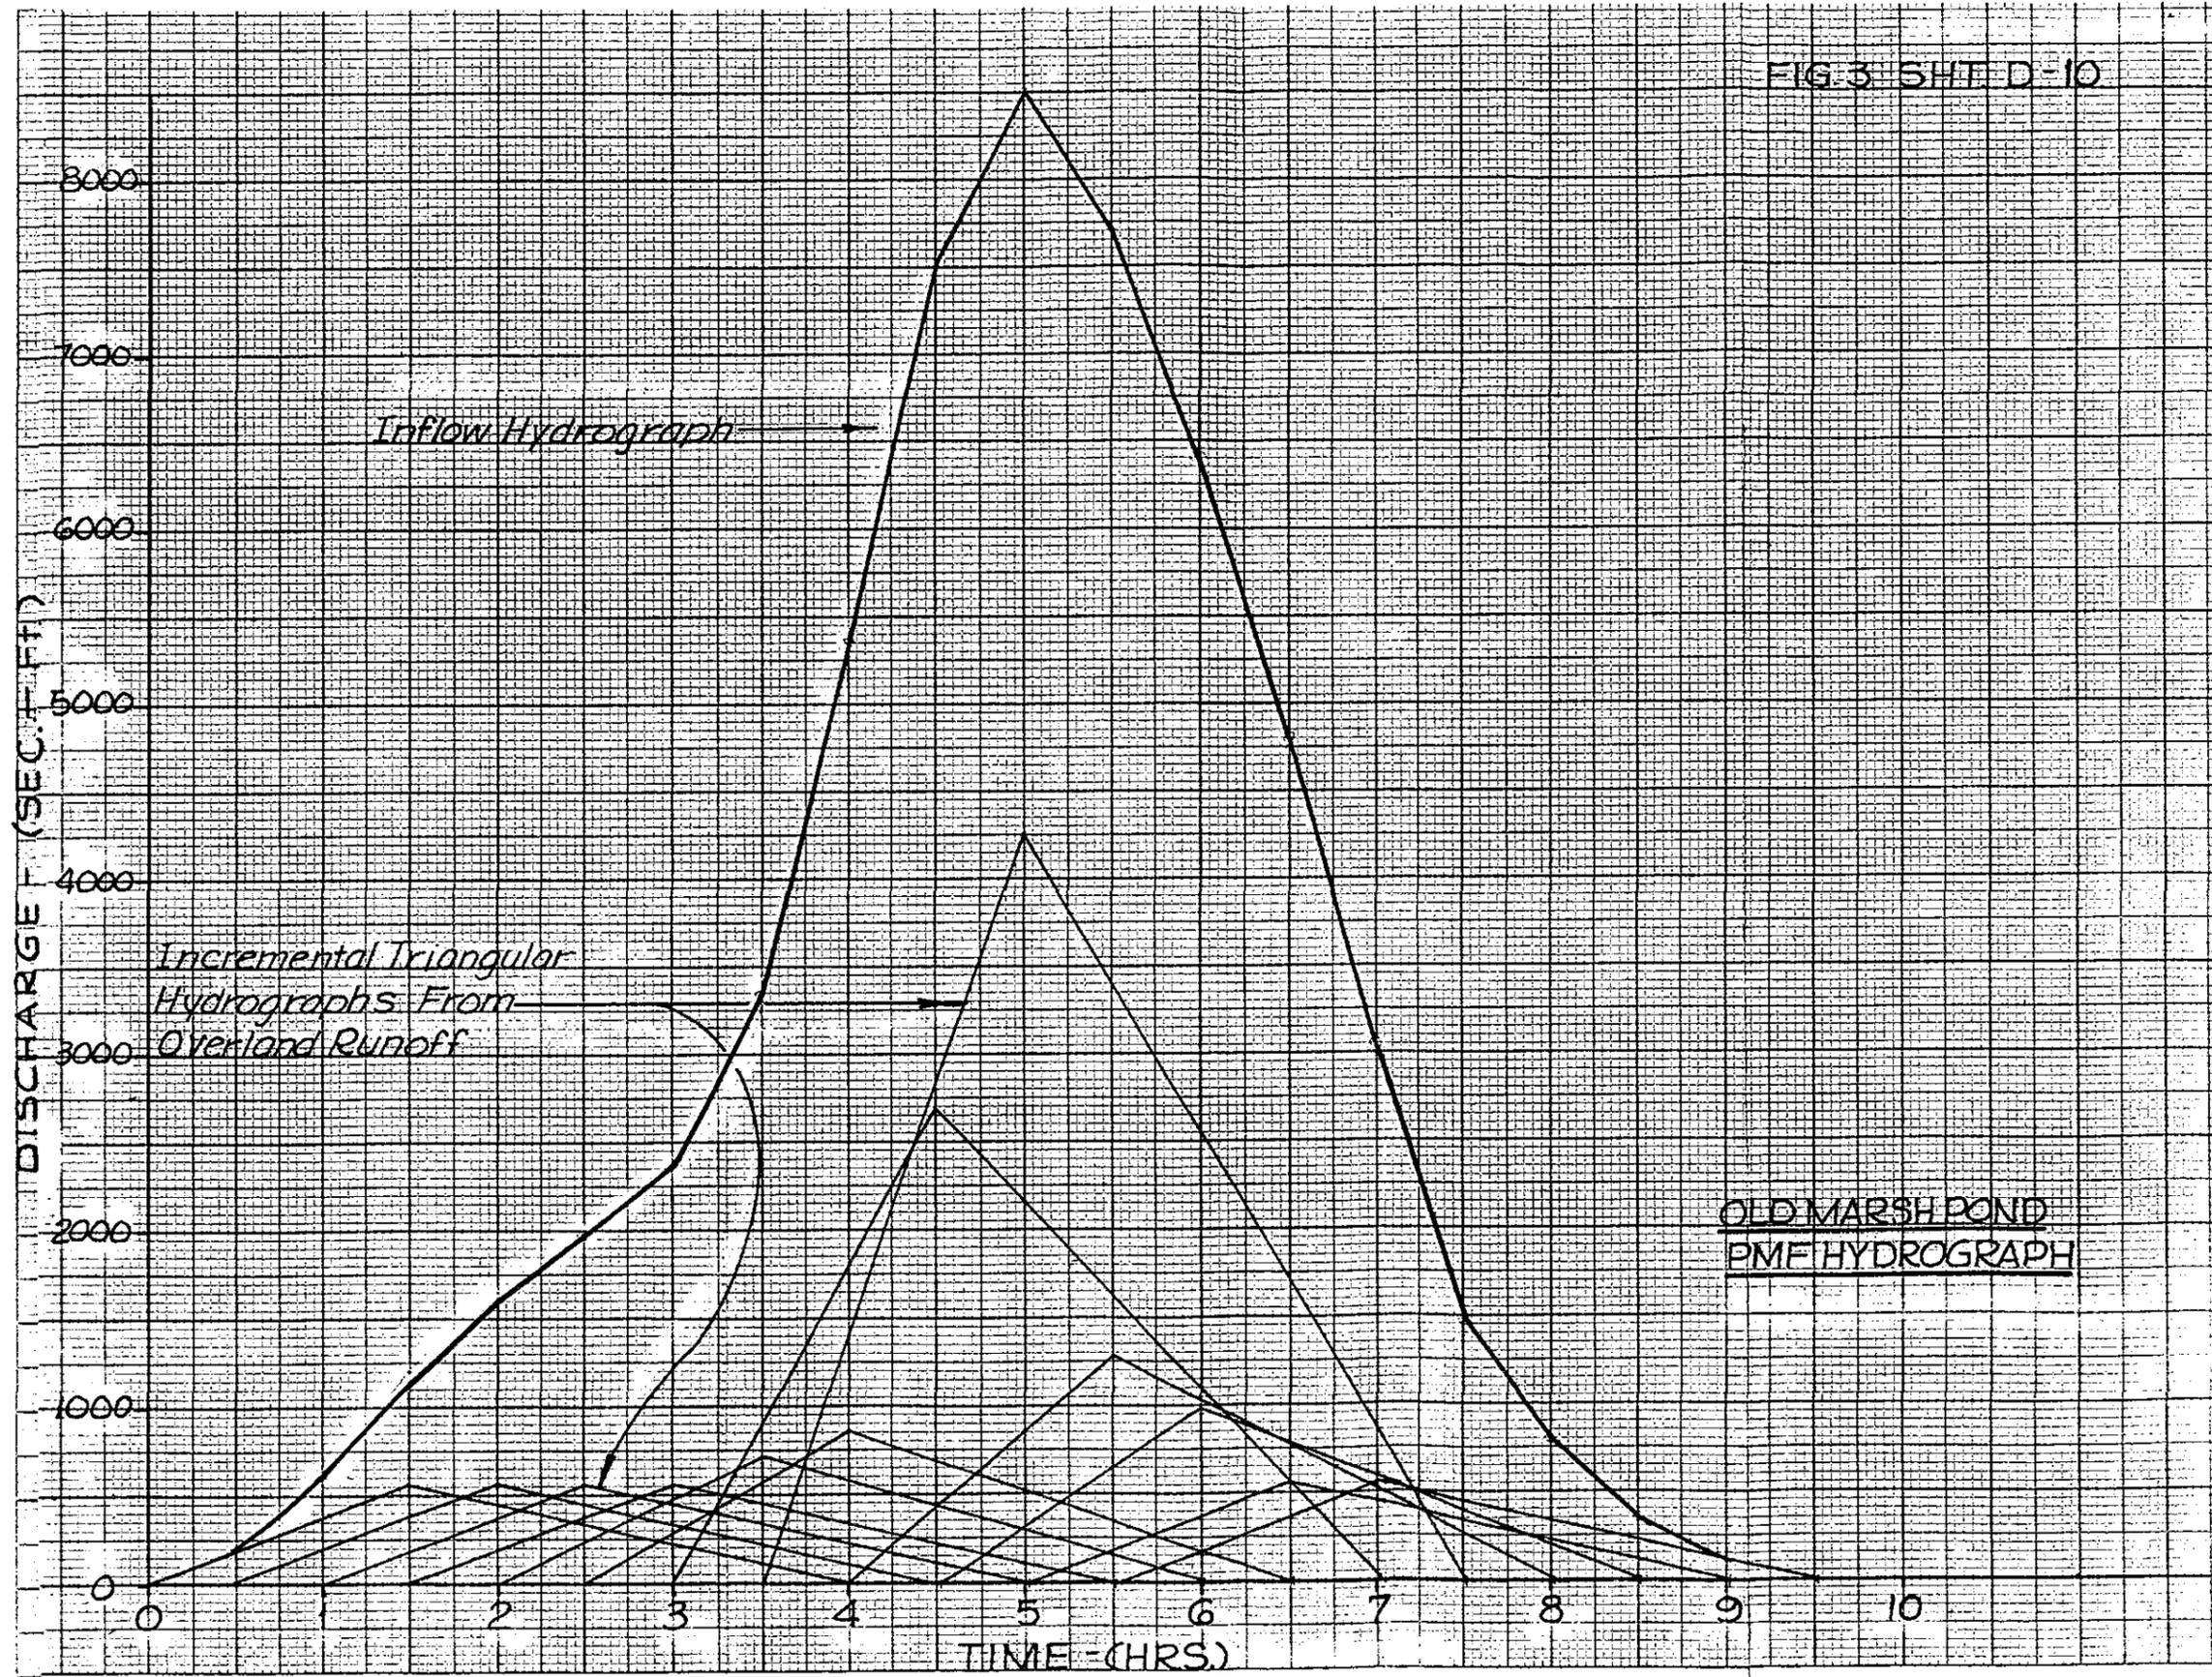
FIG. 3 SHEET D-10

Sheets D-8 and D-9, Appendix D). A PMF inflow hydrograph is shown on Figure 3. Sheet D-10, Appendix D, indicating a peak inflow of about 8,500 cfs or a CSM of about 3,600.
