MIXVILLE POND DAM CT 00302

PHASE I INSPECTION REPORT NATIONAL DAM INSPECTION PROGRAM

Identification Number:	CT 00302
Name:	Mixville Pond Dam
Town:	Cheshire
County and State:	New Haven County, Connecticut
Stream:	Tenmile River
Date of Inspection:	October 23, 1980

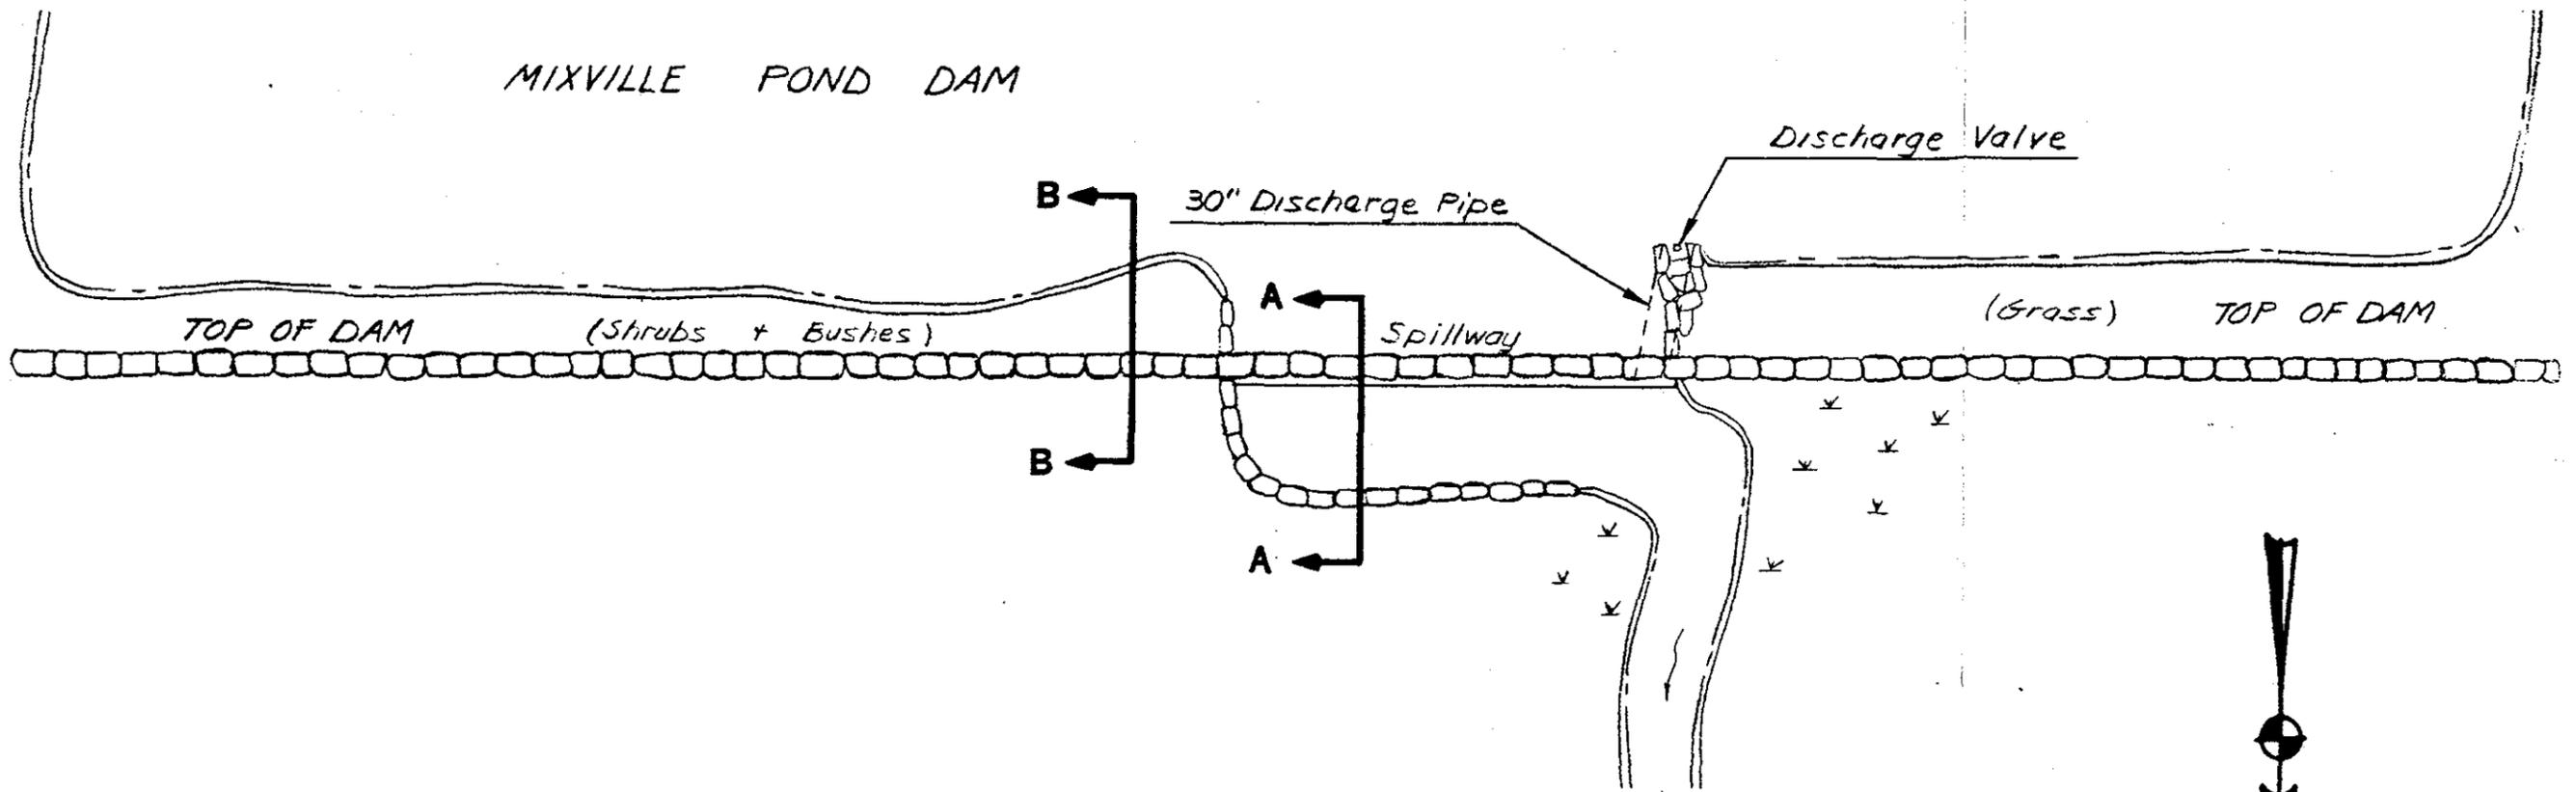
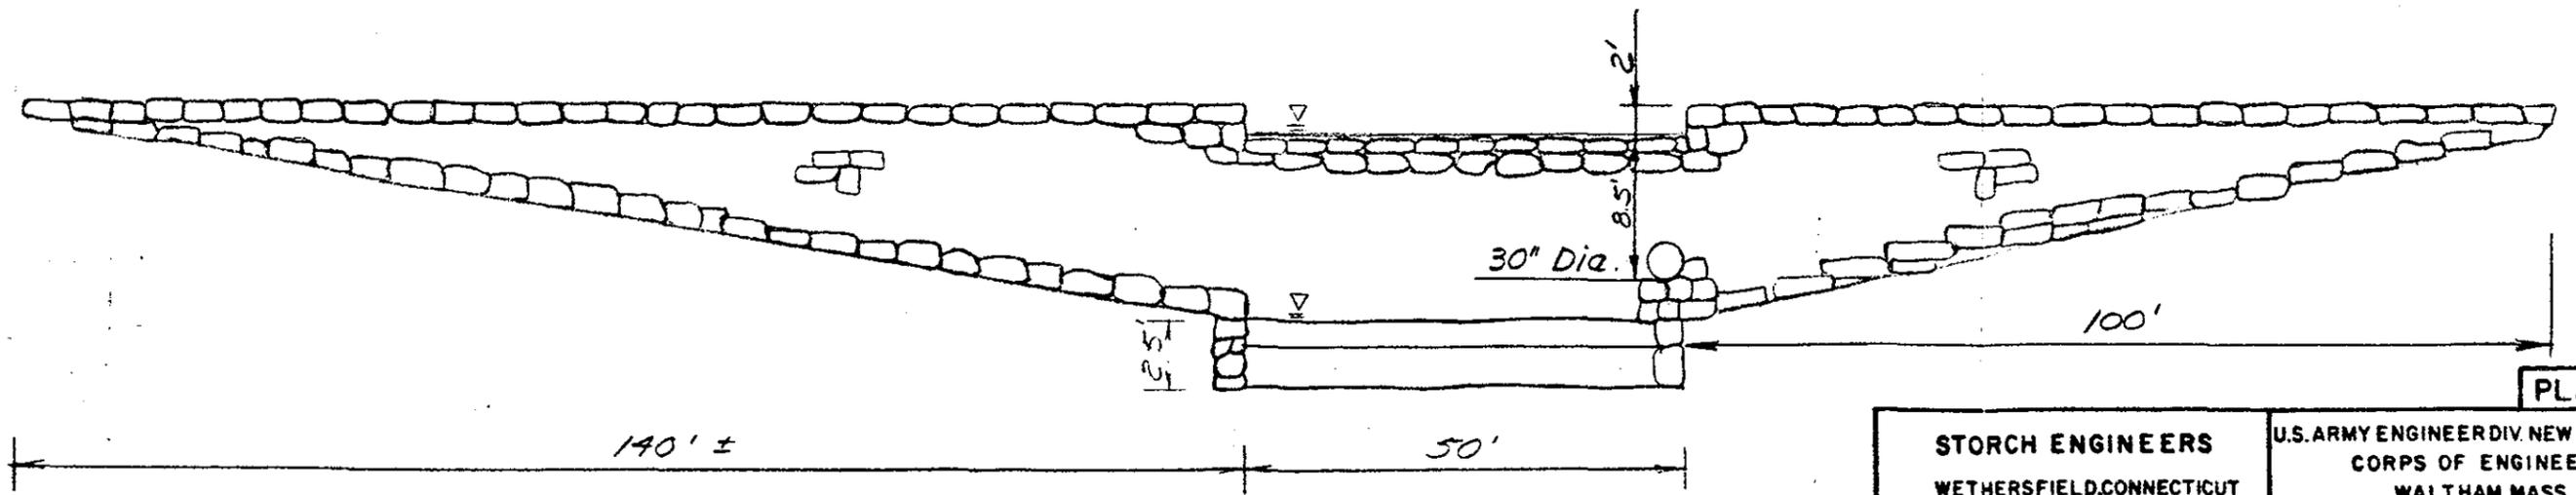
PLATE 1

b. Dam - The dam is an earth embankment with a vertical stone masonry face that gradually tapers off toward the ends of the dam. There is trimmed grass on the crest to the west of the spillway and there is thick brush on the crest to the east of the spillway (Photos 1 and 2). The crest of the dam is 2 feet above the spillway. The upstream earthen face is largely below the pond surface so its slope cannot be determined. The downstream stone masonry face is mortared in some areas but is generally dry (Photo 5). A stone has fallen out of the base of the wall to the east of the spillway (Photo 4) and several stones below the spillway are bulging out. There is a solid stone apron at the toe below the spillway. The horizontal and vertical alignment of the dam is good.
