**THAMES RIVER BASIN
STAFFORD, CONNECTICUT**

**RIVERSIDE POND DAM
CT. 00336**

**PHASE 1 INSPECTION REPORT
NATIONAL DAM INSPECTION PROGRAM**

OCTOBER, 1980

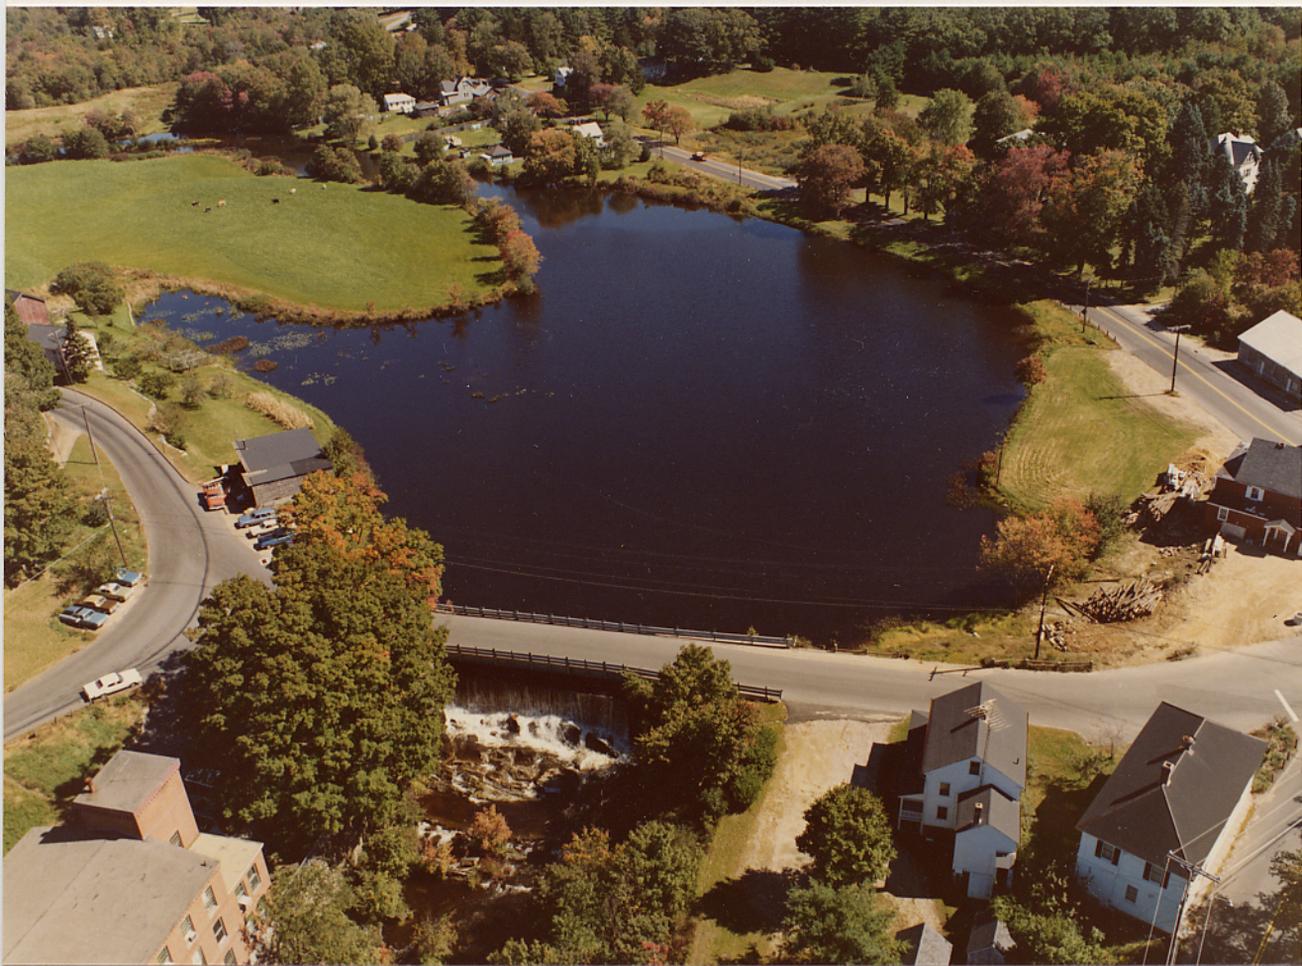
OVERVIEW PHOTO ~ Riverside Pond Dam

Based on the visual inspection, the dam at Riverside Pond and its appurtenances are judged to be in POOR condition.

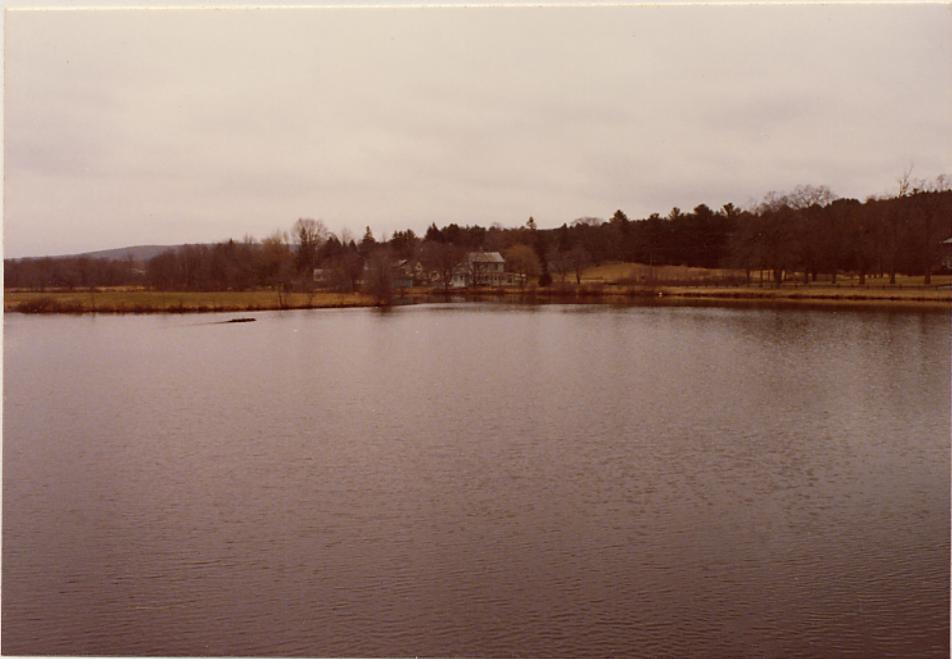
PHOTO C-8 Overview of Riverside Pond from crest of dam.
