HATTERTOWN POND DAM

CT 00313

**PHASE I INSPECTION REPORT
NATIONAL DAM INSPECTION PROGRAM**

MAY 1981

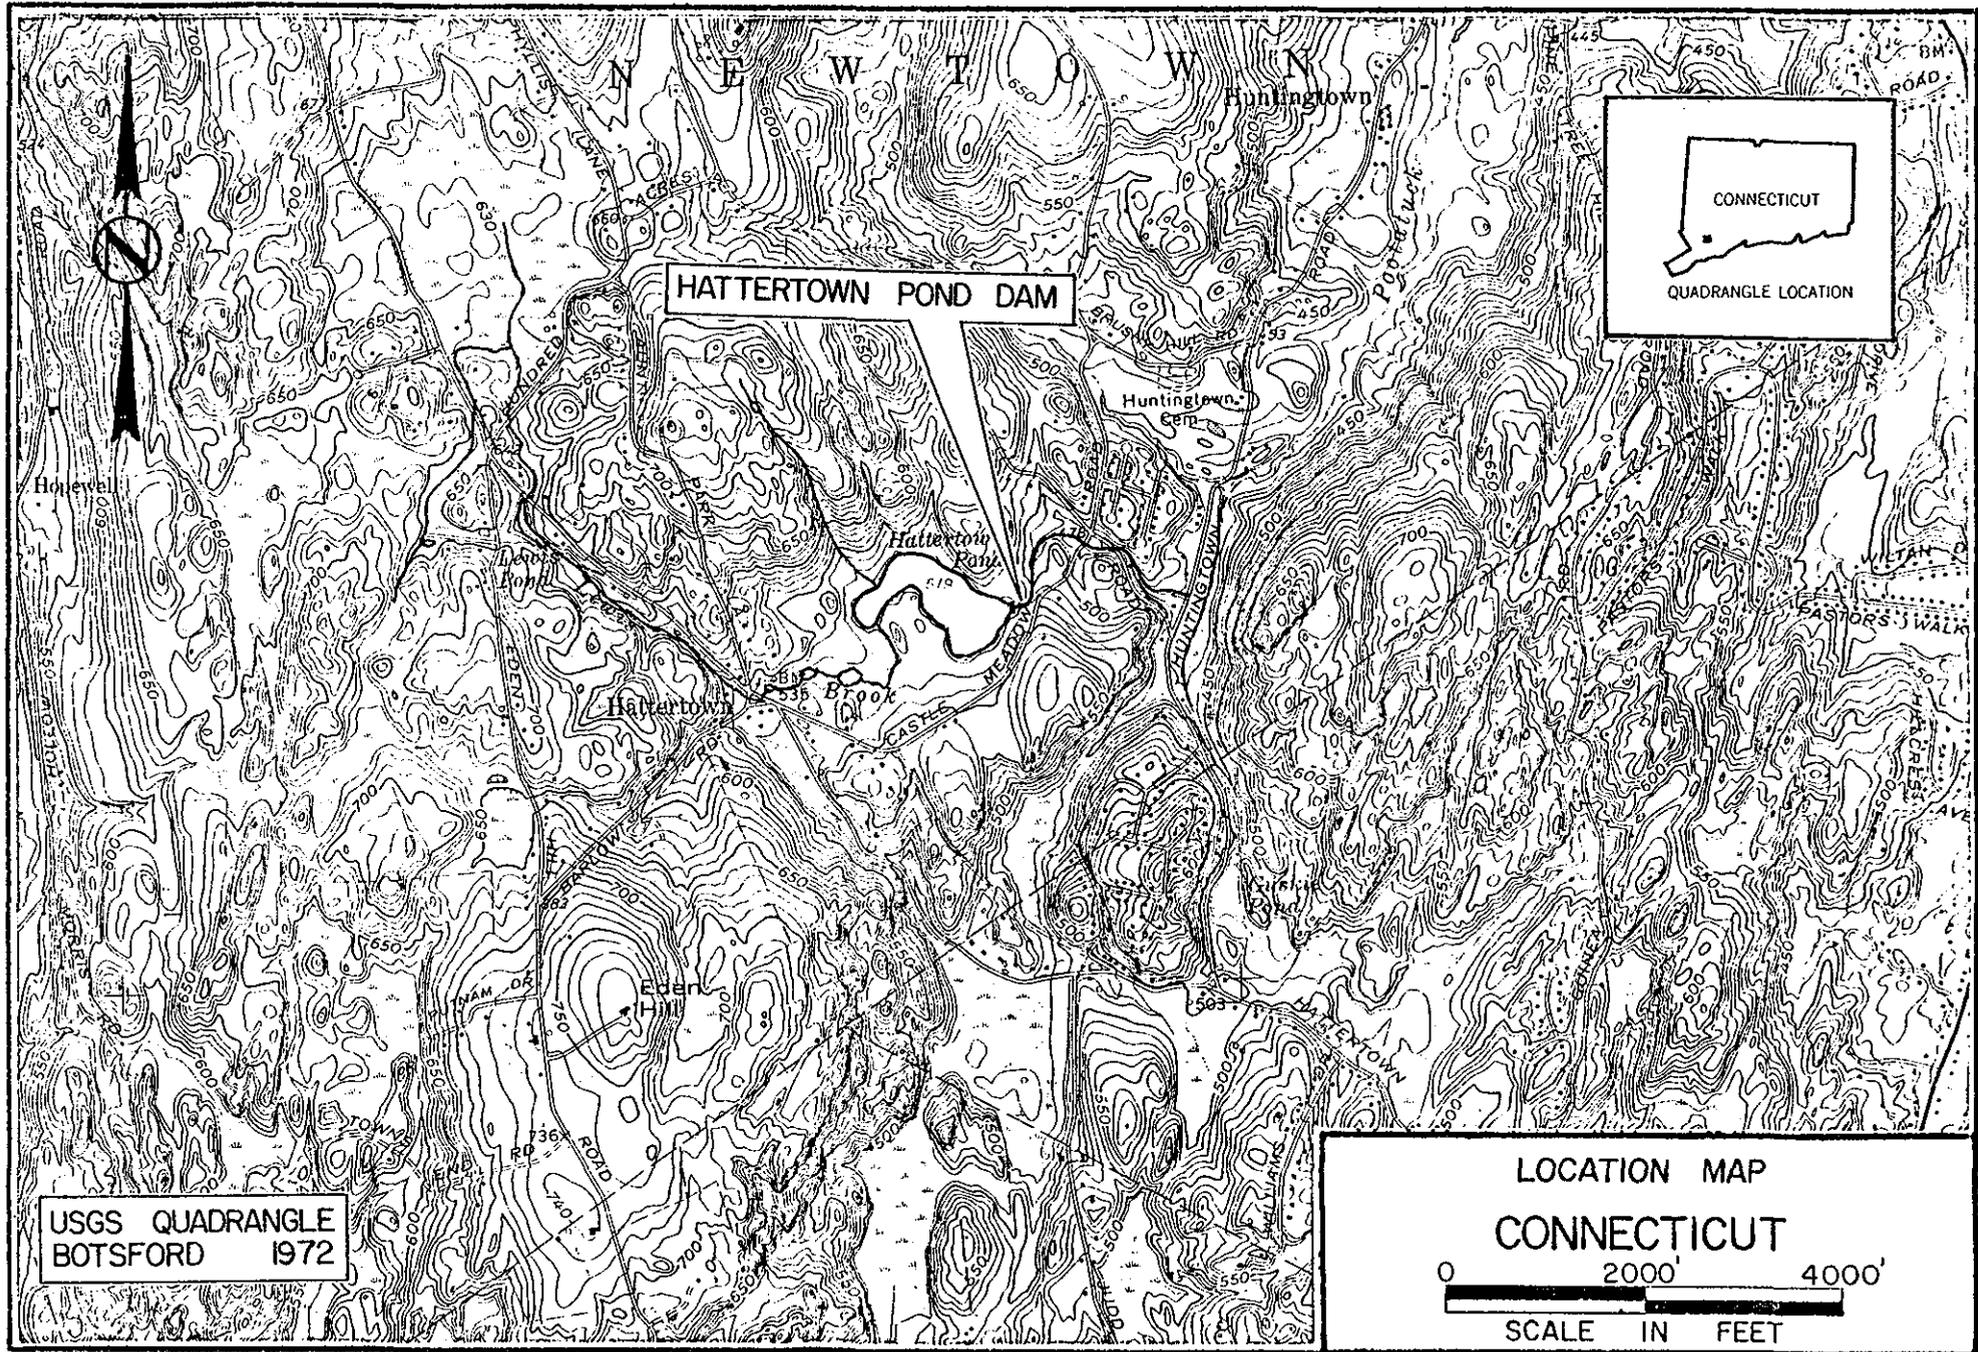
**OVERVIEW PHOTO-HATTERTOWN POND DAM
FEBRUARY 7, 1981**

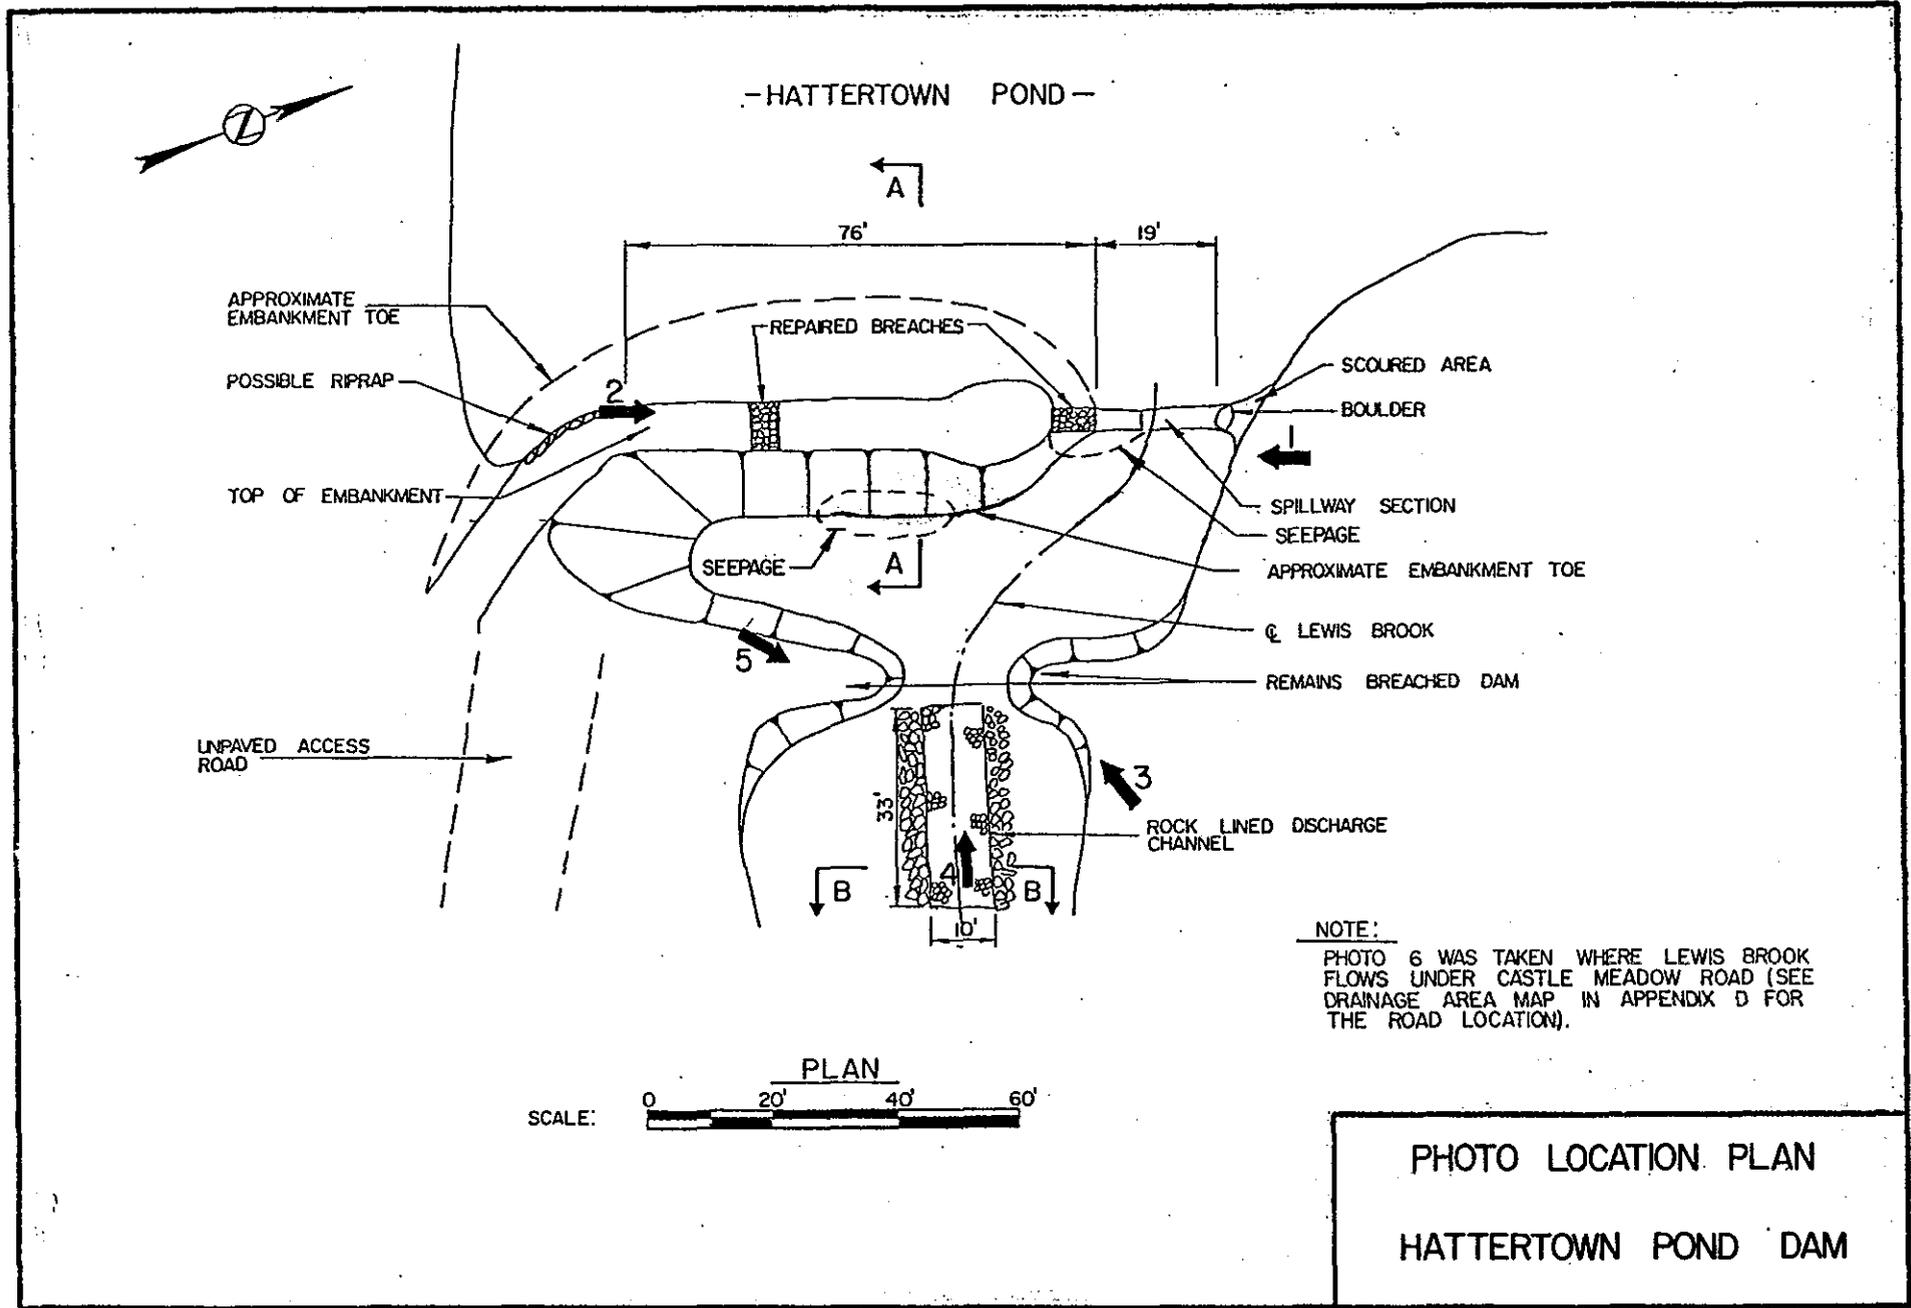
b. Dam — The dam is a crude rock and earthfill embankment with a concreted spillway section located at the left abutment (Photo 1). Two portions of the existing dam have been breached and filled with rocks and other rubble (Photos 2, 3, and 4). The remainder of the dam has been overgrown with trees ranging from 4 to 10 inches in diameter. Erosion along root networks was extensive thus increasing the deviations from the intended horizontal and vertical alignments. The top of the dam is very irregular and varies from 3 to 9 feet in width and up to 1 foot vertically. In addition, a total of approximately 20 to 30 gallons per minute (gpm) were seeping under the concrete spillway crest, through the repaired breach adjacent to the spillway, and along the toe near the center of the dam. The seepage appeared to contain no suspended particles and was generally clear.

Photo 1 Spillway (foreground), top and downstream slope of embankment.
