LAKE GAILLARD DAM
CT. 00387

PHASE I INSPECTION REPORT
NATIONAL DAM INSPECTION PROGRAM

SEPTEMBER 1978

Identification Number: CT 00387
Name: Lake Gaillard Dam
State Location: Connecticut
County Location: New Haven
Stream: Branford River
Date of Inspection: August 1, 1978

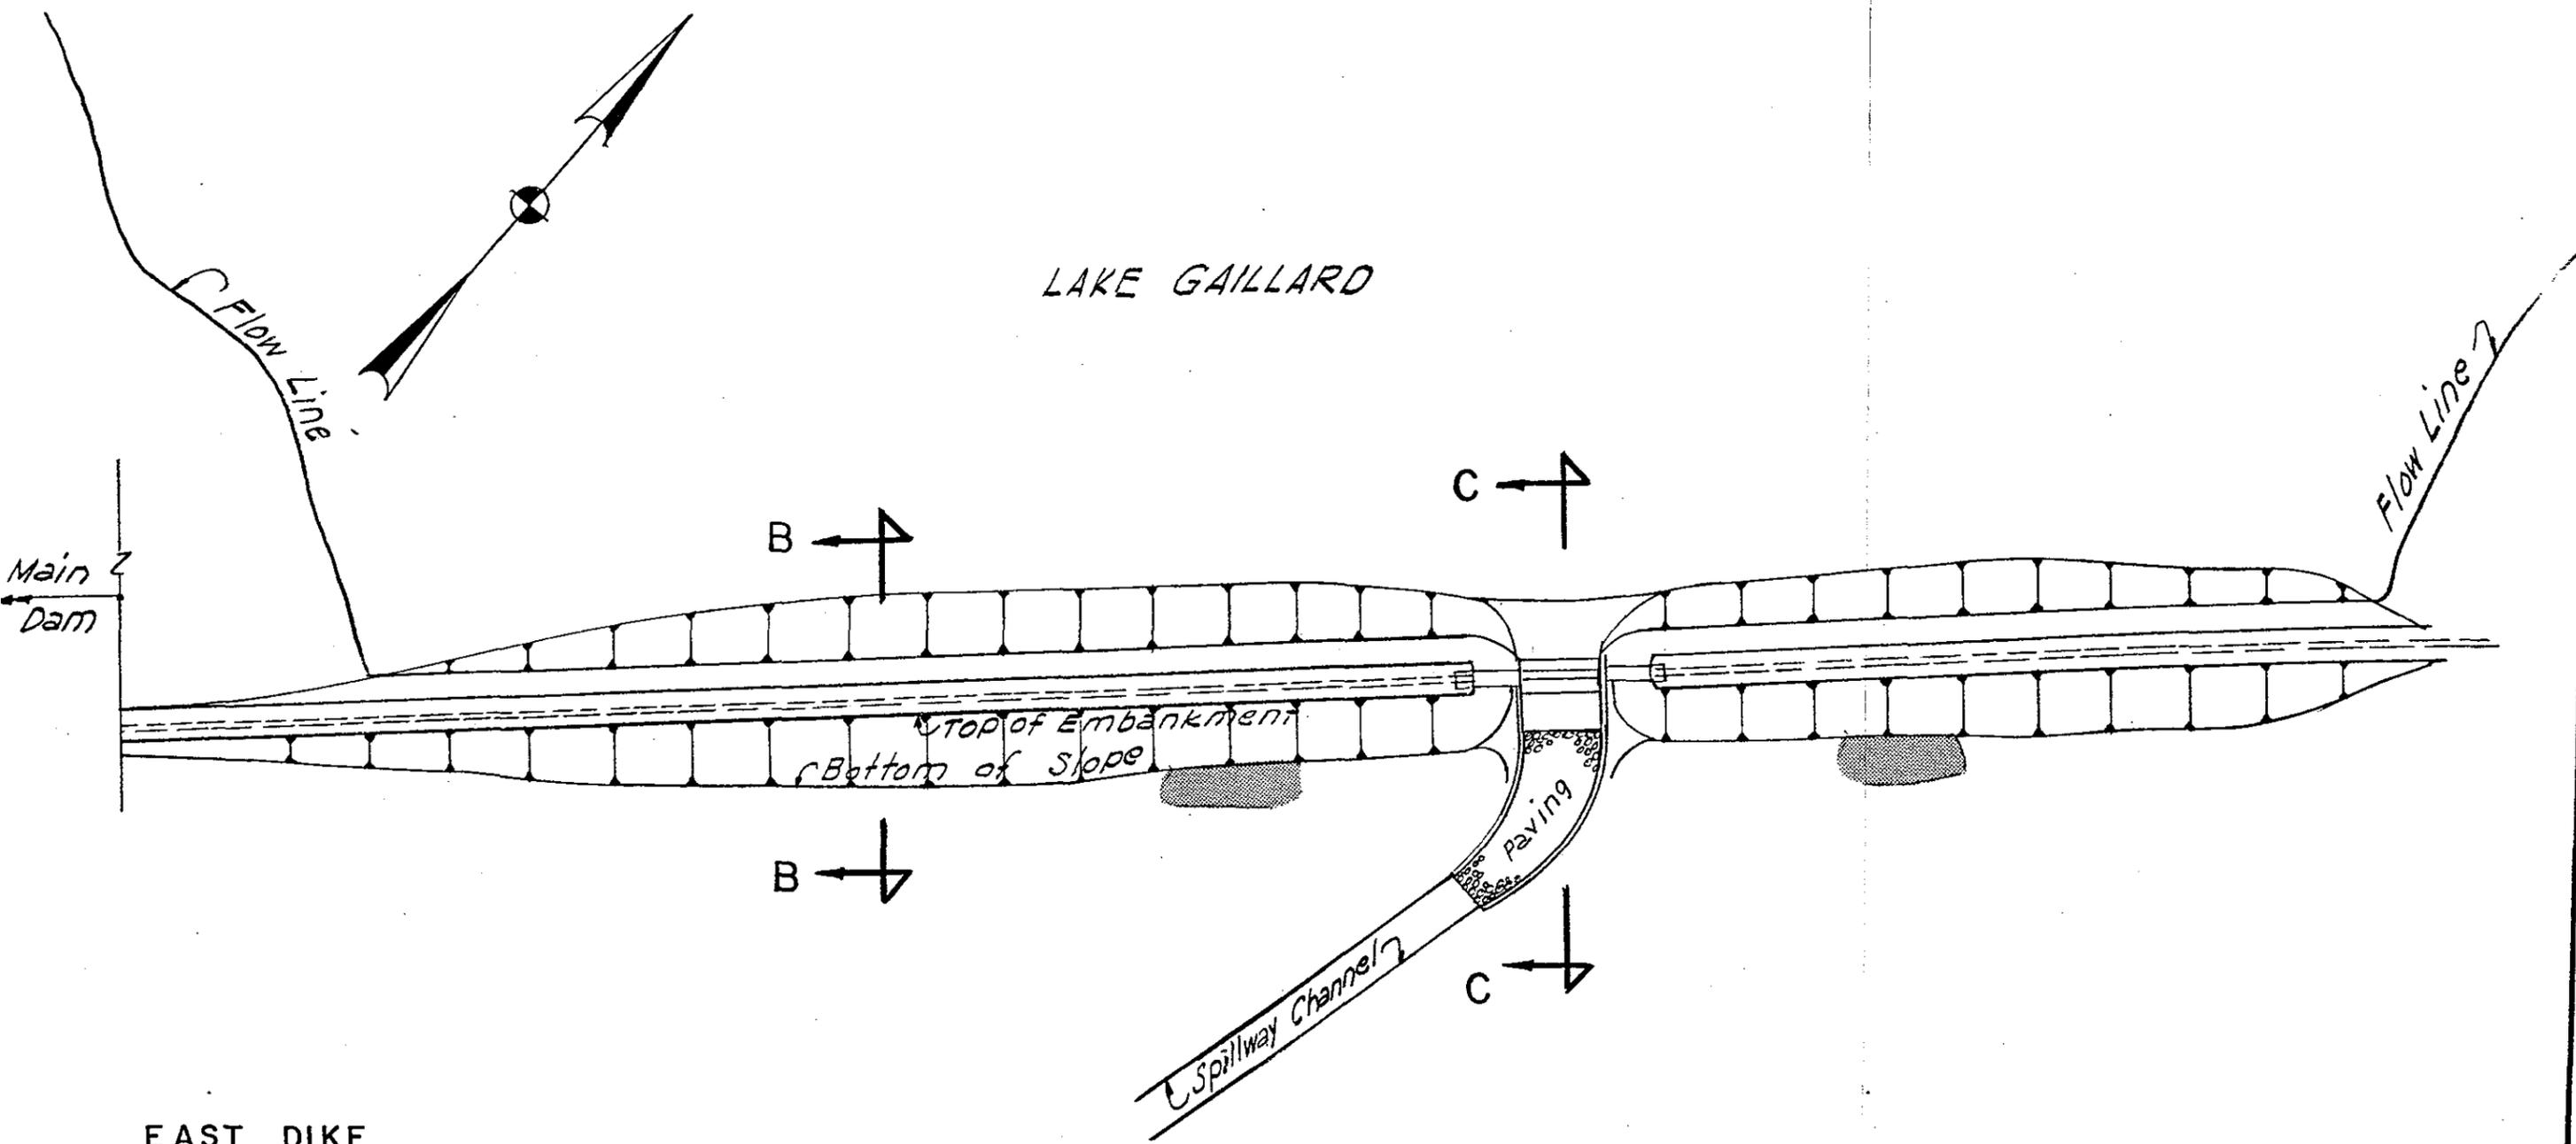
PLATE-2	
STORCH ENGINEERS WETHERSFIELD, CONNECTICUT	U.S. ARMY ENGINEER DIV. NEW ENGLAND CORPS OF ENGINEERS WALTHAM, MASS.
NATIONAL PROGRAM OF INSPECTION OF NON-FED. DAMS	
LAKE GAILLARD DAM	
BRANFORD RIVER	CONNECTICUT
	SCALE: AS SHOWN
	DATE: AUGUST 1978

The east dike where the water level is approximately 3 to 5 feet below the spillway crest has a straight alignment with no signs of movement or distress. In two spots that are delineated on Plate 2, Appendix B, there are wet or soft areas which are usually dry only during the month of August. Although these spots are spongy, there is no visible sign of any seepage.
