GLOBE HOLLOW RESERVOIR DAM

CT. 00012

PHASE I INSPECTION REPORT
NATIONAL DAM INSPECTION PROGRAM

JUNE 1979

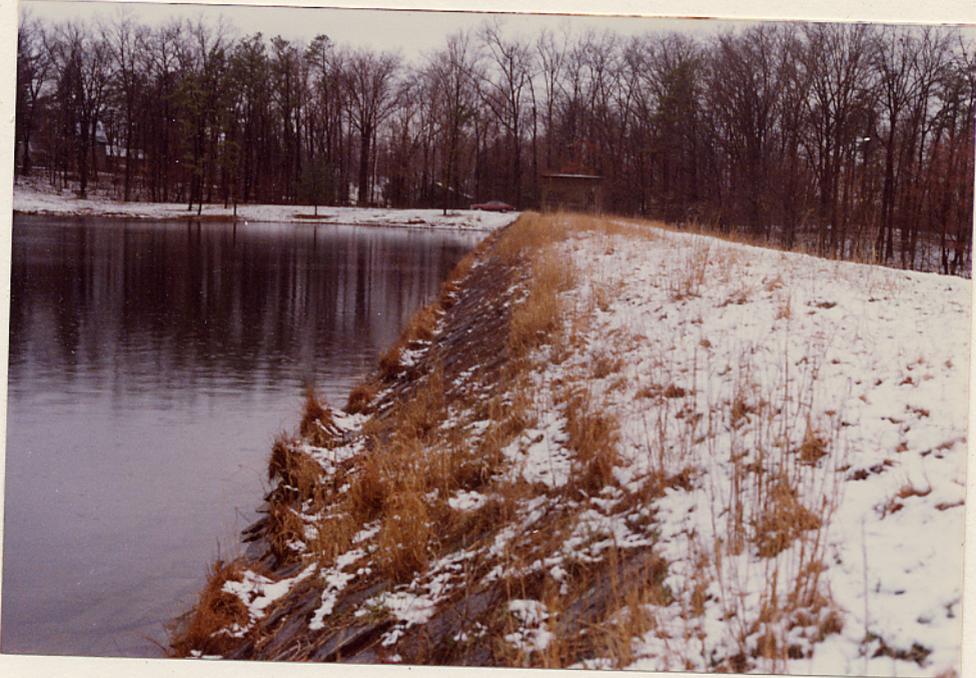
Overview of Dam from Right Abutment

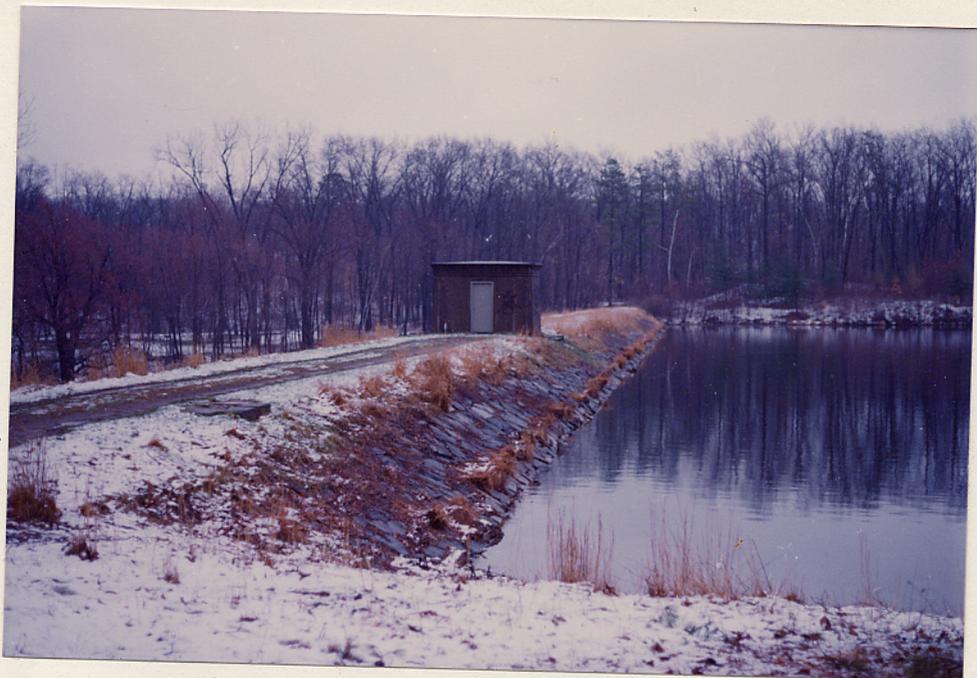
Overview of Dam from Left Abutment

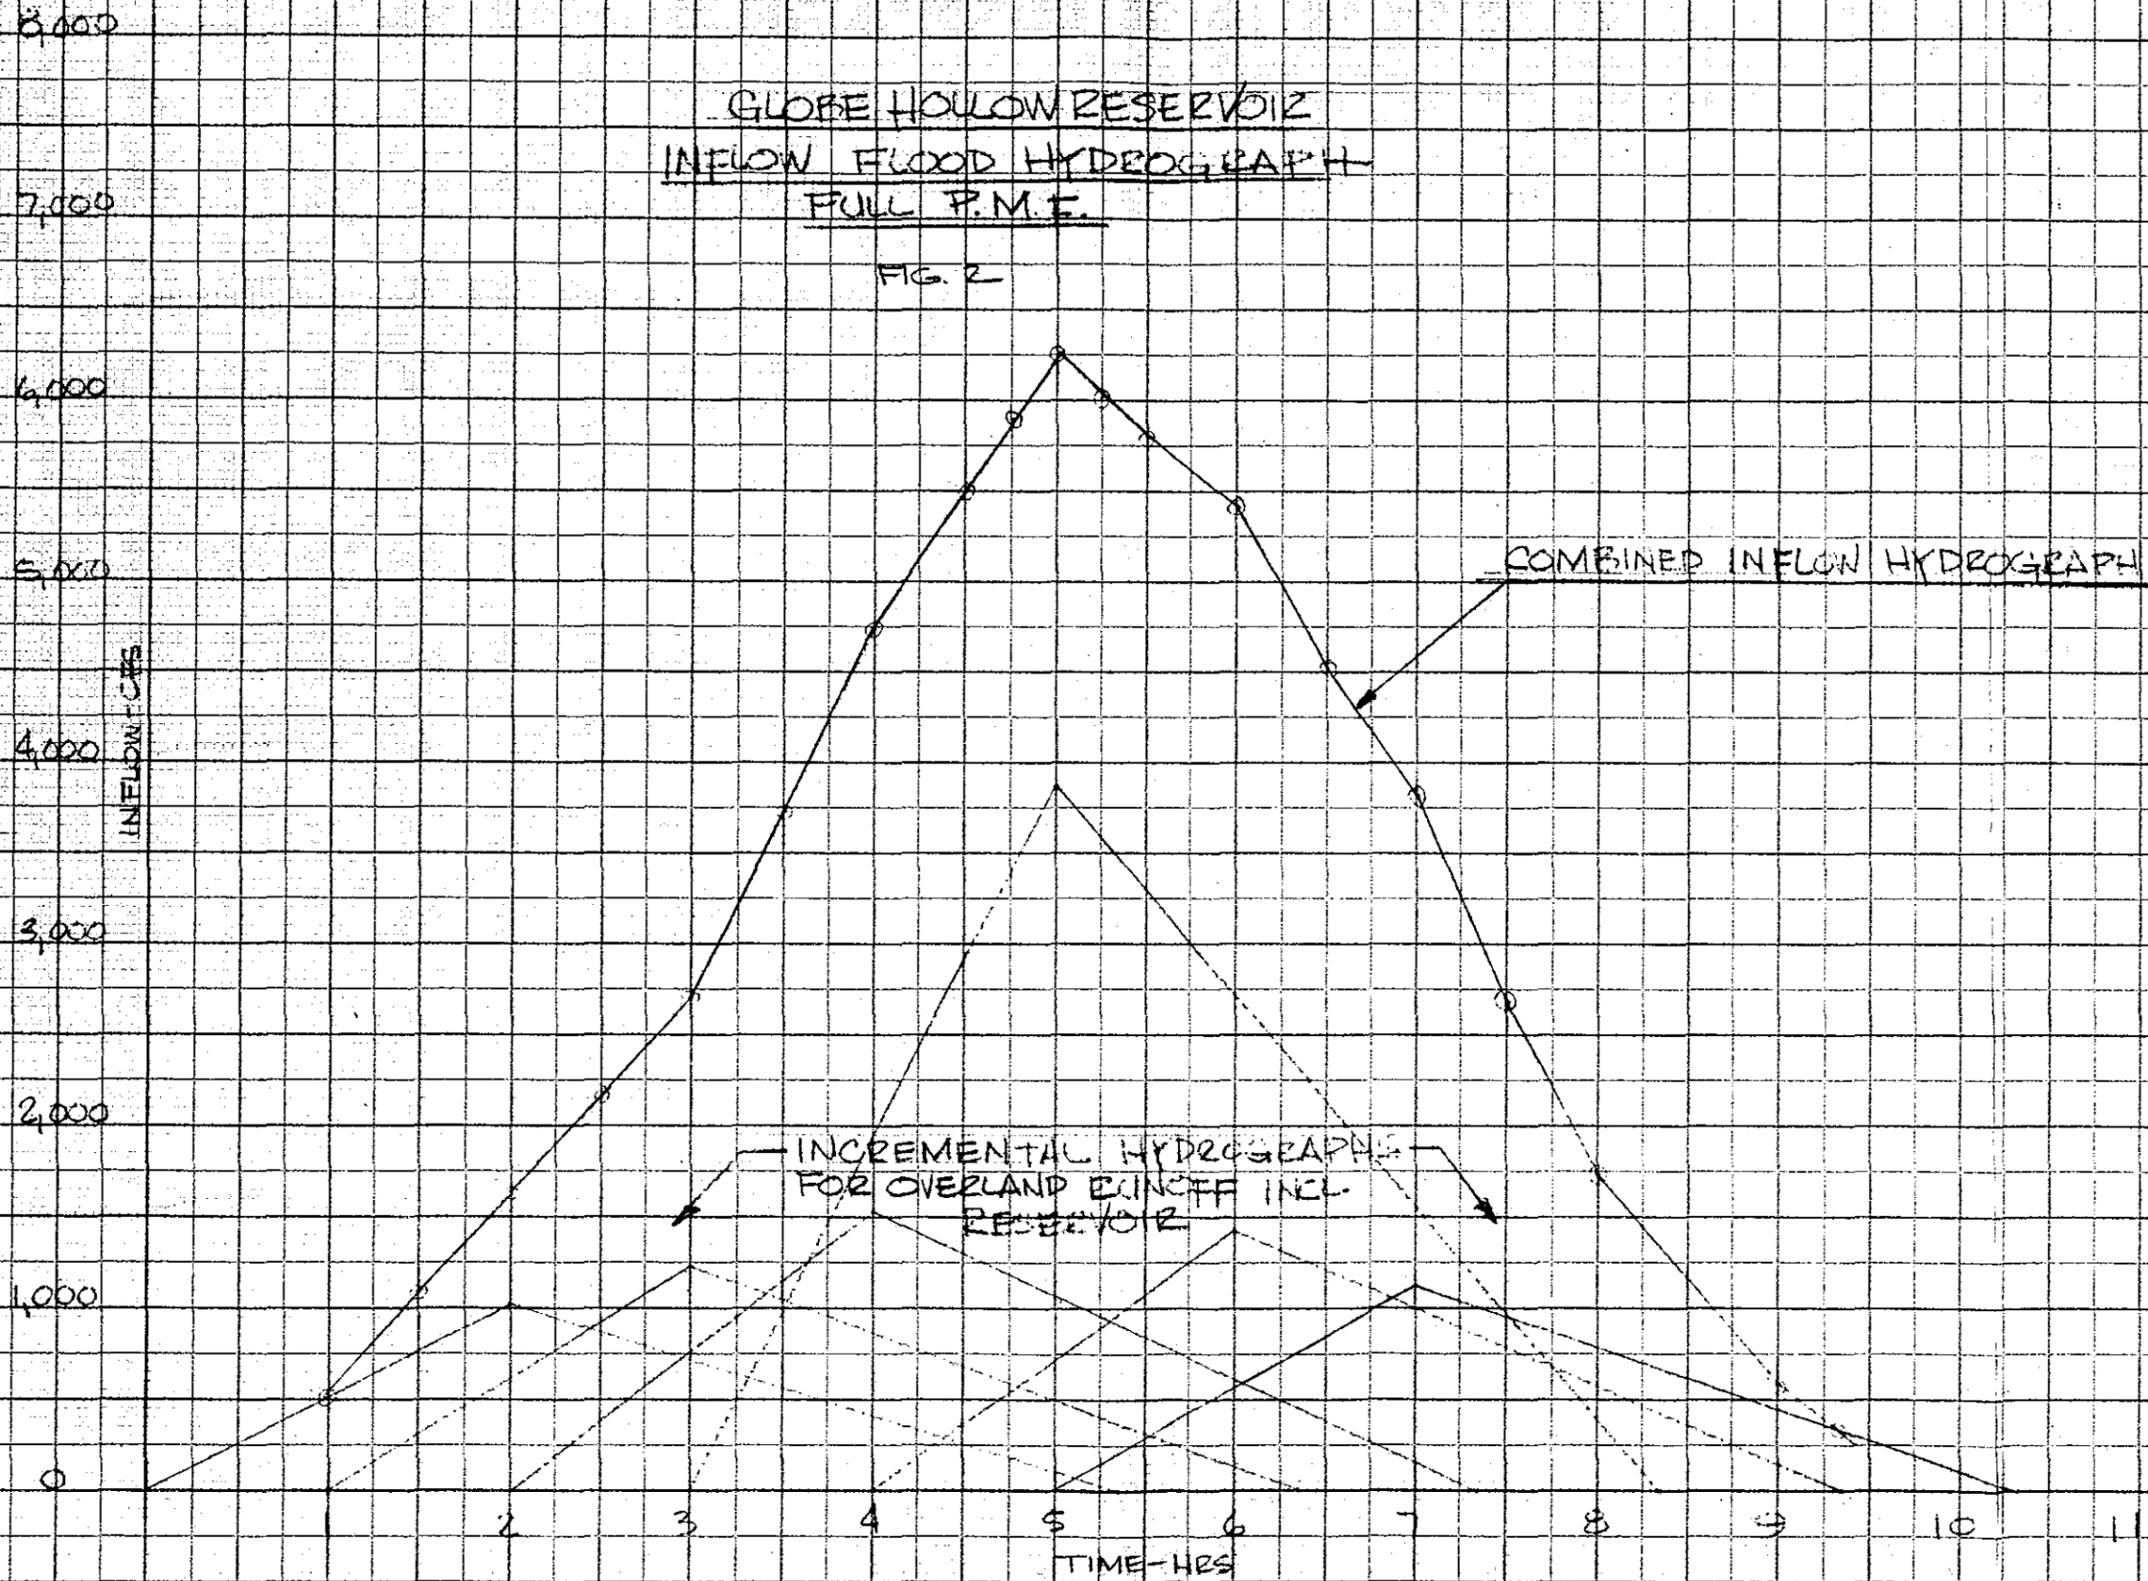
FIG. 2

A triangular incremental unitgraph was assumed for the inflow hydrographs, using a computed lag time value of 2.0 hours to derive a time-to-peak for the triangular hydrograph of 2.0 hours (see computations on Sheets D-3 and D-6, Appendix D). A PMF inflow hydrograph is shown on Fig. 2, Sheet D-7, Appendix D, indicating a peak inflow of about 6,250 cfs or a CSM of about 2,790.

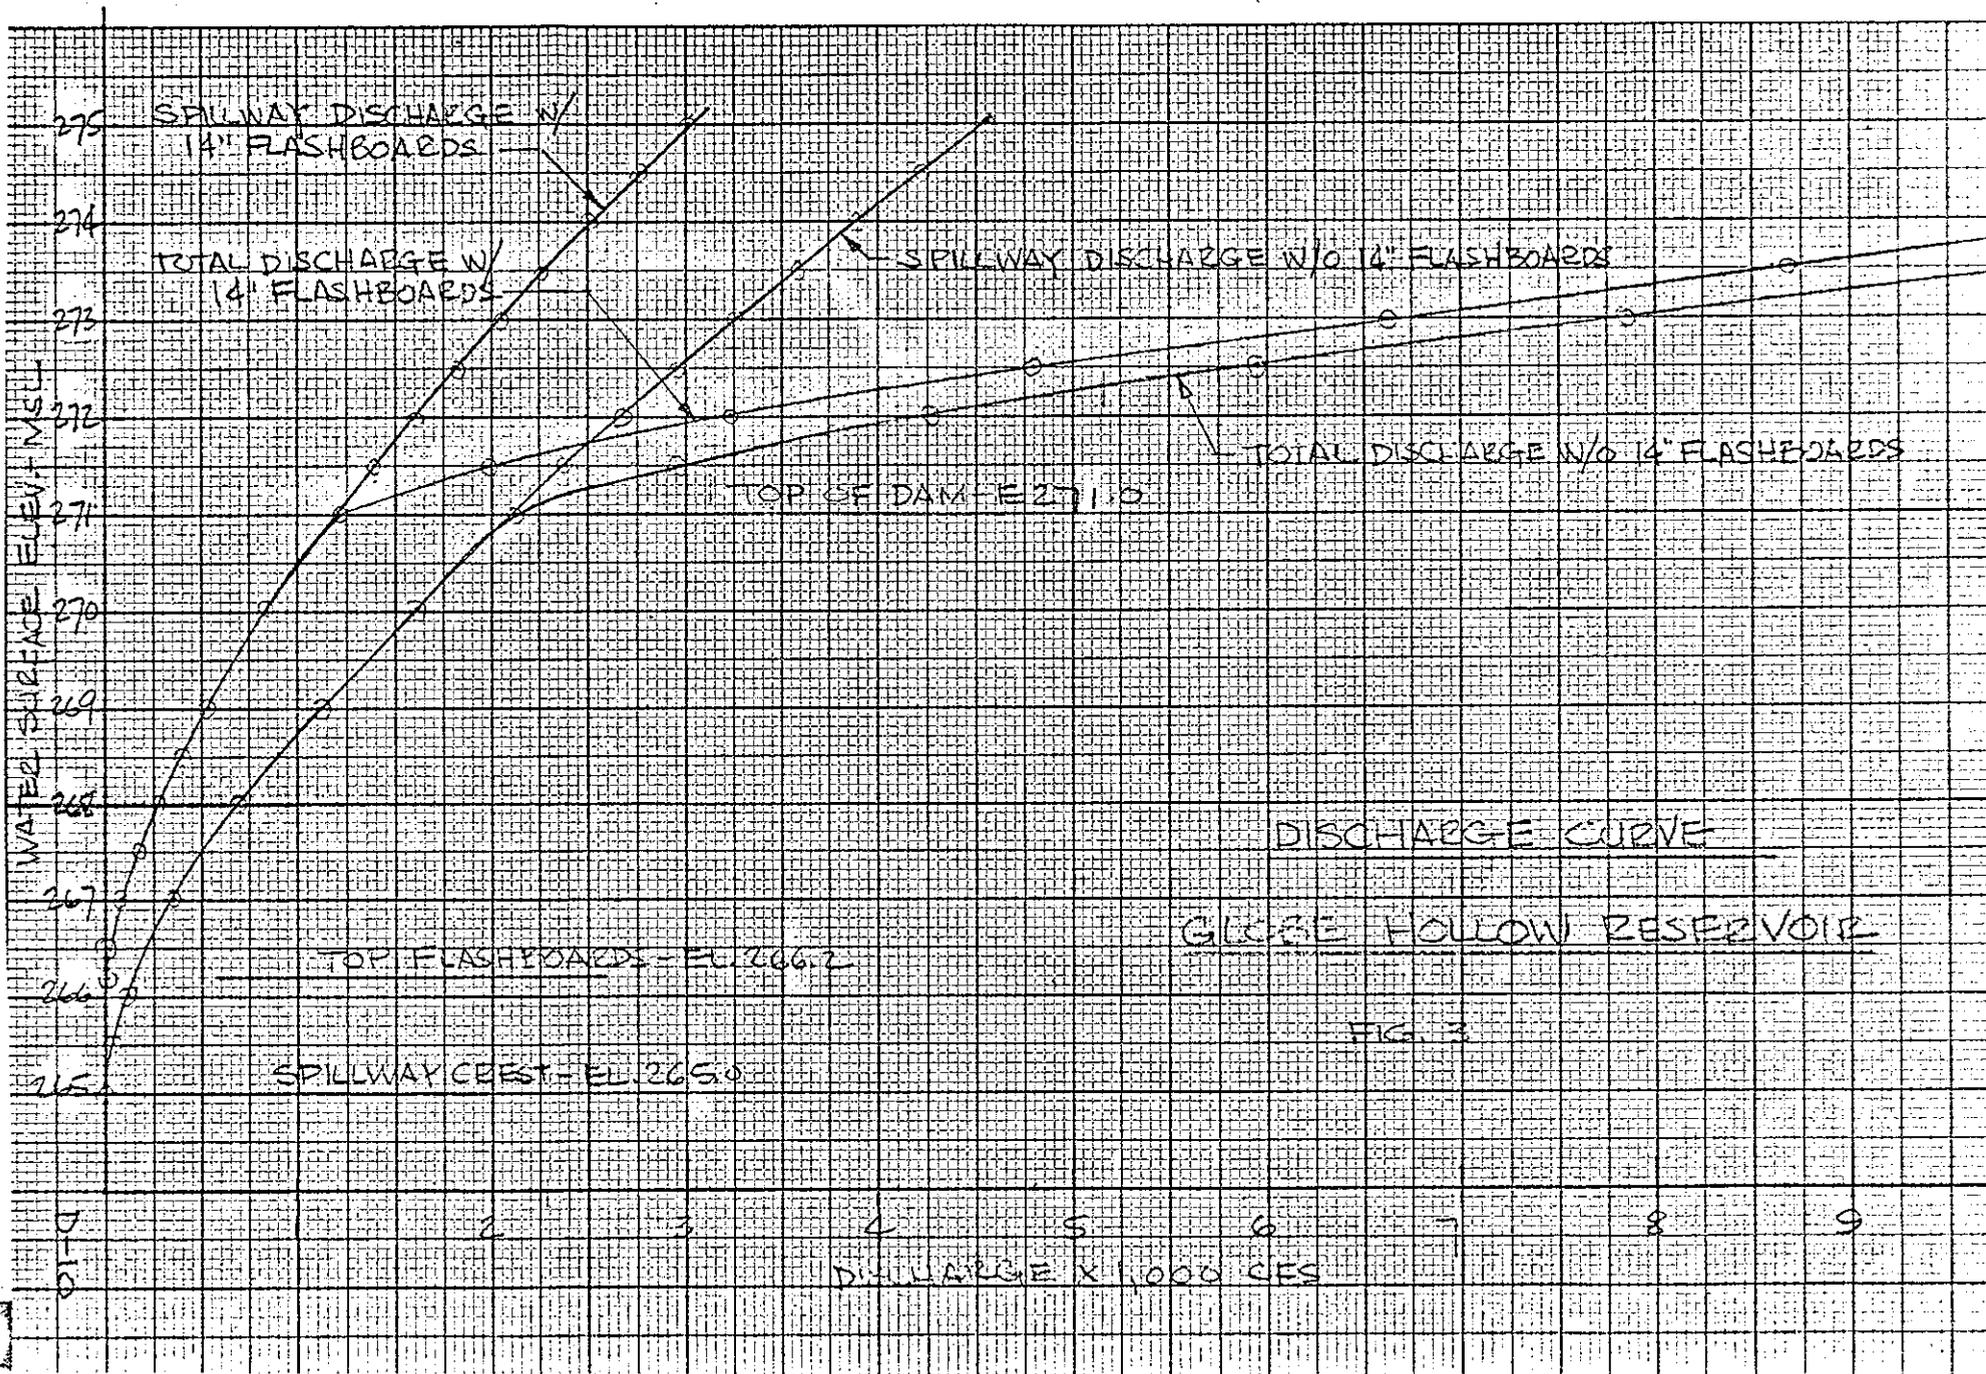
FIG. 3

Discharge tables and curves for the spillway and for over the top of the dam are shown on Sheets D-8 and D-9 and Fig. 3 Sheet D-10, Appendix D. Because of their small capacity, the effect of the outlet pipes was neglected. The spillway capacity at top of dam, elevation 271.0 MSL, is 2,120 cfs, assuming that flashboards are not installed. When both 24 in. outlet pipes function as blowoff pipes their combined capacity is 130 cfs with the water surface at test flood elevation and about 126 cfs with the water surface at top of dam.
