Periodic Inspection Report No. 6
Hopkinton Lake
Hopkinton, New Hampshire

SUBJECT: Independent Technical Review (ITR) of Periodic Inspection Report
No. 6, Hopkinton Lake, Hopkinton, New Hampshire

PERIODIC INSPECTION NO. 6
HOPKINTON LAKE
HOPKINTON, NEW HAMPSHIRE

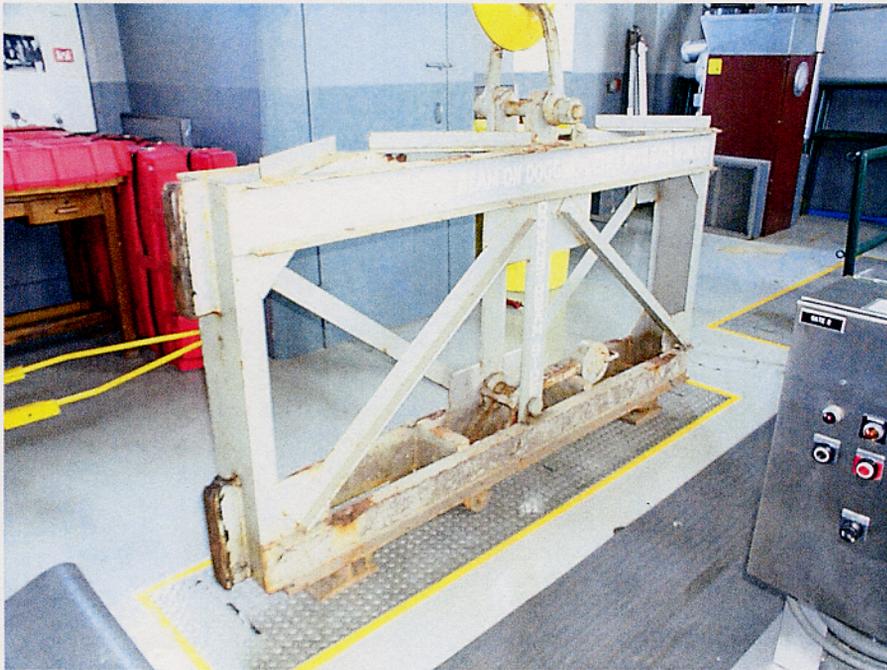
(3) Replacement of the bent counterweight arm of the emergency gate lifting beam and the modification of the gate hook has been deferred pending an investigation and design by Engineering/Planning Division.

Photo B-2 - Emergency Gate Lifting Beam.

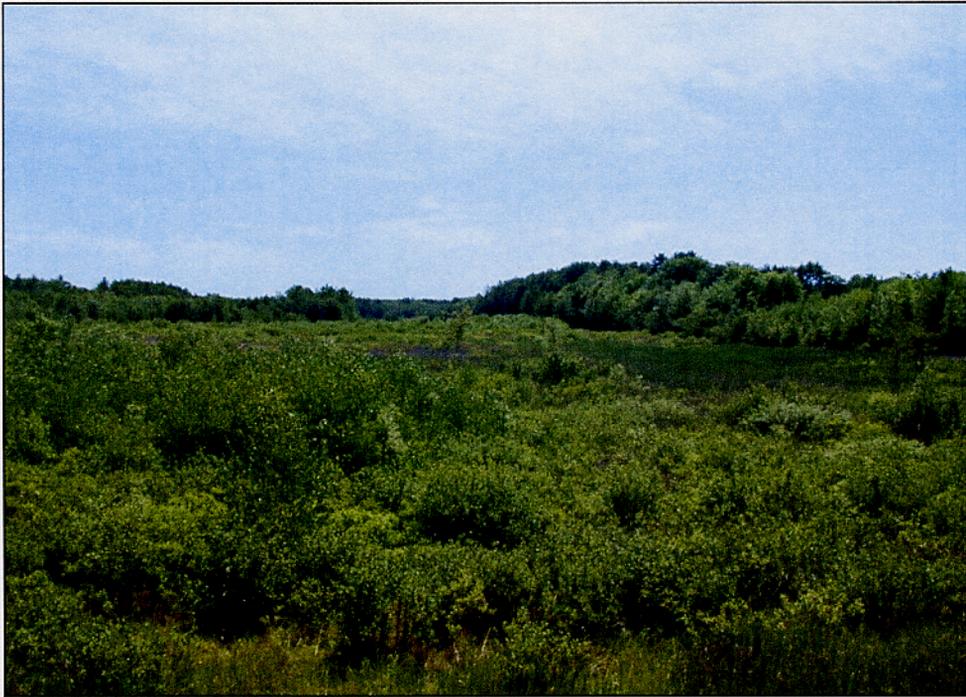
(1) Approach Channel. The approach channel was in overall good condition. Some vegetation was observed in the approach channel, but will not obstruct flow (Photo D-1).

Photo D-1: Spillway approach channel, looking U/S.

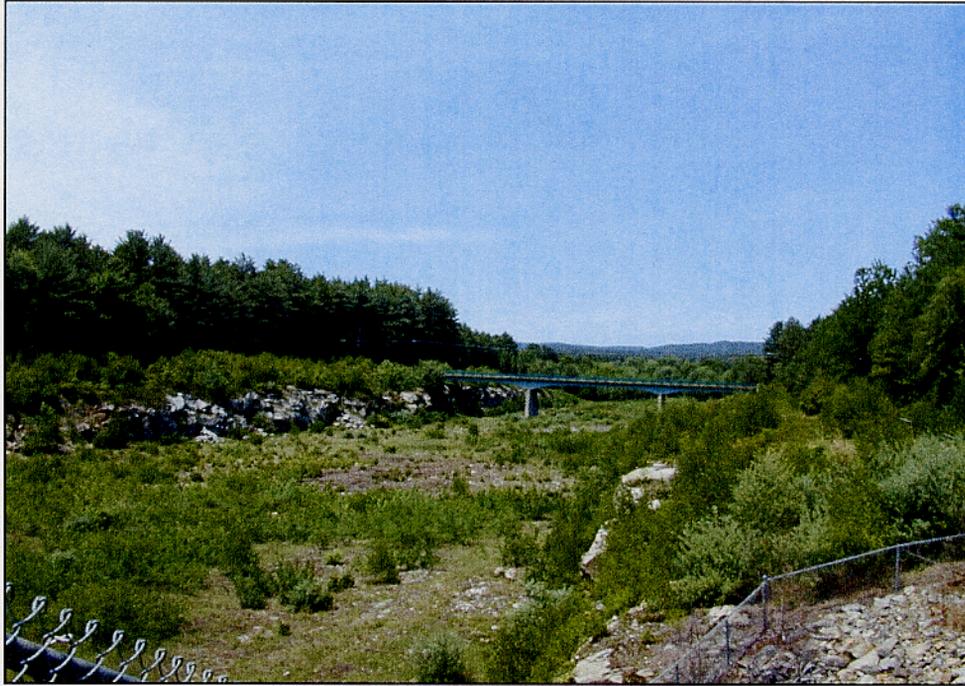
(3) Exit. The spillway discharge channel was in good condition with no major outgrowth of trees or vegetation (Photo D-3).

Photo D-3: Spillway discharge channel, looking D/S.

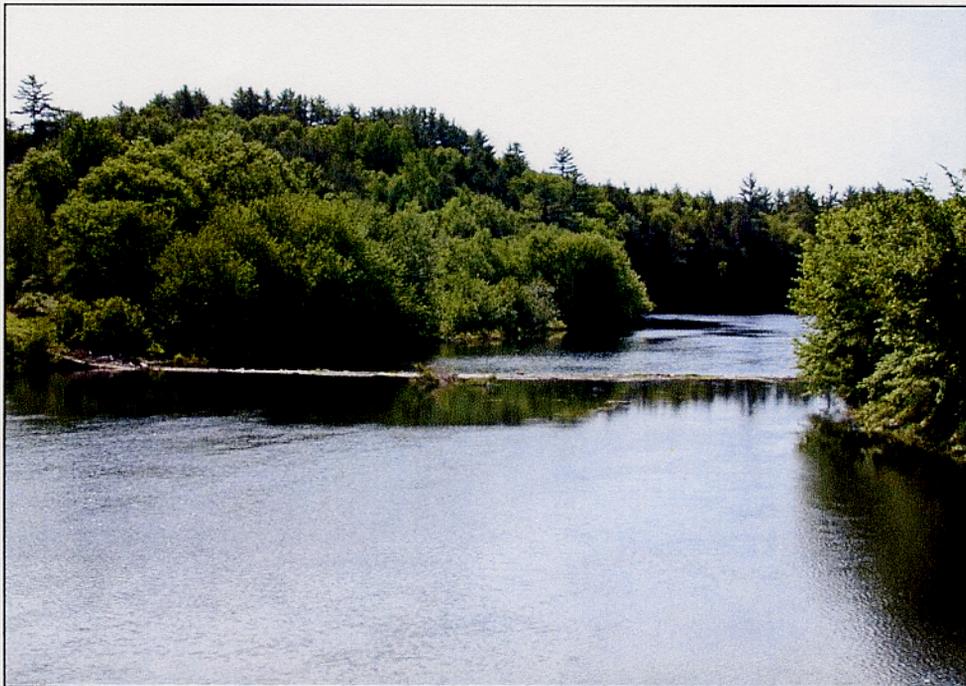
(a) Inlet Channel. The inlet was in good condition with no apparent obstruction to flow (Photo D-4).

Photo D-4: View of the inlet channel, looking U/S.

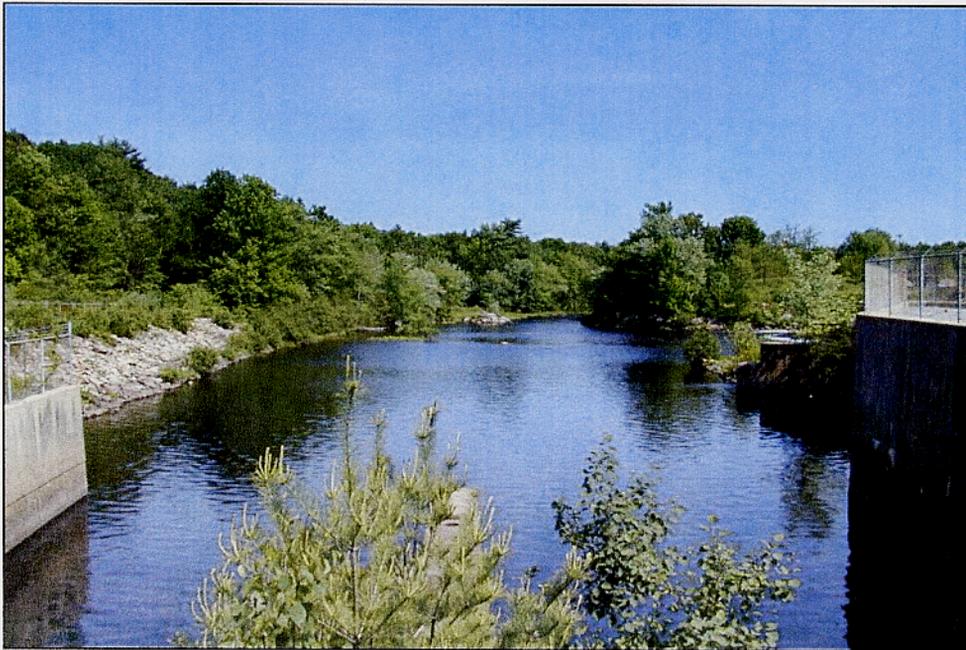
(4) Exit Channel. The exit channel is in good condition (see Photo D-6).

Photo D-6: View of outlet channel, looking D/S.

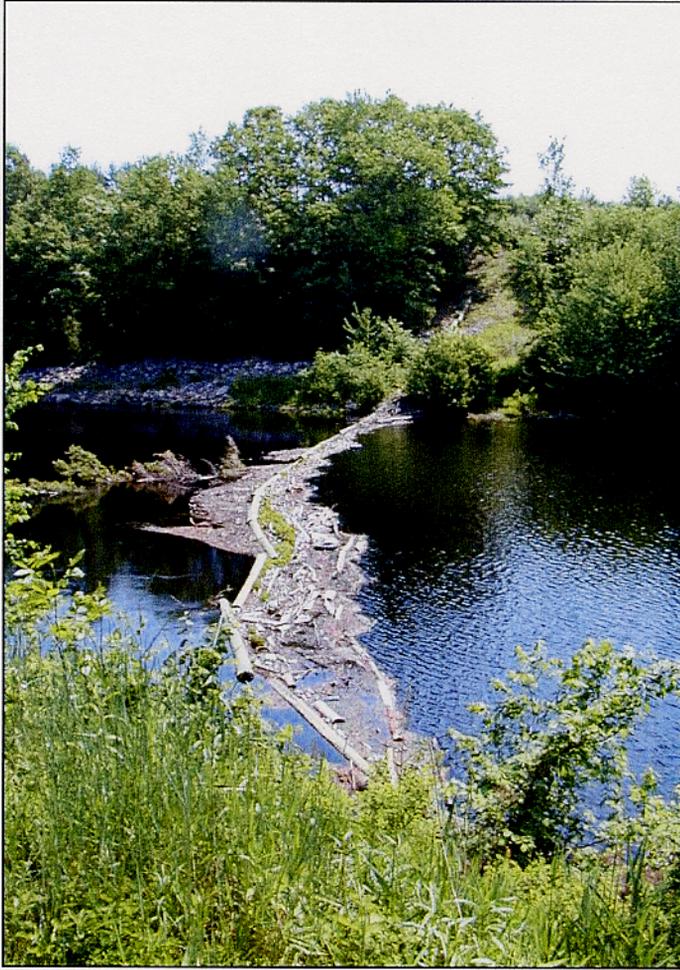
(b) Log Boom. The log boom was generally in good condition. All of the logs appeared to be floating properly. There was a buildup of debris behind the log boom at the time of the inspection, but is scheduled to be removed during June-July 2002.

Photo D-7: View of log boom.

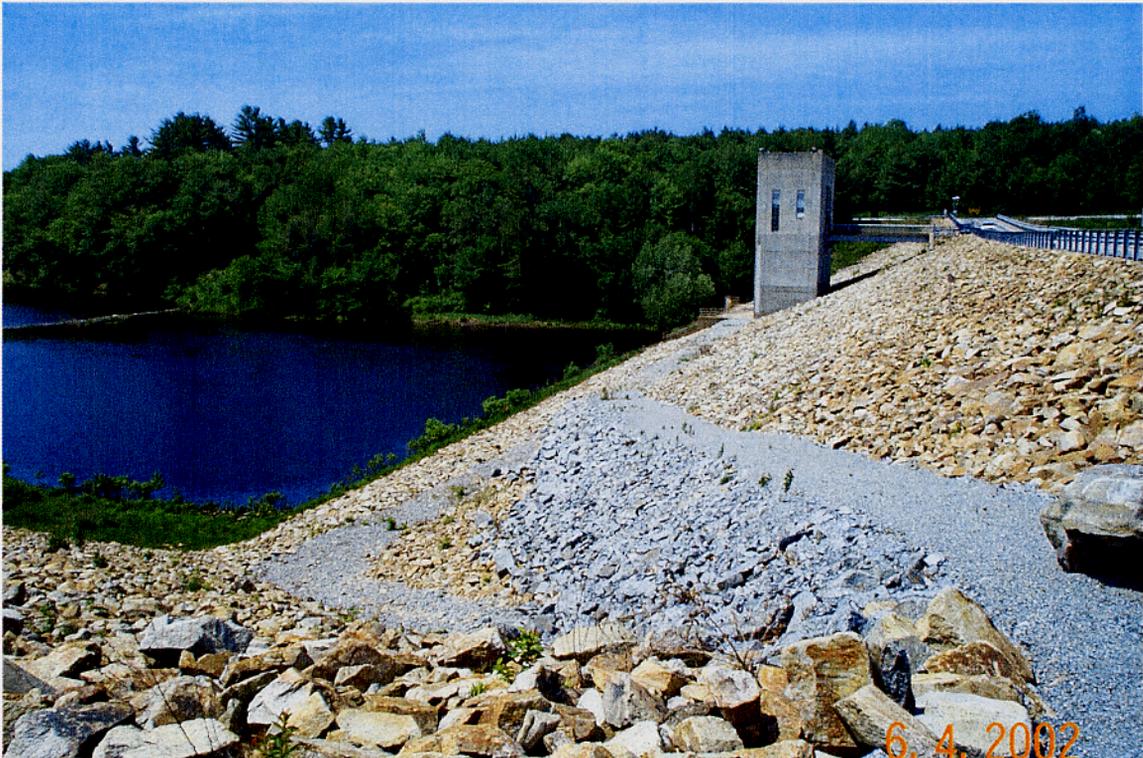
(a) **Upstream Slope.** The upstream rock-fill slope protection appears stable and properly aligned (Photo E-1). The stone protection is in good condition. There is minor vegetation on the slope and large brush, trees, and grass along the toe at the water's edge. The access roads from the project office to the upstream berm and the downstream berm are both in good condition.

Photo E-1: Upstream slope of the dam.

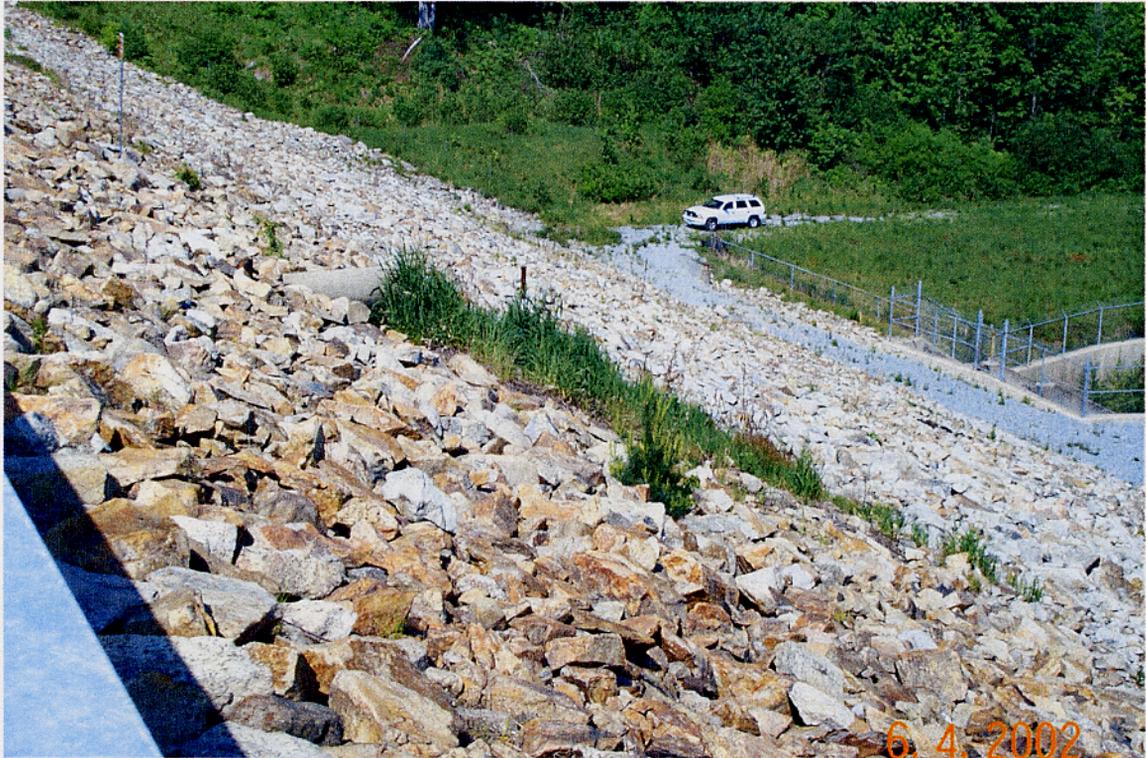
Photo E-3: Downstream slope. Note the grass growing below the east drain outlet pipe.

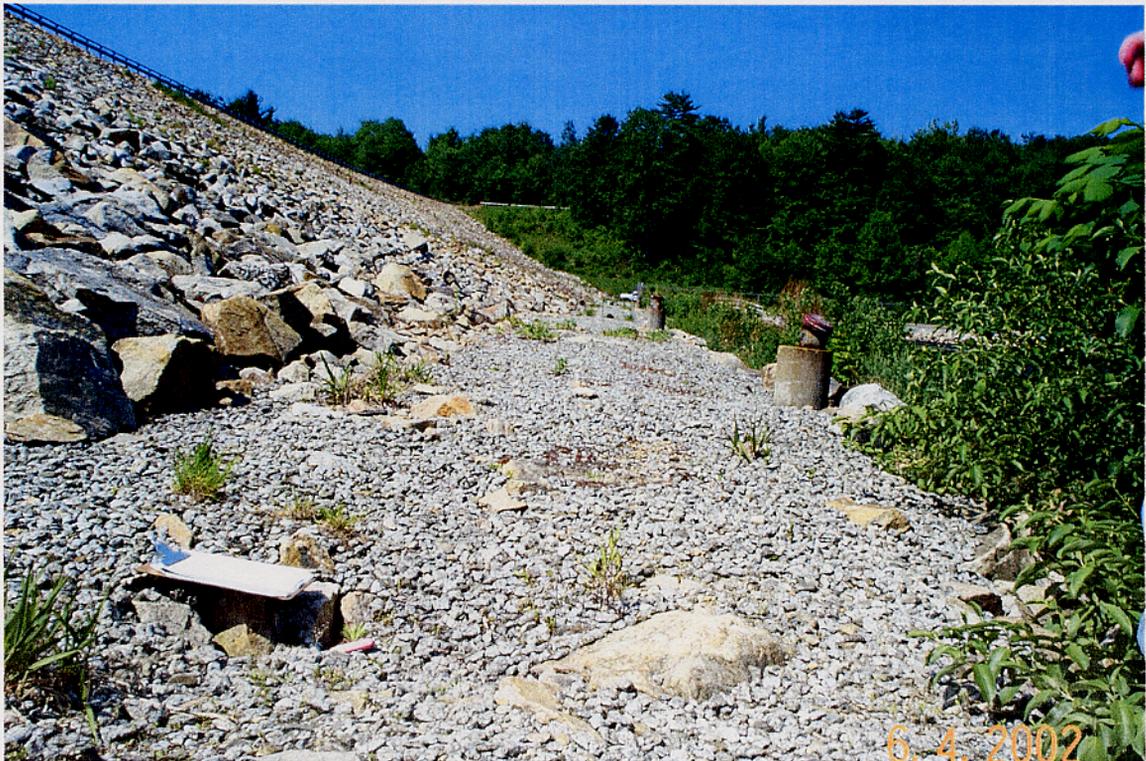
Photo E-4: Downstream rock toe. Hole in crushed stone near RW-5.

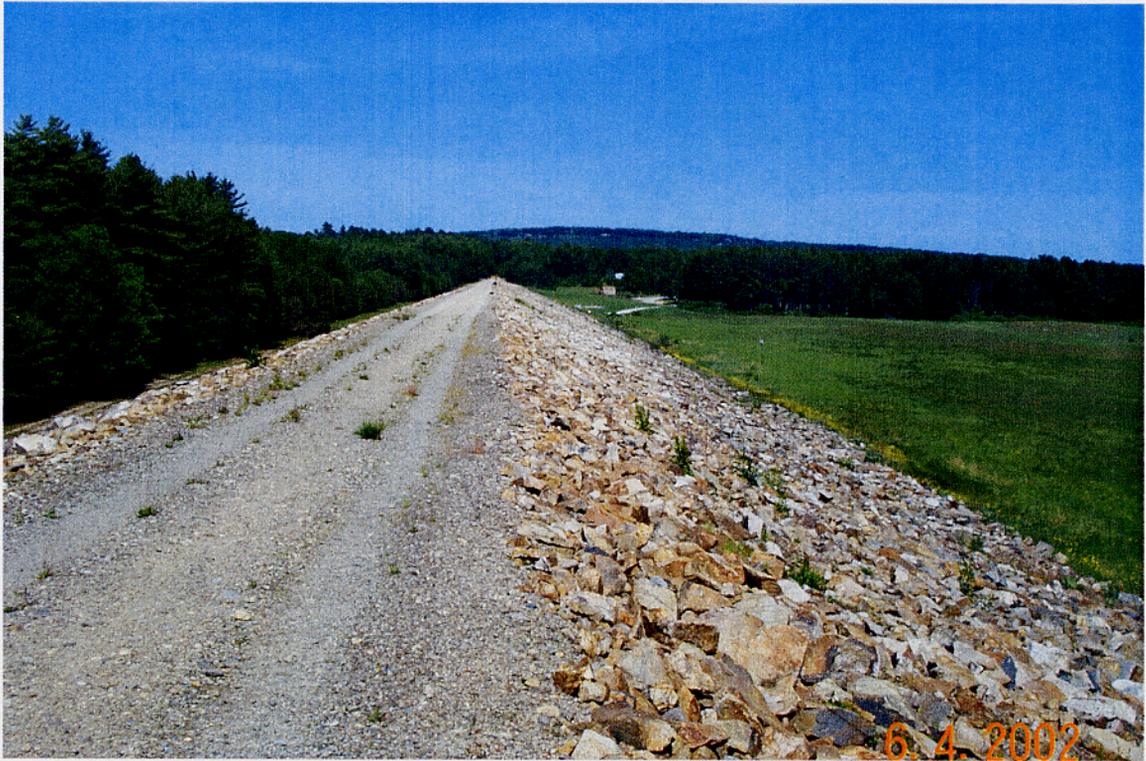
(12) Vegetation along the upstream toe of Dike H-2 has been removed as recommended in the last periodic inspection report.

Photo E-9: Dike H-2. Crest, upstream slope and upstream blanket.

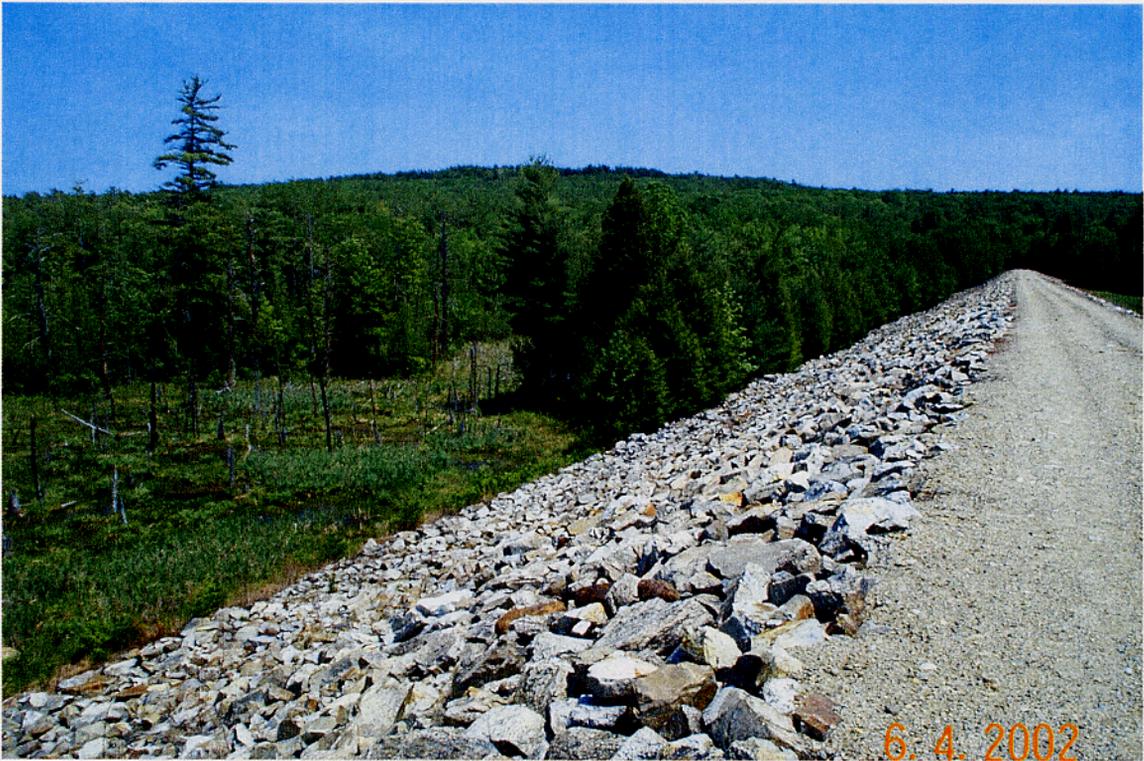
Photo E-13: Dike H-3. Area of the trees and wetland adjacent to the downstream toe.

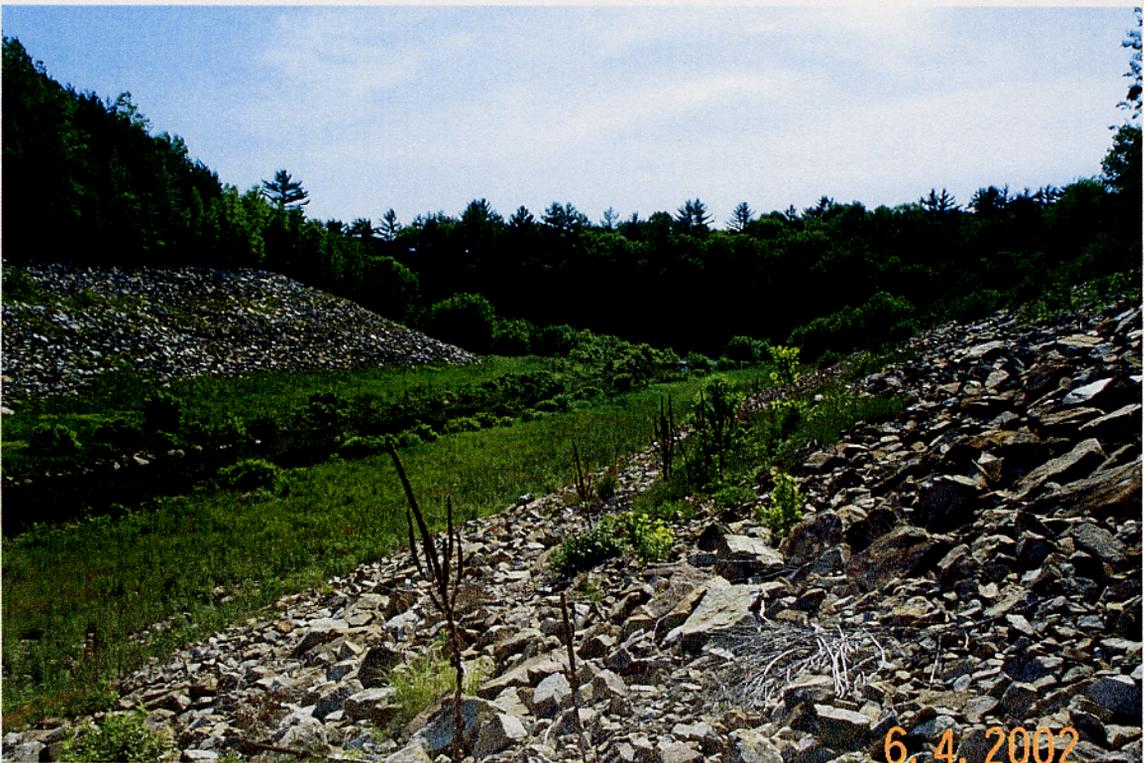
Photo E-14: Canal No. 1. Note the vegetation along the channel, on the slopes, and at the top of the slopes.

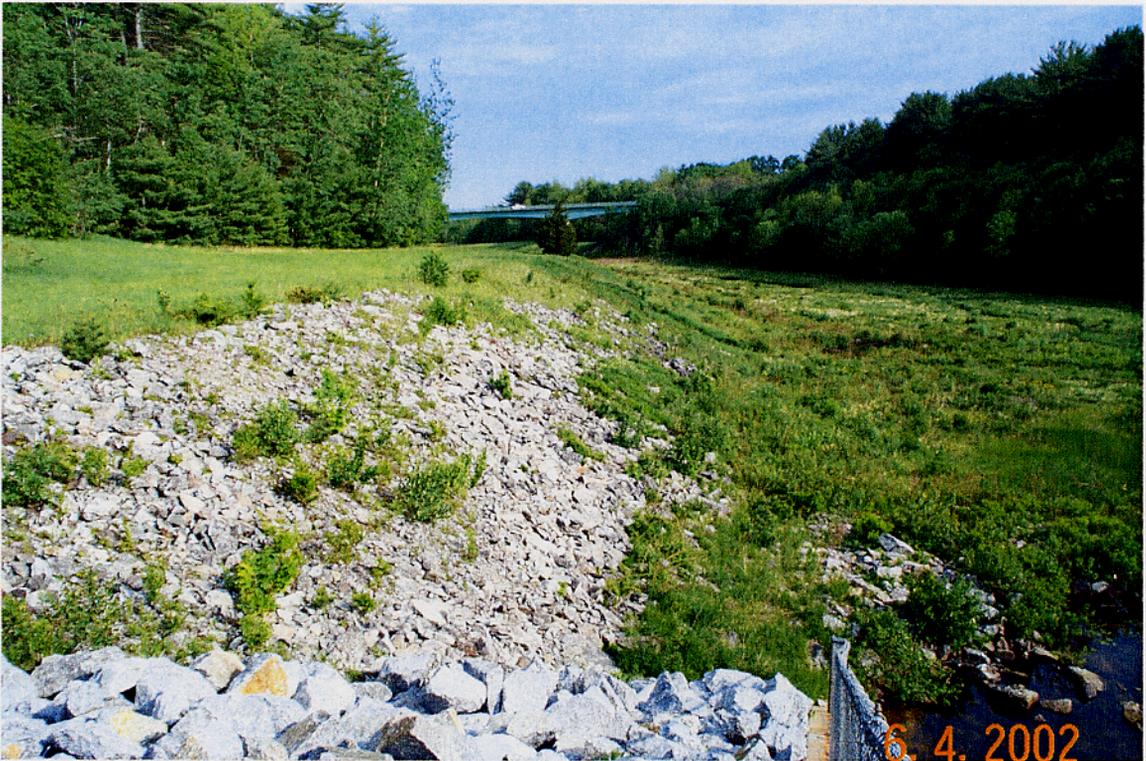
Photo E-15: Canal No. 2 and the left downstream abutment of the south weir. The large trees and brush has been cleared.

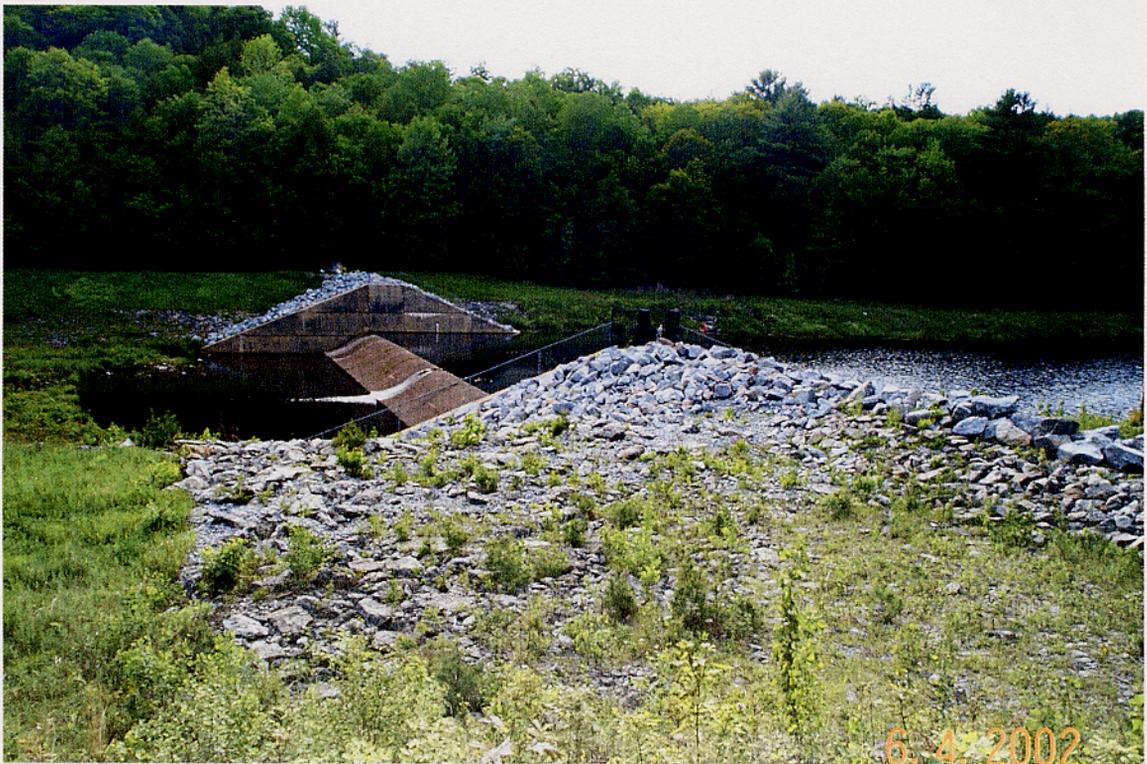
(7) Stone protection has been repaired/replaced at the south weir

Photo E-16: South Weir. Stone on the dike abutments has been placed.

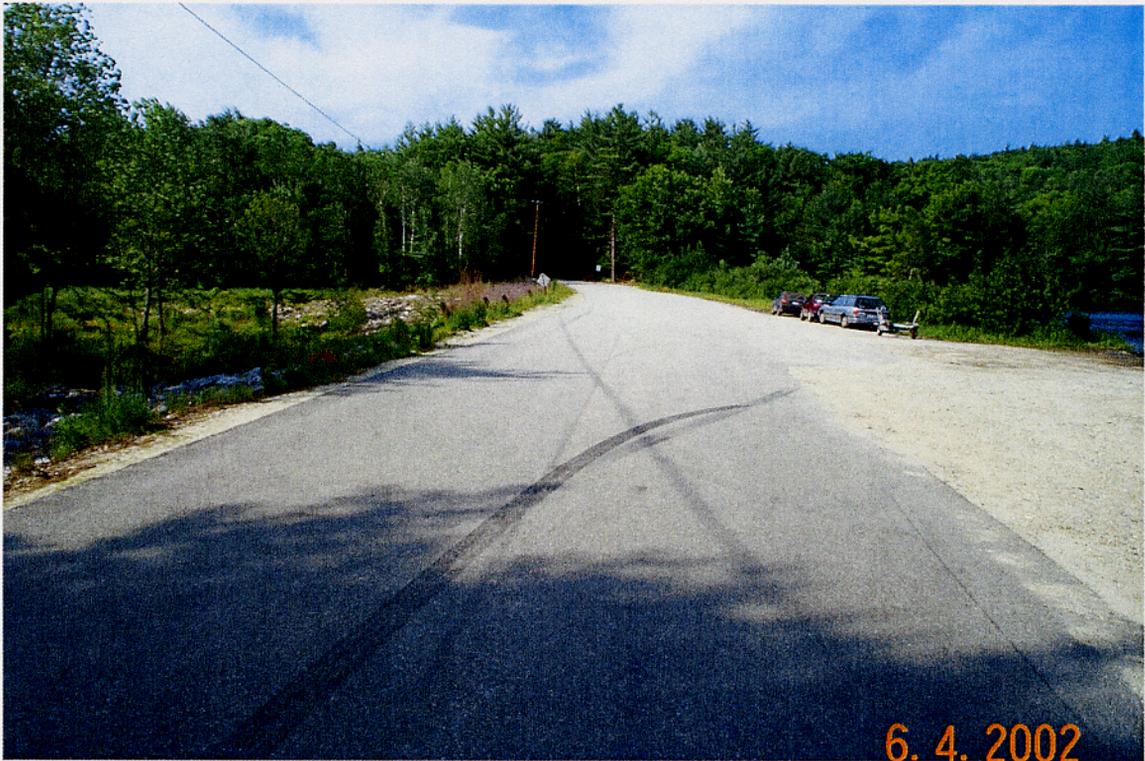
Photo E-17: North Weir. Note the vegetation on the upstream and lakeside of the dike. The road has recently been paved.

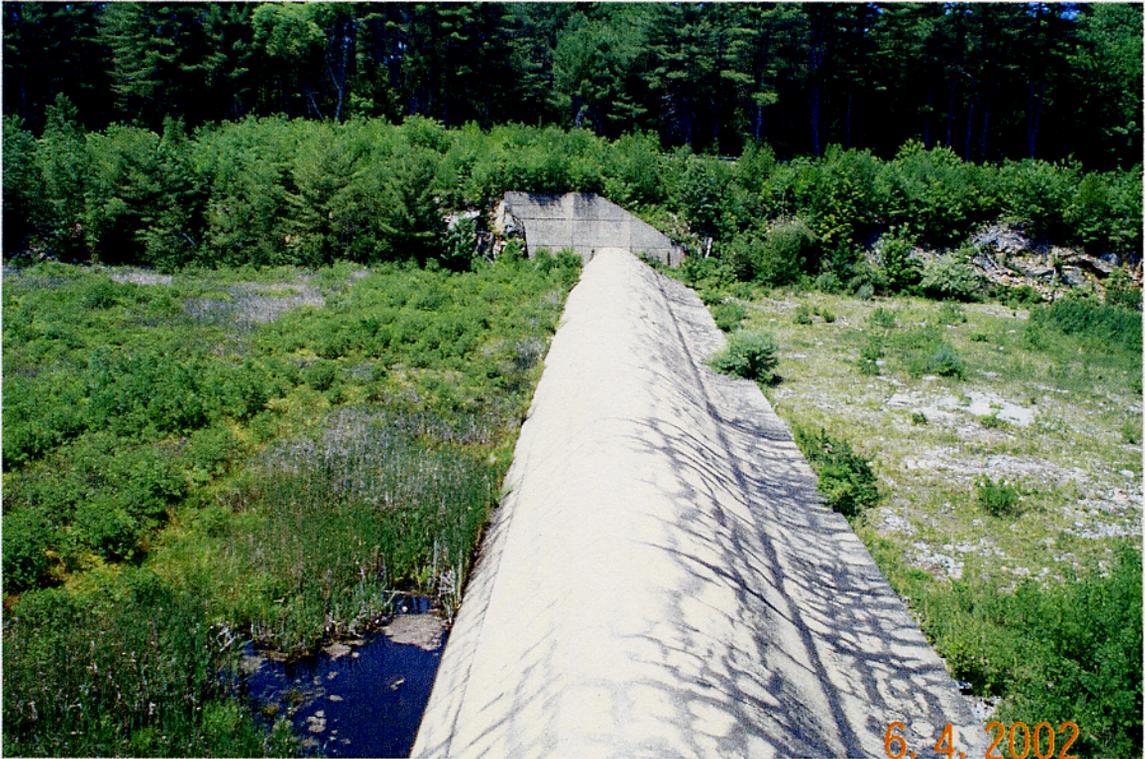
Photo E-19: Spillway. Note the vegetation growing at the top of the wingwall.

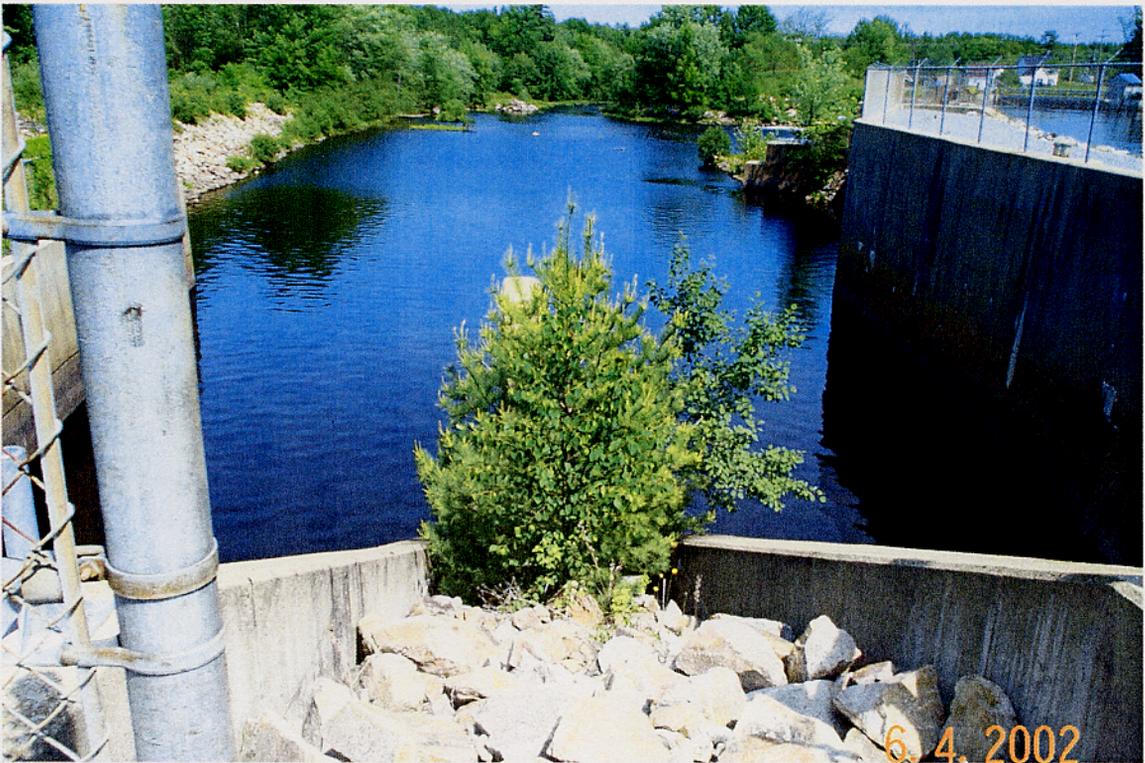
Photo E-20: Outlet and center pier. Note the trees growing in the stone.

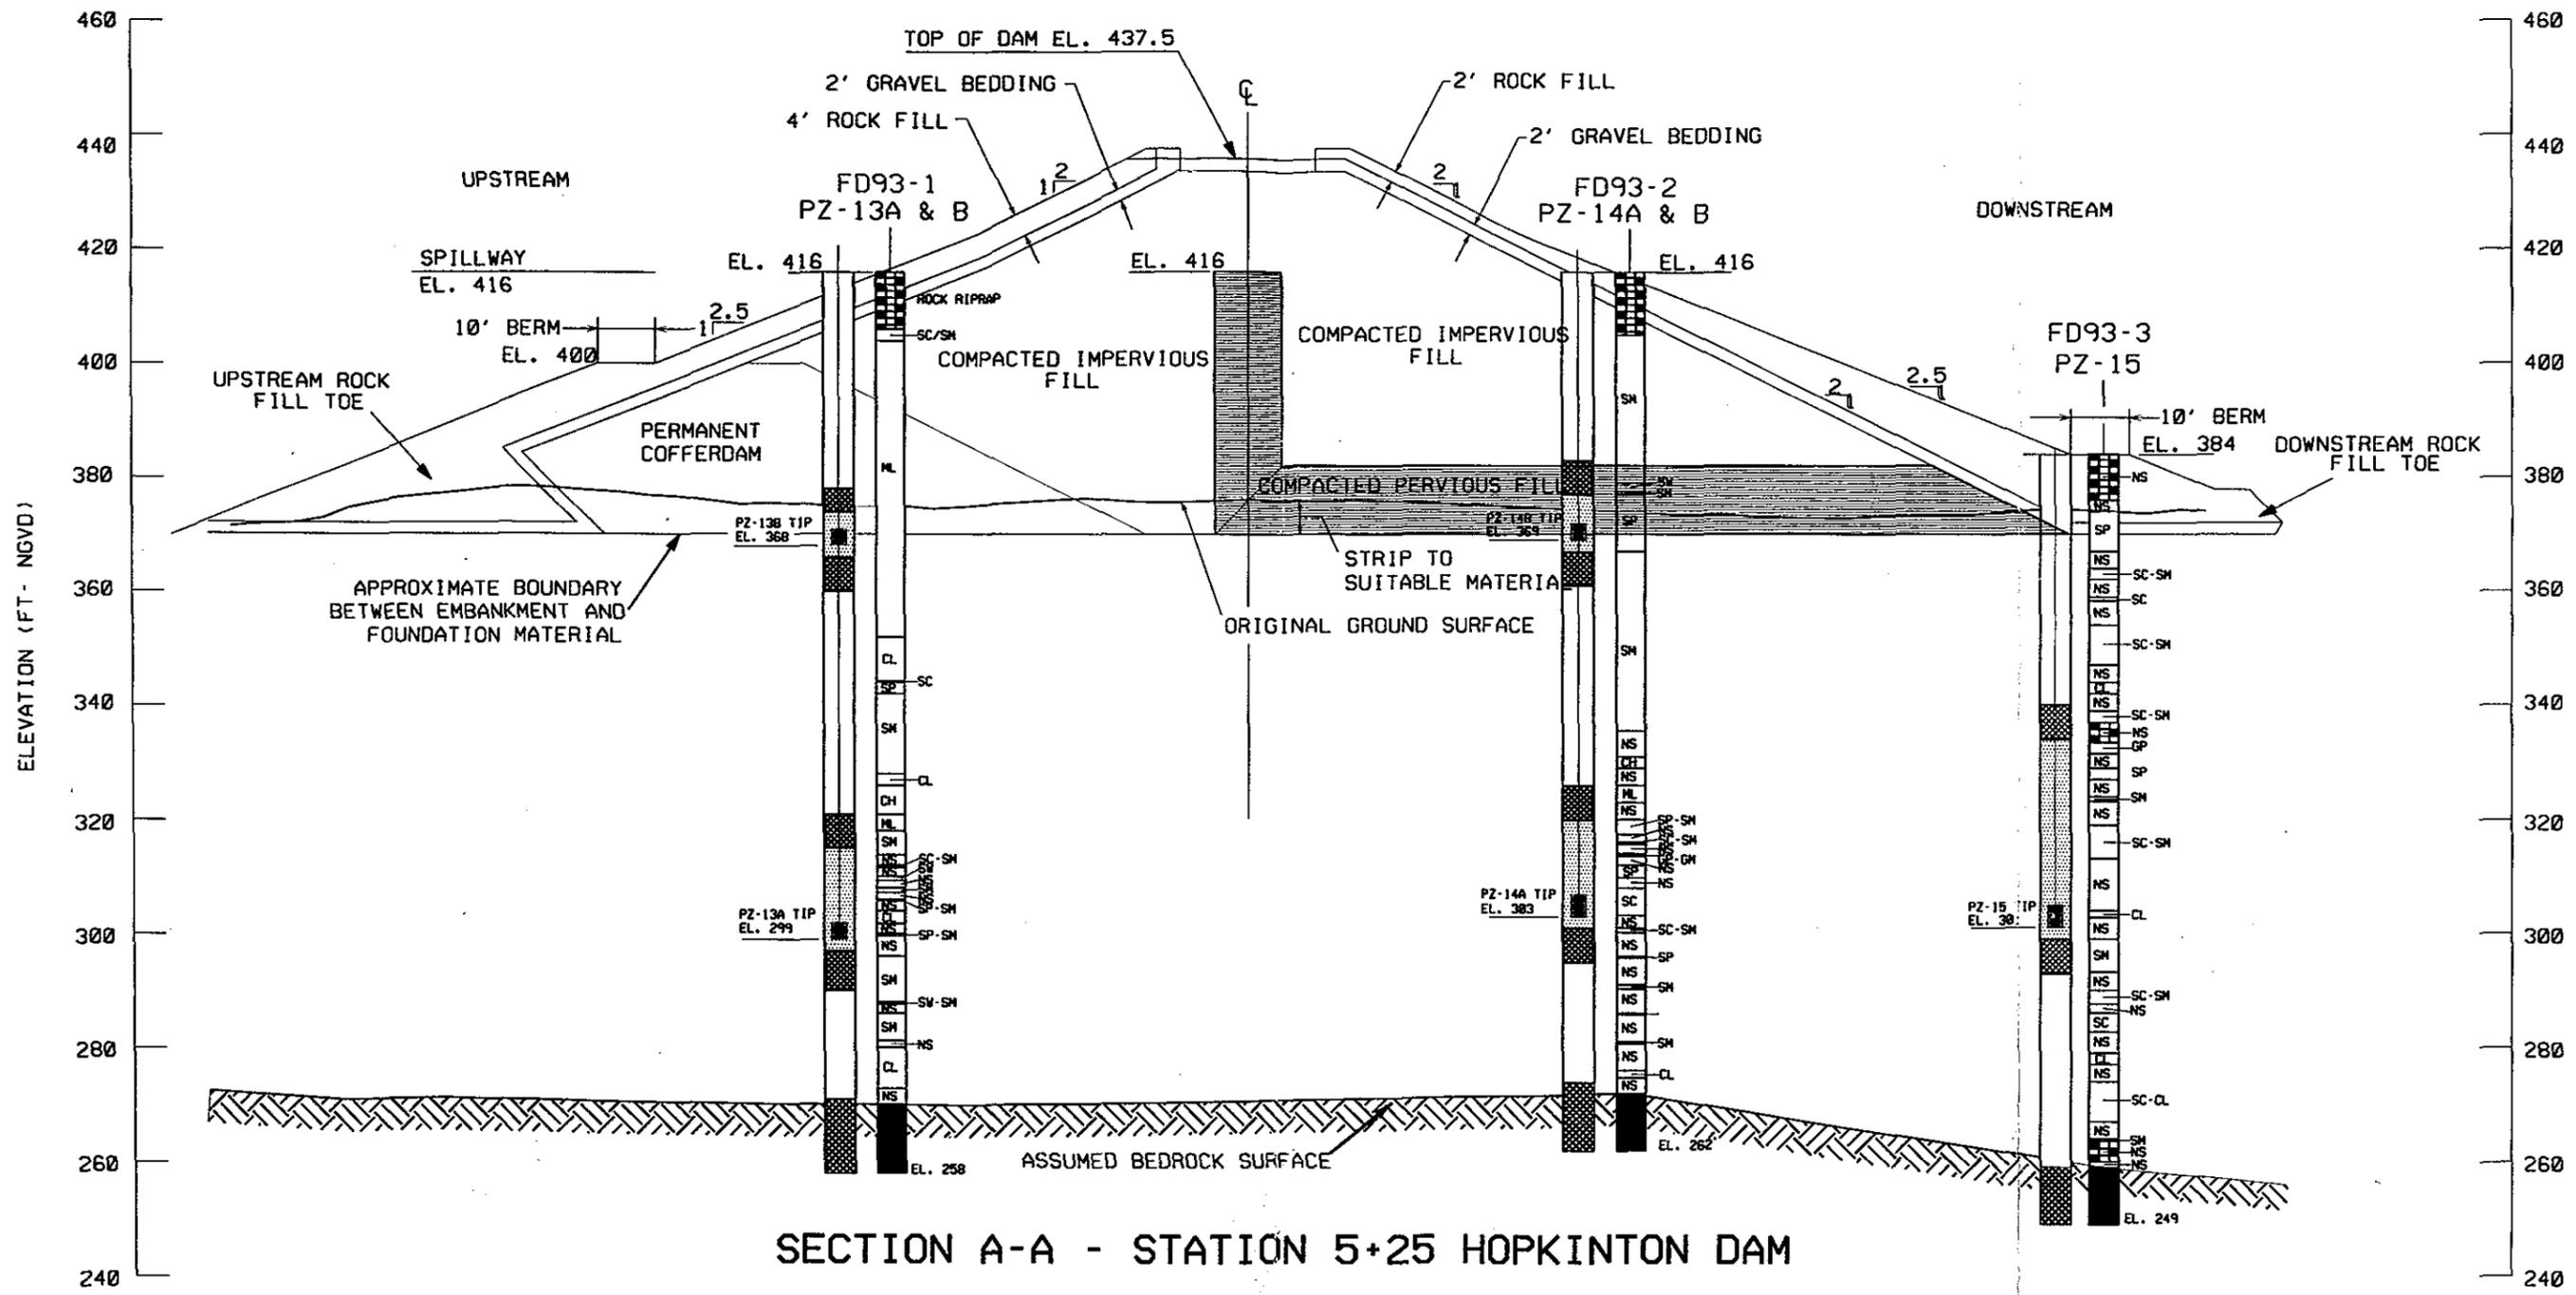
SECTION A-A - STATION 5+25 HOPKINTON DAM

- (2) Station 5+25, Section A-A: Piezometers PZ-13A&B, PZ-14A&B, and PZ-15 were installed during 1993 at approximately Sta. 5+25 (Plate 2, Section A-A; Plate 19). Time-history data are shown together in Appendices C and D for the past five years and for the high pool event, respectively. Normal piezometric levels in deep piezometers PZ-13A, PZ-14A, and PZ-15 are below the original ground surface levels, indicating that there is not a significant artesian condition in the gravels underlying the dam. The level in PZ-13B is generally 5 to 7 feet higher than the pool level. The high levels may be the result of surface water infiltration and/or groundwater perching. Piezometric levels in PZ-13B generally tend to increase with higher pool levels, although there were many unreliable readings and a large amount of scatter in the data. Piezometric levels are generally about 6 to 7 feet higher in PZ-13B than in PZ-14B. As would be expected, the compacted pervious fill drain layer affects the response of PZ-14B, limiting piezometric levels to an elevation corresponding to the top of the drain layer (Plate 19).

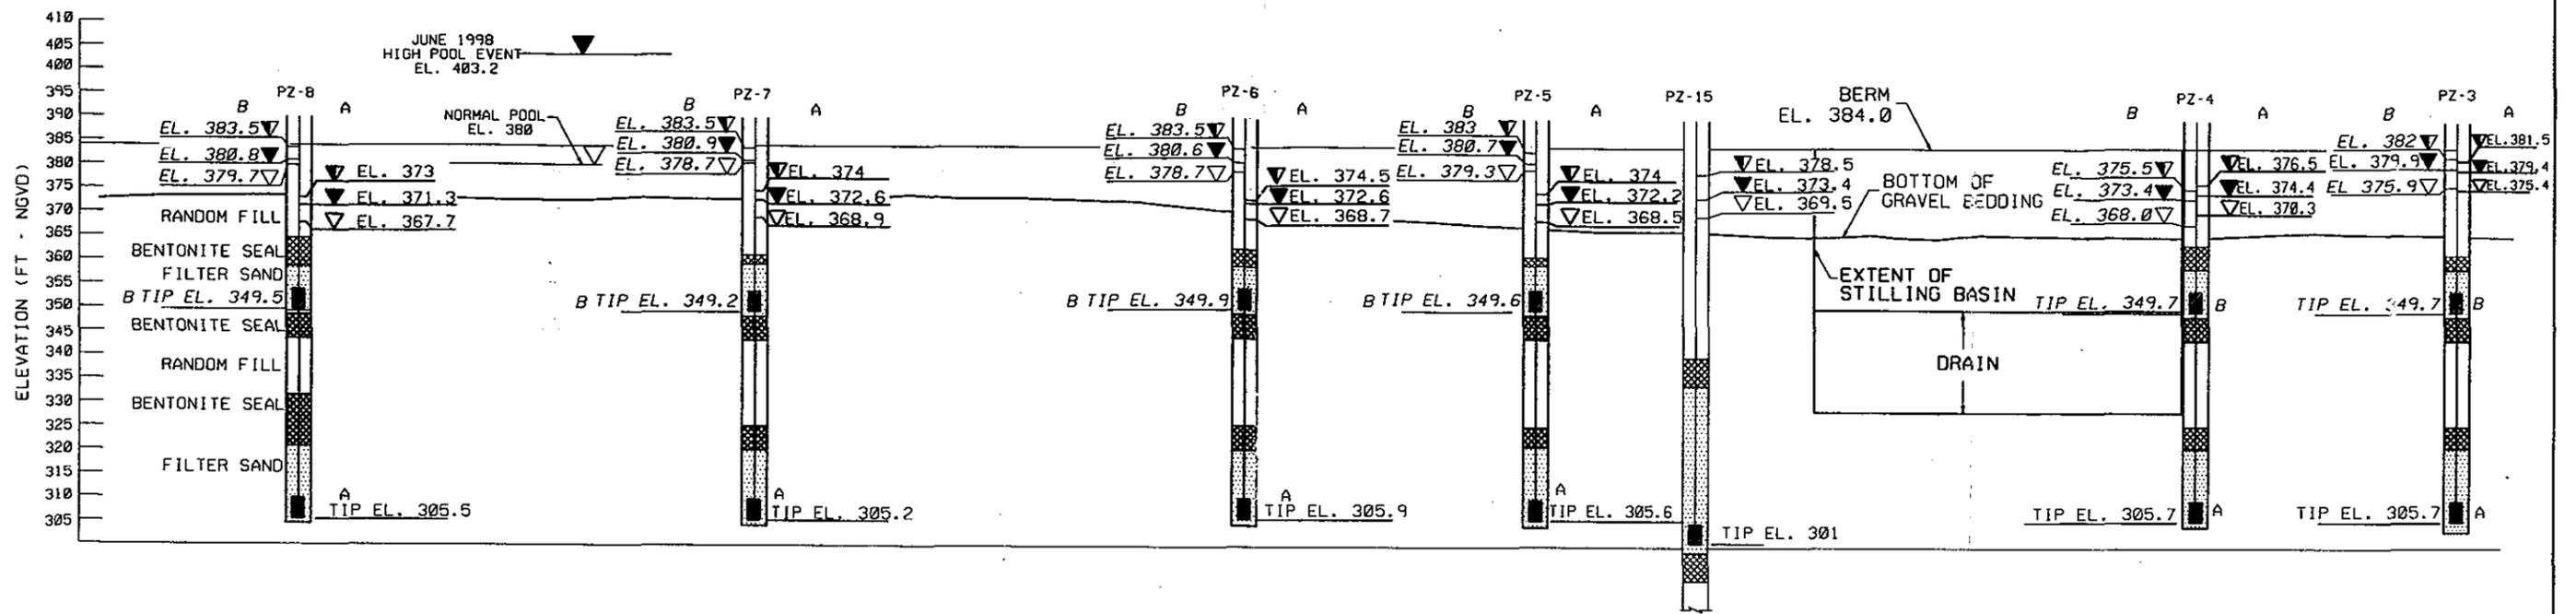
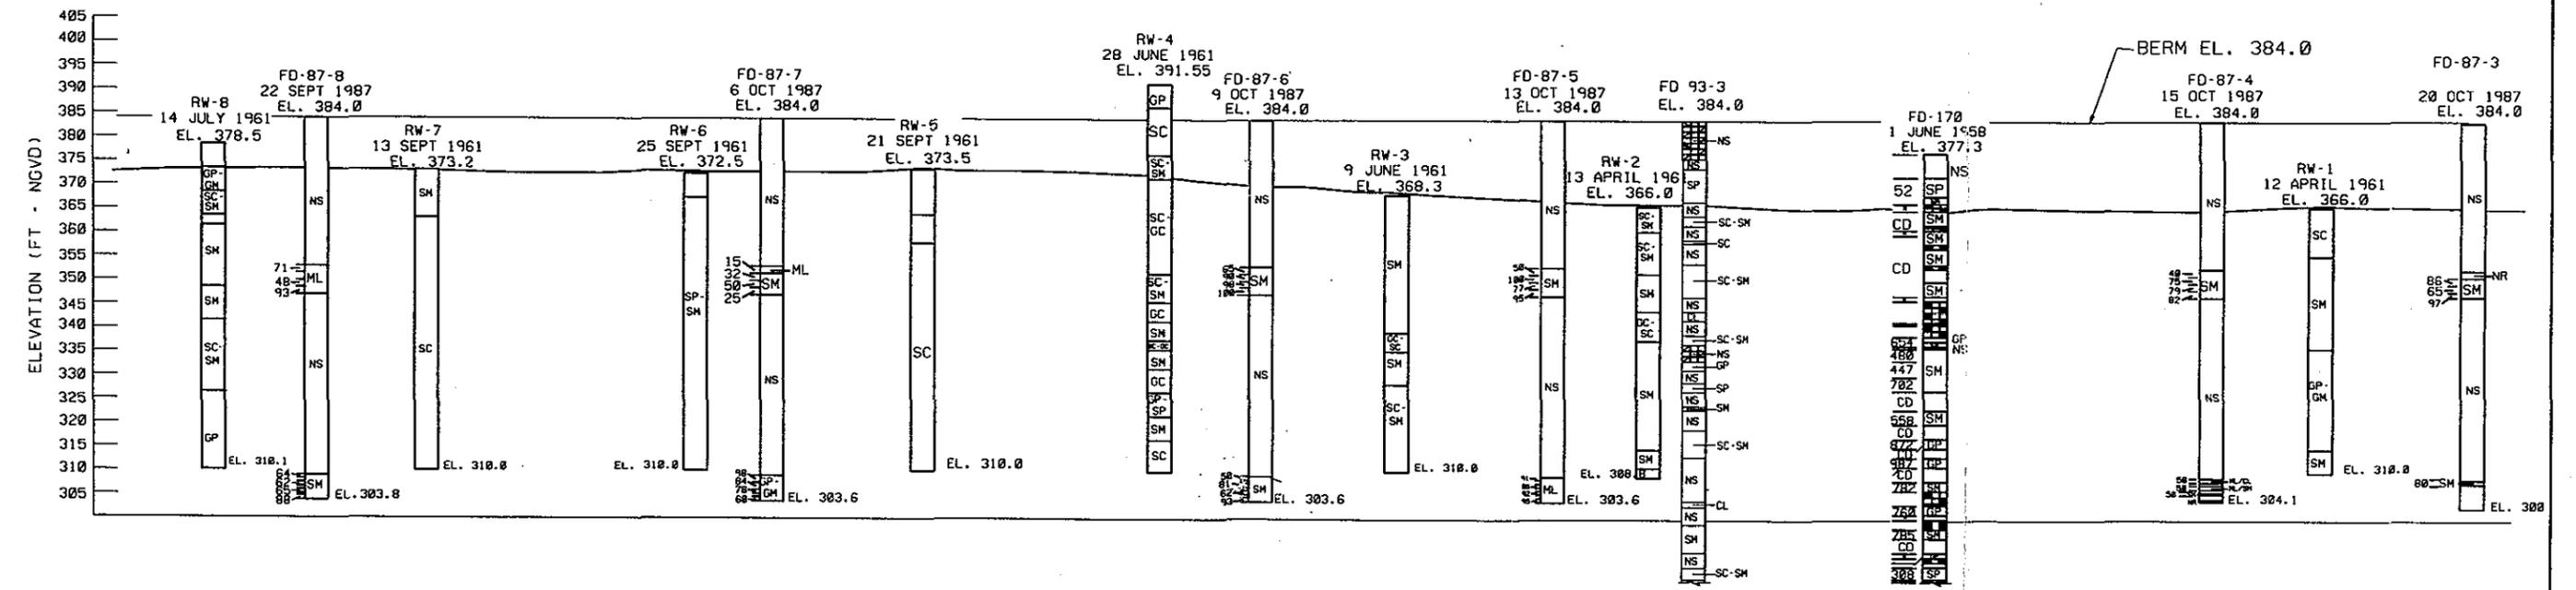
U.S. Army Corps of Engineers Concord, Massachusetts GEI Consultants, Inc.	Instrumentation Evaluation Hopkinton Dam New Hampshire	DOWNSTREAM BERM PROFILE WITH PIEZOMETRIC PORE WATER LEVELS FROM PIEZOMETERS
	Project 02065	July 2002 Plate 15

- (1) Downstream Berm, Profile B-B: Piezometers 3 through 8 are all located along the downstream berm, all in Profile B-B (Plate 15). Time-history data for the deep piezometers (PZ-3A, PZ-4A, PZ-5A, PZ-6A, PZ-7A, PZ-8A, and PZ-15) are shown together on yearly time-history plots in Appendix B and on the high pool event plot in Appendix C for Profile B-B, Deep Piezometers. Time-history data for the shallow piezometers (PZ-3B, PZ-4B, PZ-5B, PZ-6B, PZ-7B, and PZ-8B) are shown together on the yearly time history and the high pool event plot for Profile B-B, Shallow Piezometers. The data show responses similar to those shown in the prior periodic inspection report (Ref. 6). Both the deep and shallow piezometers respond to changes in pool elevation.
