Periodic Inspection Report No. 6
Hopkinton Lake
Hopkinton, New Hampshire

SUBJECT: Independent Technical Review (ITR) of Periodic Inspection Report
No. 6, Hopkinton Lake, Hopkinton, New Hampshire

PERIODIC INSPECTION NO. 6
HOPKINTON LAKE
HOPKINTON, NEW HAMPSHIRE

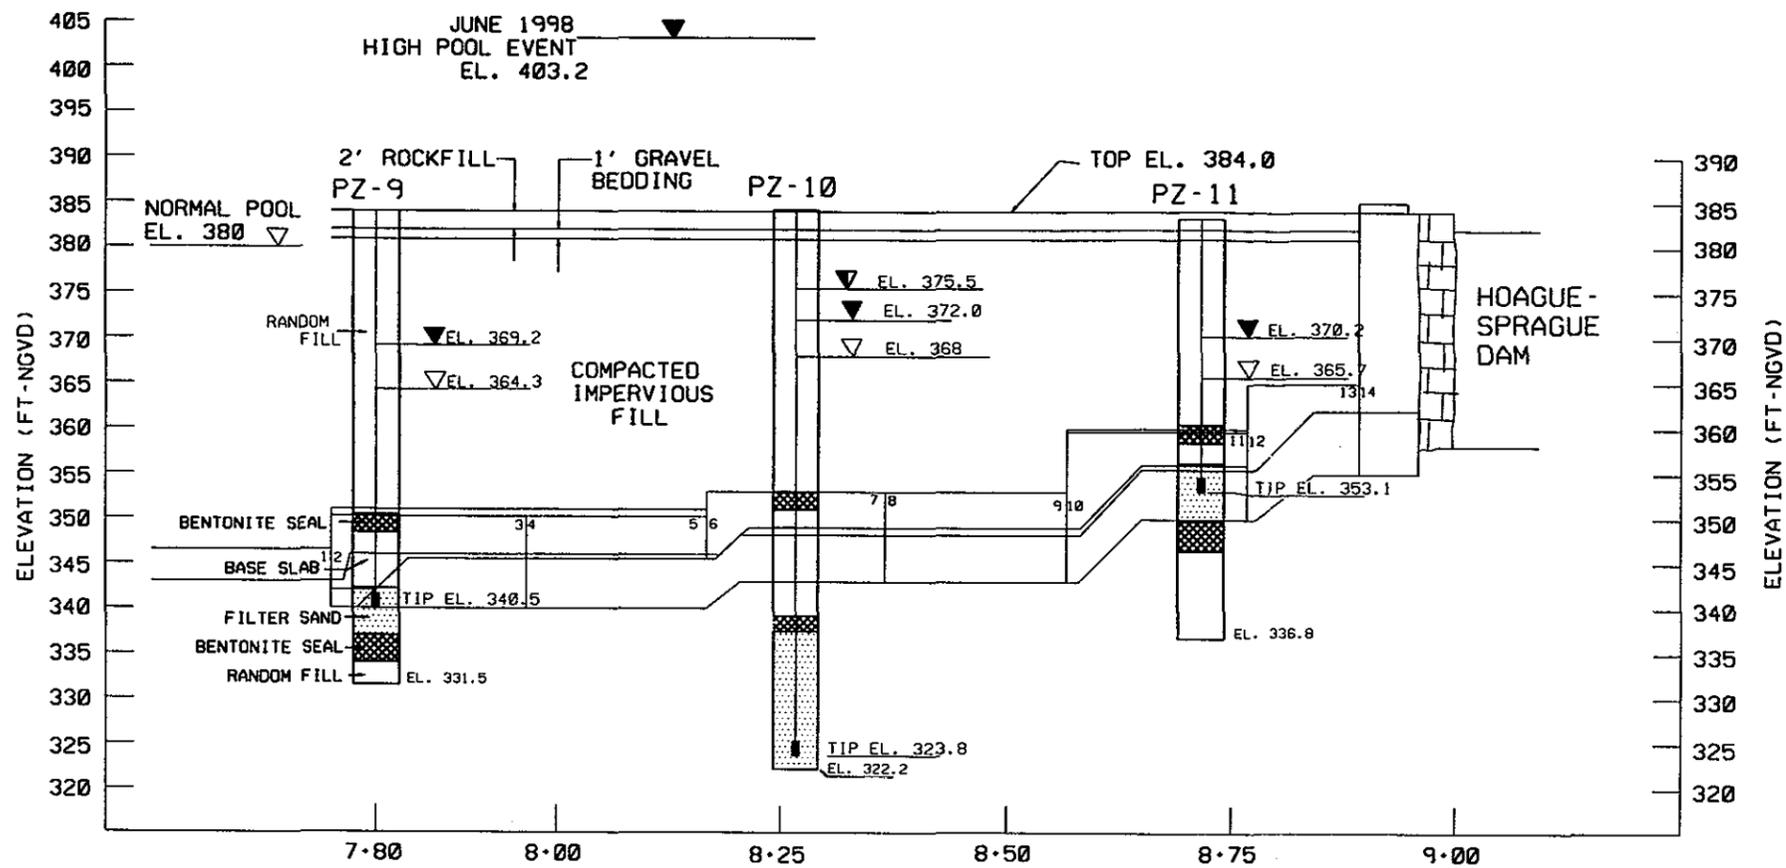
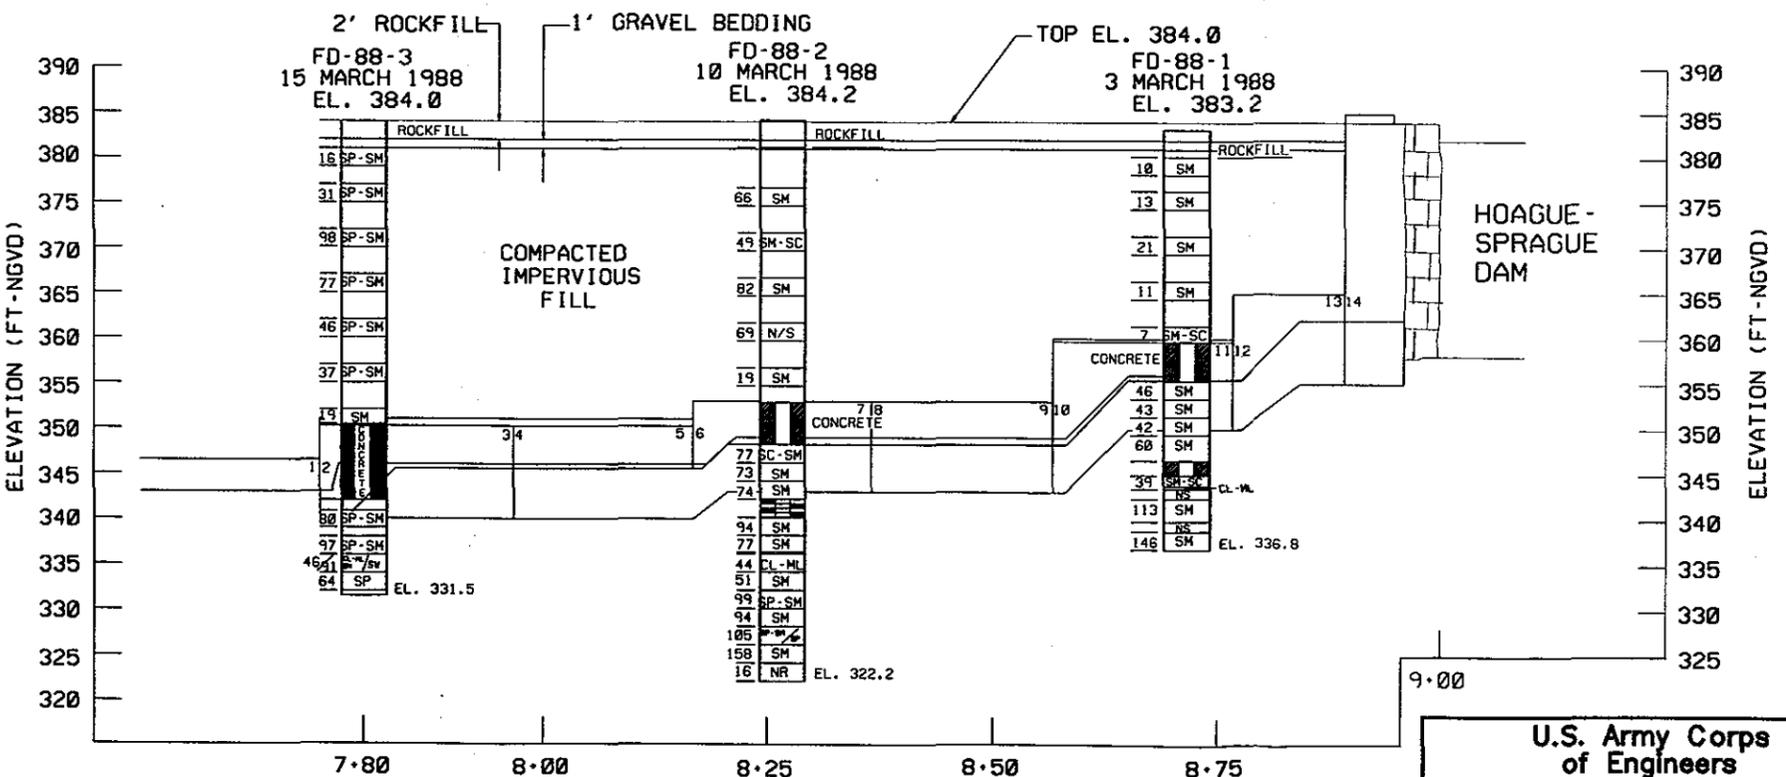
U.S. Army Corps of Engineers Concord, Massachusetts GEI Consultants, Inc.	Instrumentation Evaluation Hopkinton Dam New Hampshire	DOWNSTREAM BERM PROFILE WITH PIEZOMETRIC PORE WATER LEVELS FROM RELIEF WELLS	
	Project 02065	July 2002	Plate 16

Based on the plots of relief well water elevation vs. pool elevation, projections were made of the likely relief well water elevations for a flood pool at spillway crest. These projections are listed in Table 5. Plate 16 shows the average relief well water levels, the maximum relief well water levels recorded during the June 1998 high pool event, and the projected relief well water levels for a flood reaching spillway crest.

Based on the soil profile, only RW-1, RW-4, and RW-8 intercept the gravel layer below the dam (Plate 16). The others are located in the glacial till. The strata surrounding RW-6 are questionable; the log for the relief well indicates a gravelly (water-bearing) riverbed sand, while the adjacent boring log indicates glacial till.

During January 1994, the relief wells were flushed (Ref. 7). Up to 7.7 feet of sediment was removed from the wells. Based on drawings showing design well depths (Plates 16 and 25), it appears that between 0.5 and 3.5 feet of sediment may have remained at the bottom of the wells after flushing (approximately 2 to 15% of the well screen length). It was also reported in Instrumentation Appendix No. 4 that inspection by a down-hole camera in 1992 had indicated a significant build-up of mineral deposits on the well screens that would restrict flow into the wells.

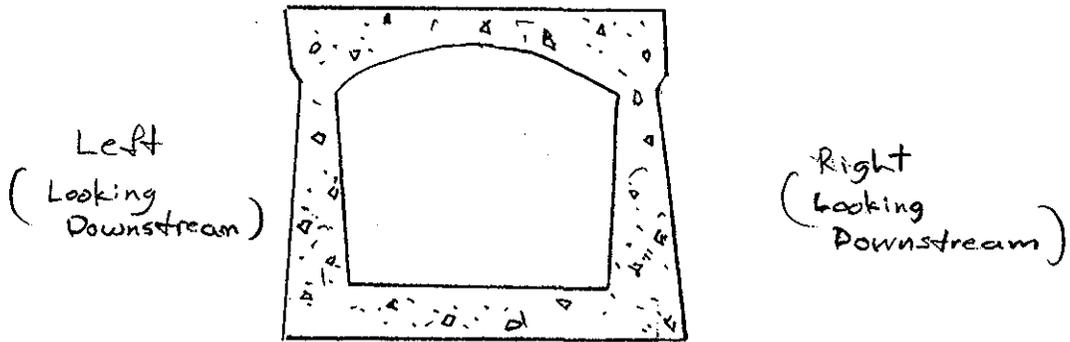
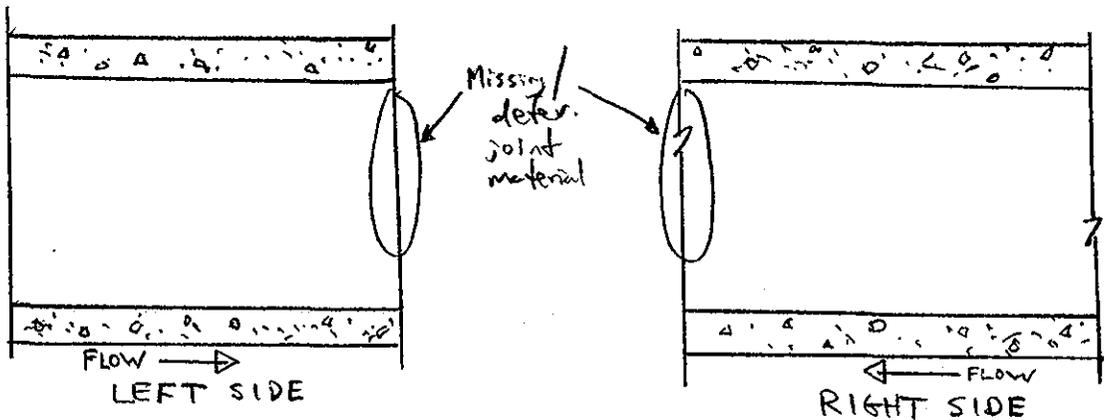
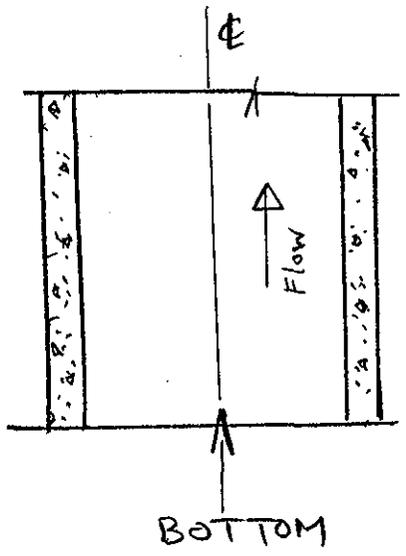
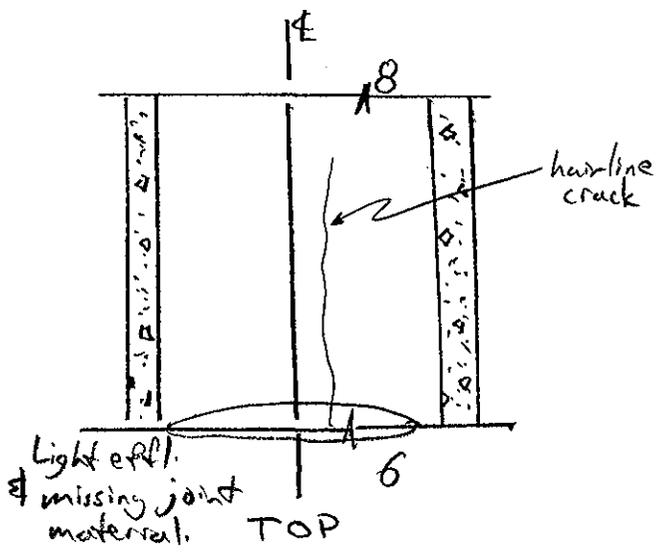
Conduit 2
Monolith 8

Non-structural cracks are located in various areas of the project and are described in the main report. The concrete in the transition and conduit is in overall good condition, except for joint deterioration between the monoliths. There are hairline cracks in various other features such as the spillway retaining walls, and the inlet and outlet structures. Sketches provided below illustrate the general location and extent of cracking and concrete deterioration in the conduits.
