# A Case History of Port Mansfield Channel, Texas

GITI REPORT 12

May 1977

GENERAL INVESTIGATION OF TIDAL INLETS

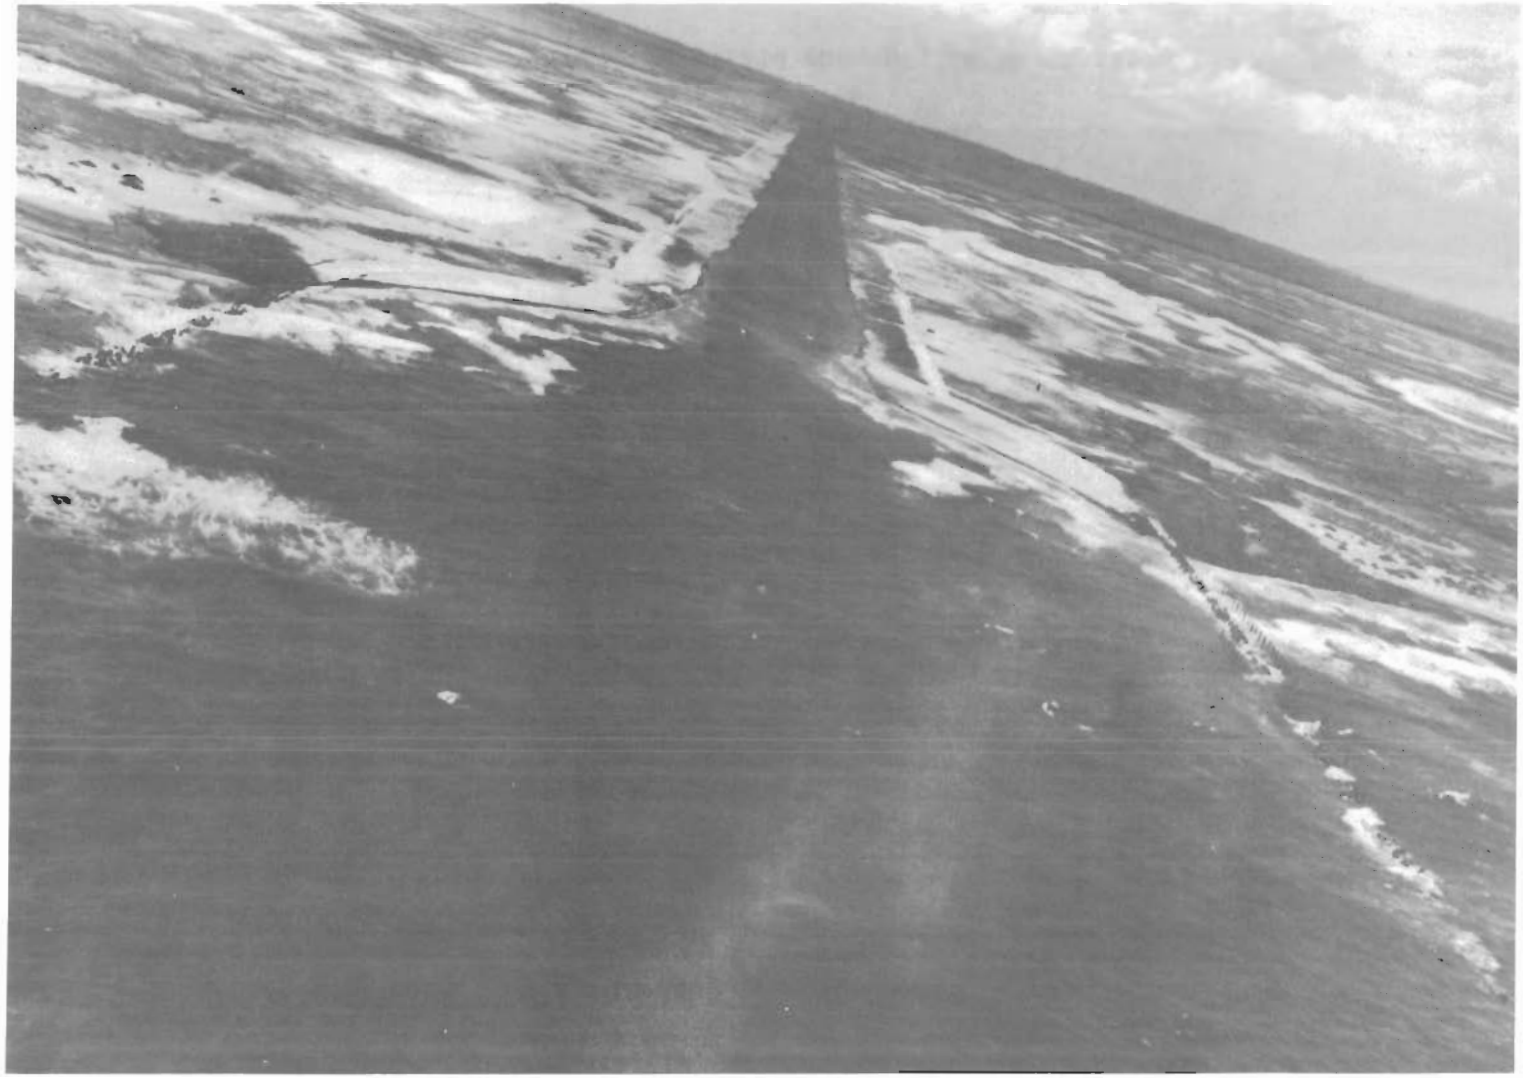
Shortly after the project was completed in September 1957, storm wave action and scouring currents caused the landward ends of both the north and south jetties to be flanked, greatly decreasing their effectiveness. Surveys made in February 1958 to determine the extent of damage to the channel entrance indicated extensive subsidence of the jetties resulting from channels scoured 2 to 4 feet (0.61 to 1.22 meters) below the natural bottom along both sides of the north jetty and along the channel side of the south jetty (Hansen, 1960). At the shoreline, the north jetty crown was from 3 to 7 feet (0.91 to 2.13 meters) underwater with settlement progressively greater seaward (Hansen, 1960). The entire south jetty had also subsided although many of the tetrapods remained above water. This rapid subsidence was attributed to the tetrapods being placed on the sandy gulf bottom without a stone blanket to distribute the load and prevent erosion (Hansen, 1960). The extensive subsidence of the tetrapods coupled with the high-void ratio, permitted rapid shoaling of the channel entrance. The channel entrance was completely closed by January 1961.

Figure 5. Port Mansfield channel entrance, November 1957.

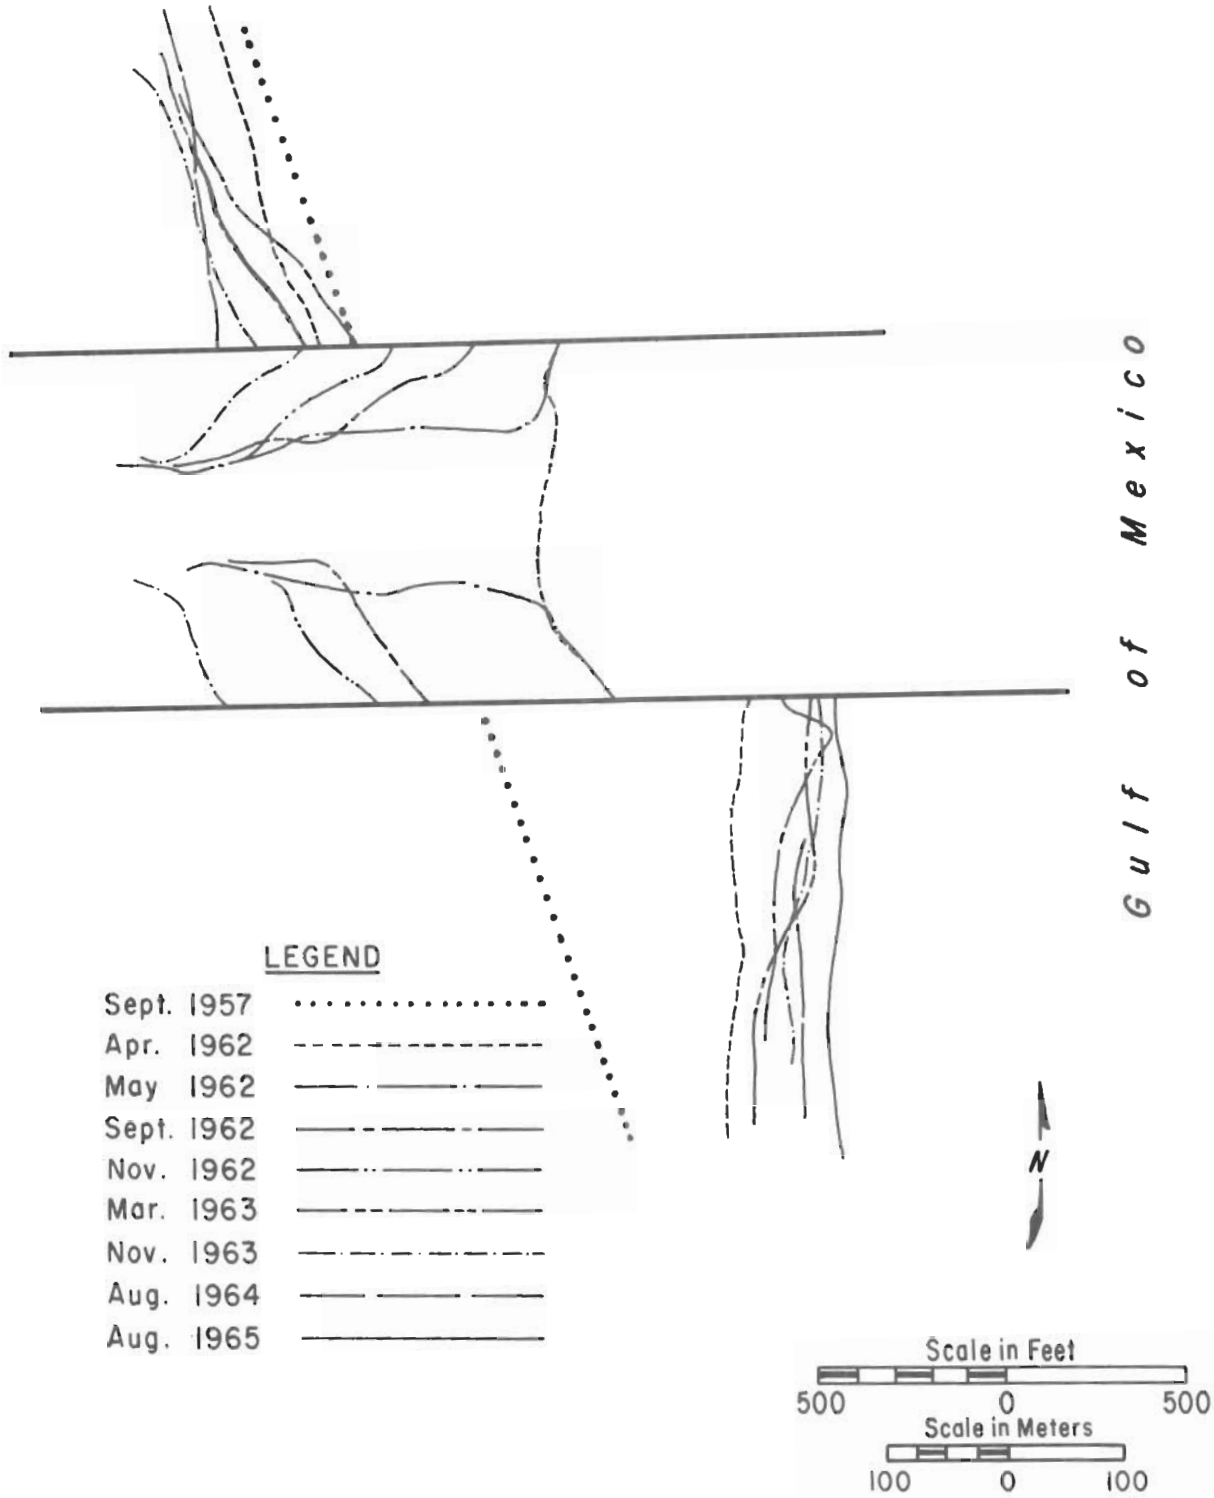
Figure E-7. Mean sea level shoreline surveys from April 1962 to August 1965.

Figure E-7 shows an advance of the MSL contour of approximately 240 feet (73.15 meters) along the outside of the south jetty between 1962 and 1965, and a general recession adjacent to the north jetty. The fillet south of the channel achieved approximate equilibrium conditions in the position of the MSL contour.
