MAJOR REHABILITATION PROJECT

CAPE COD CANAL BRIDGES

CAPE COD CANAL
BOURNE, MASSACHUSETTS

DESIGN MEMORANDUM

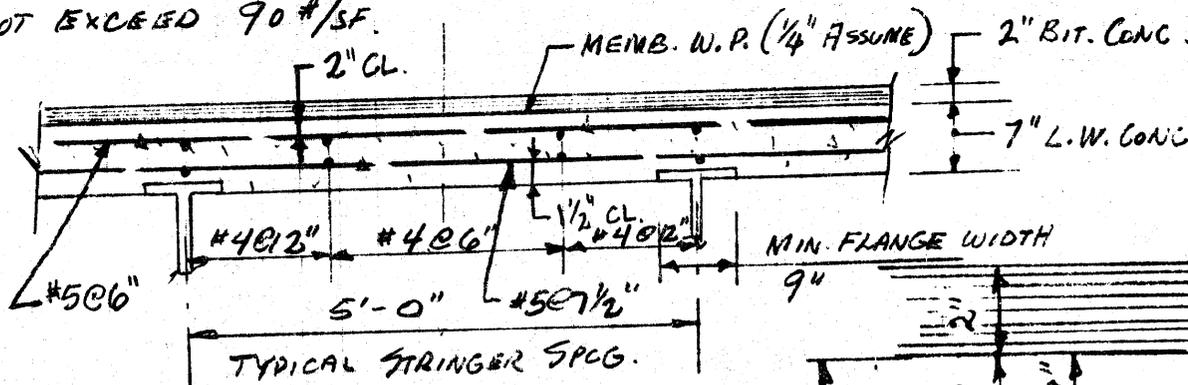
① 7" L.W. CONC. STRUCT. SLAB W/MEMBRANE W.P. & 2" BIT. CONC. WEAR. SURF.
WEIGHT OF ORIGINAL DECK

7" THICK LIGHTWEIGHT CONC. ("HAYDITE") = $\frac{7}{12} \times .110 = 0.064 \text{ K/SF}$
 2" " BIT. CONC. WEARING COURSE = $\frac{2}{12} \times .156 = 0.026$
 TOTAL = 0.090 K/SF

DESIREABLE THAT WEIGHT OF REPLACEMENT DECK
NOT EXCEED 90 #/SF.

Q.L. MOM = $\pm .090 \times 5^2 \times \frac{1}{10} = \pm 0.23 \text{ K}$

LL. MOM. (AASHTO 1.3.2(C))
S = 5.0 - 0.37 = 4.63'

M = $\pm \frac{4.63 + 2}{32} \times 16 \times 1.3 \times 0.8 = \pm 3.45 \text{ K}$

TOTAL DESIGN MOM = $\pm 3.68 \text{ K}$

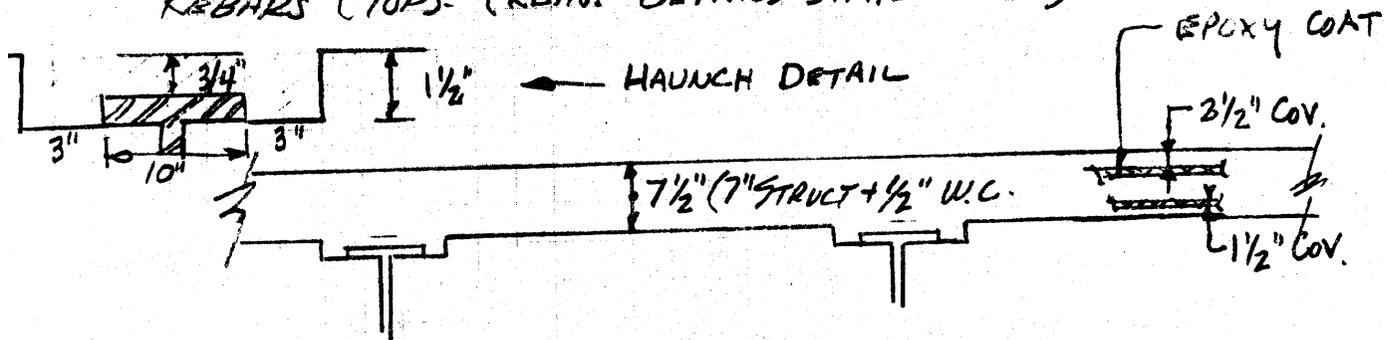
III $7\frac{1}{2}$ " ($\frac{1}{2}$ " W.C.) NORMAL WGT. CONC SLAB WITH EPOXY COATED REBARS (TOP). (REINF DETAILS SAME AS I)

WGT. PROP. SLAB
 $7\frac{1}{2}$ " CONC. (NORM. WGT) = $7.5/12 \times .150 = .094$ k/sf

HAUNCH AREA
 $3 \times 1.5 \times 2 = 9$ in²
 $.75 \times 10 = 7.5$
 $\Sigma = 16.5$ in²

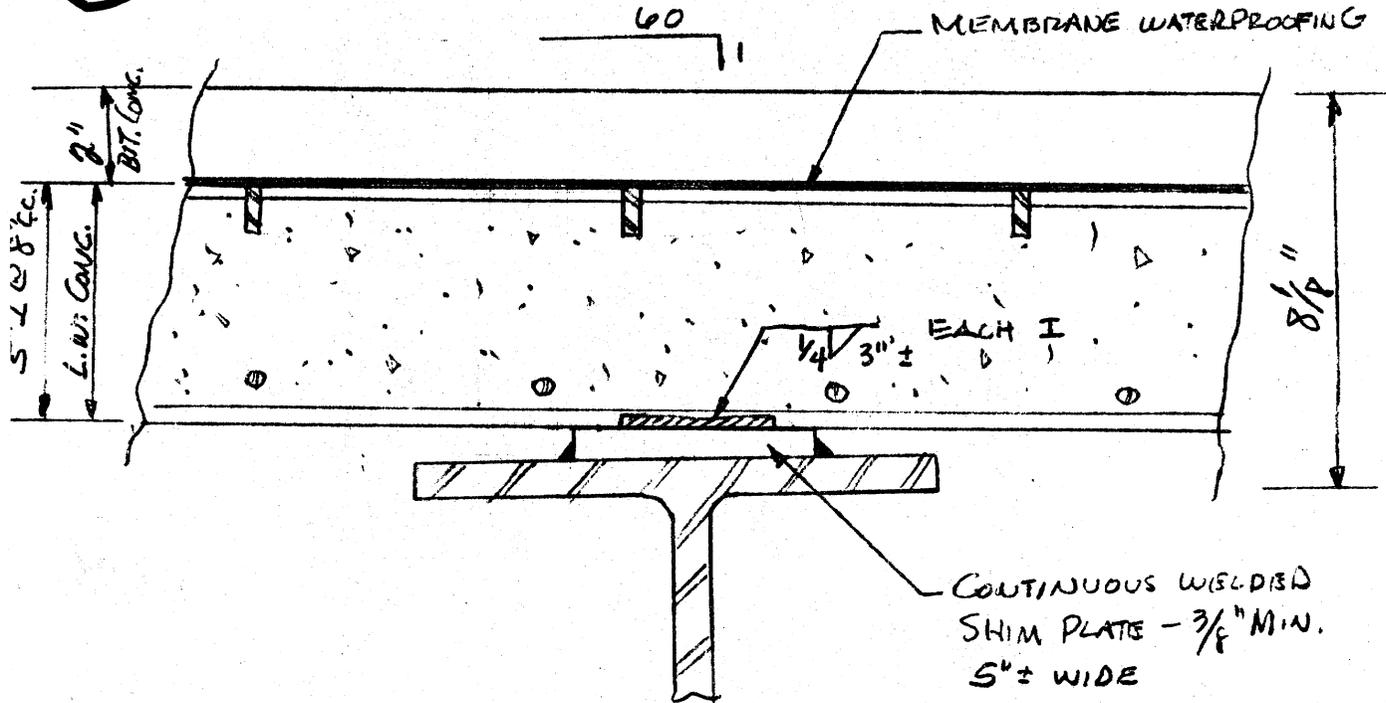
(VI) 5" L.W. CONCRETE FILLED STEEL GRATING + MEMB. W.P. + 2" BIT CONC.

WGT/SF	
STEEL SHIMS/WELD	- 1.50 #
STEEL GRATING	- 16.48
L.W. CONC. FILL	- 43.80
2" BIT CONC.	- 26.00
	<u>87.78 #/SF</u>

Deck slab shall be a 5" deep I-Beam 10" O.C. filled with light weight concrete with a compressive strength of 4000 psi. The dead load of the Deck with 1.1" and wearing surface is 88 lb/sf.

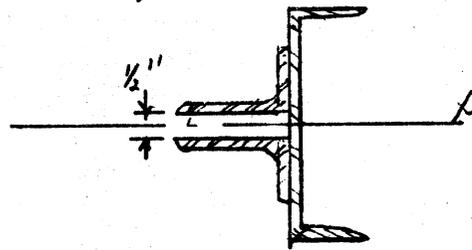
1/4 MC 10 x 28.5 for reinforcement
 $A = 8.37$ $\bar{x} = 1.12$ $I_x = 127$ in⁴ $I_y = 11.4$ in⁴

$C_g = \frac{(7.05(-1.63) + 8.37(1.12))}{7.05 + 8.37}$
 $= \frac{-2.12}{15.42} = -0.14$ "

$I_y = 17.8 + 7.05(1.49)^2 + 11.4 + 8.37(1.26)^2$
 $= 58.14$ in⁴

$r_y = \left(\frac{58.14}{15.42}\right)^{1/2} = 1.94$

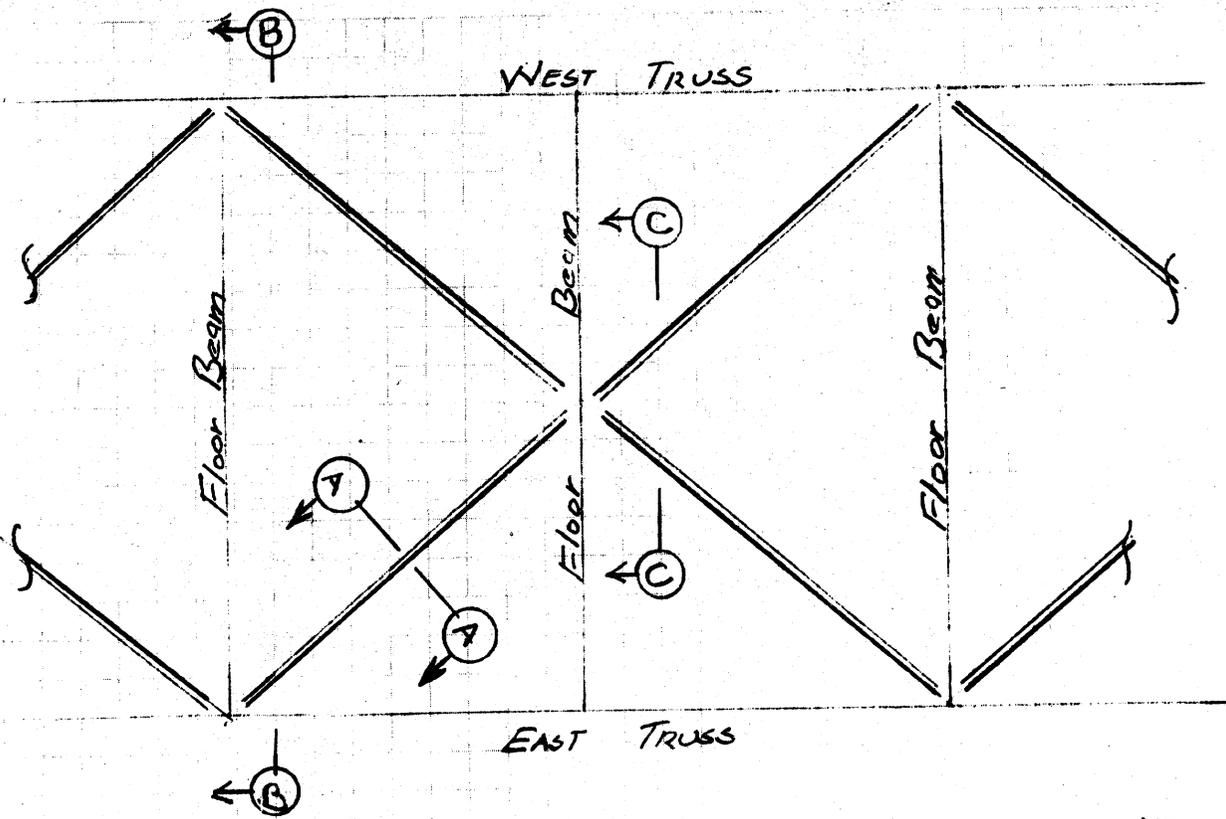
TYPICAL PLAN OF TOP LATERAL BRACING.

NEW MC 10X28.5

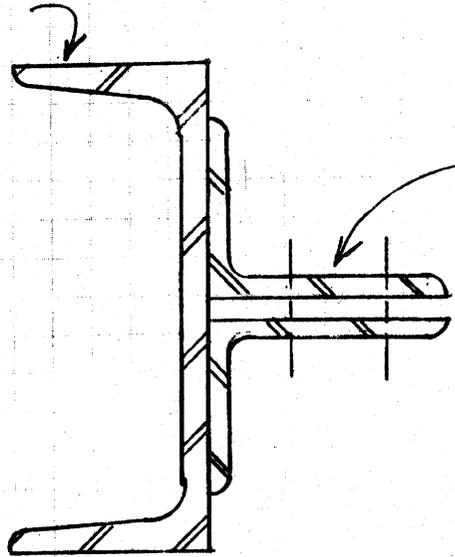
SECTION A-A

Exist Angles
 2L5x3 1/2 x 7/8 Span 7,6 & 4
 2L5x3 1/2 x 7/16 Span 5
 3/8" - Span 7,6
 1/2" - Span 5,4

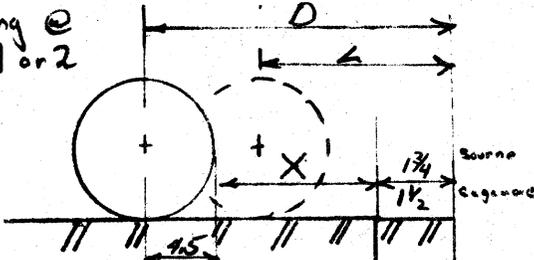
Bearing @ Pier 1 or 2

max pin movement = 5.91"
roller movement = 2.96"

@ 32° x = 2.31" Bourne
@ 60° x = 1.75" Sagamore

Sagamore Pier #1	-30°F	-0.41	5.59	2.63	roller projected out by 1.87"
	0°F	0.31	6.31	3.35	roller projected out by 1.15"
	60°F	1.75	7.75	4.79	
	120°F	3.19	9.19	6.23

Restrictions on deck removal due to movement of bolts in slotted holes. The maximum allowable movement is 15 inches movement at Pier 4 or South Abutment could be as much as 19.24" with deck removal. Since the exact location of the bolts are not known in the slotted holes at this time the following restrictions are recommended.

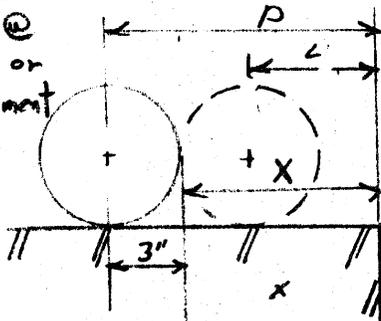
Bearing @ Pier 4 or South Abutment

max pin movement = 4.86"
roller movement = 2.43"

@ 28° x = 3.5" Bourne
@ 71° x = 5.5" Sagamore

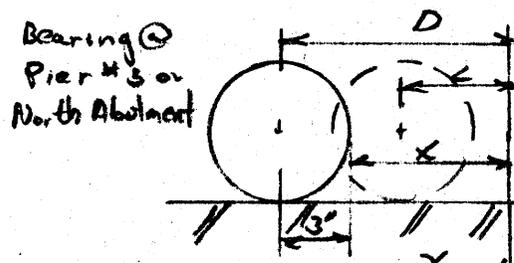
max pin movement = 1.02
roller movement = 0.51"

@ 35° X = 3.3125" Bourne
@ 76° X = 2.50" Sagamore

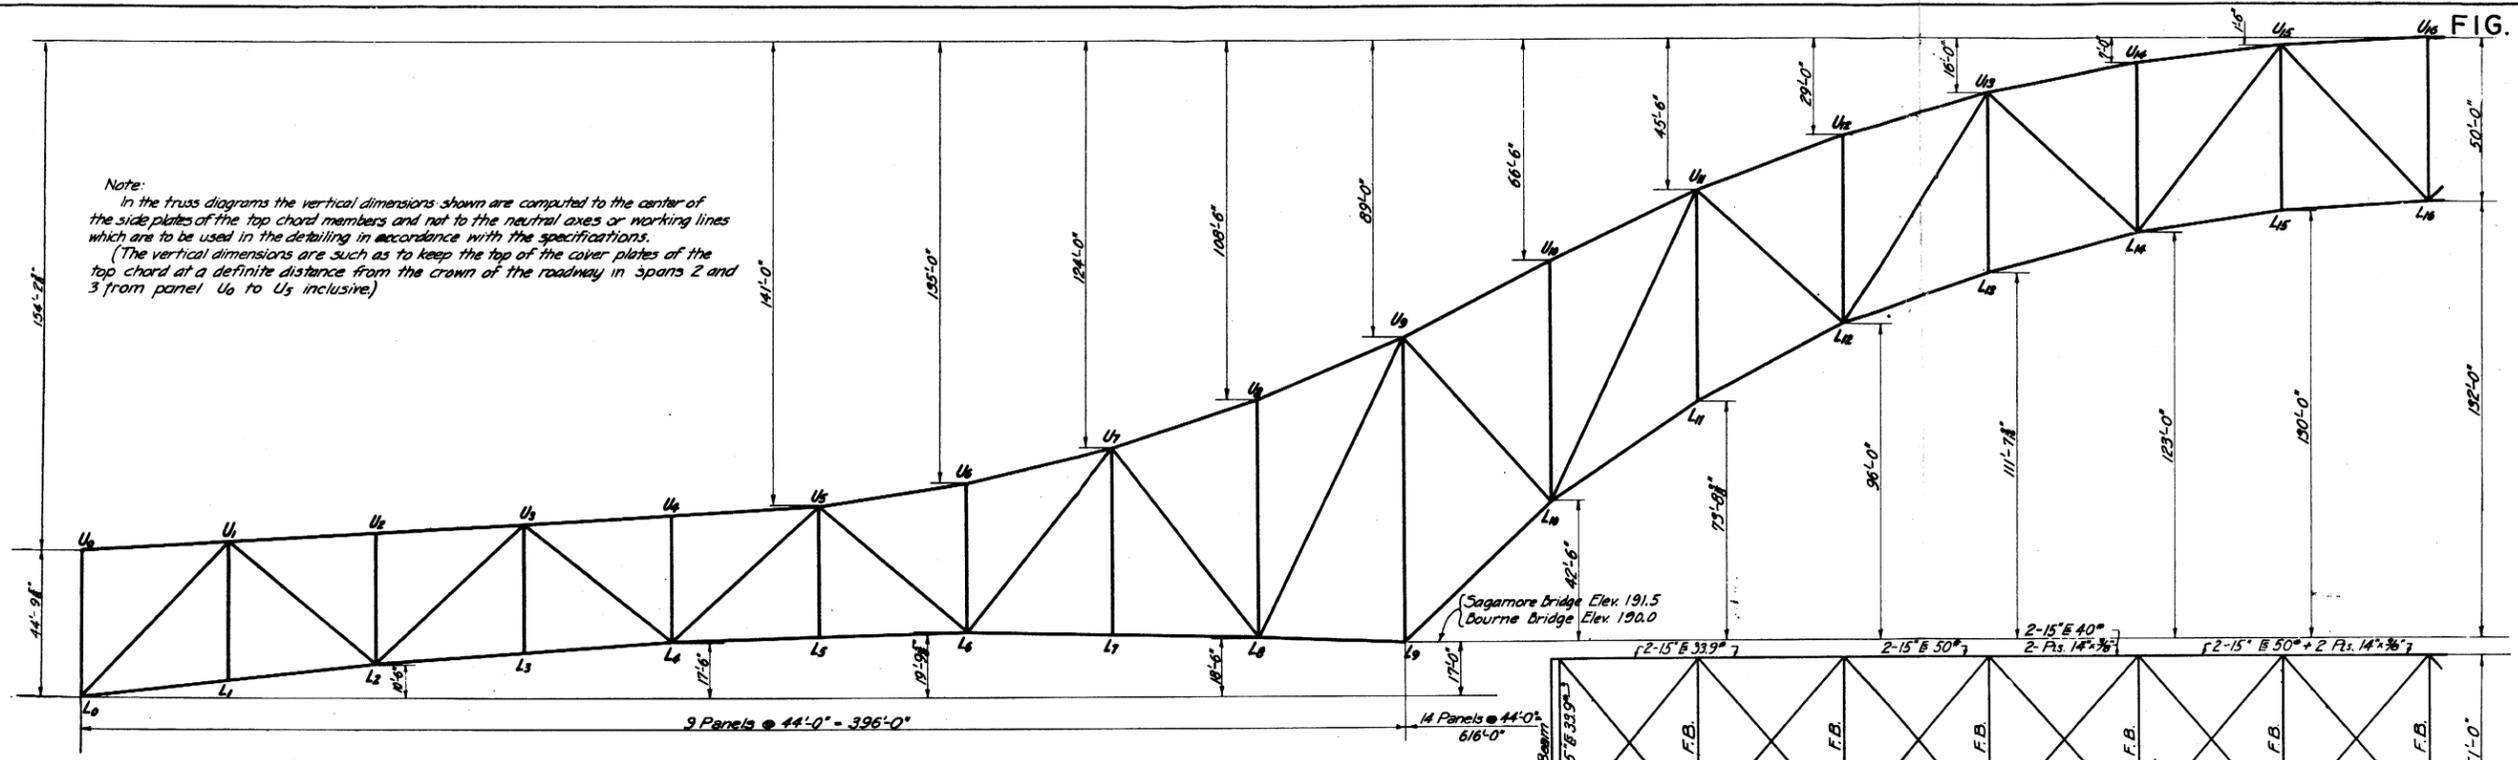
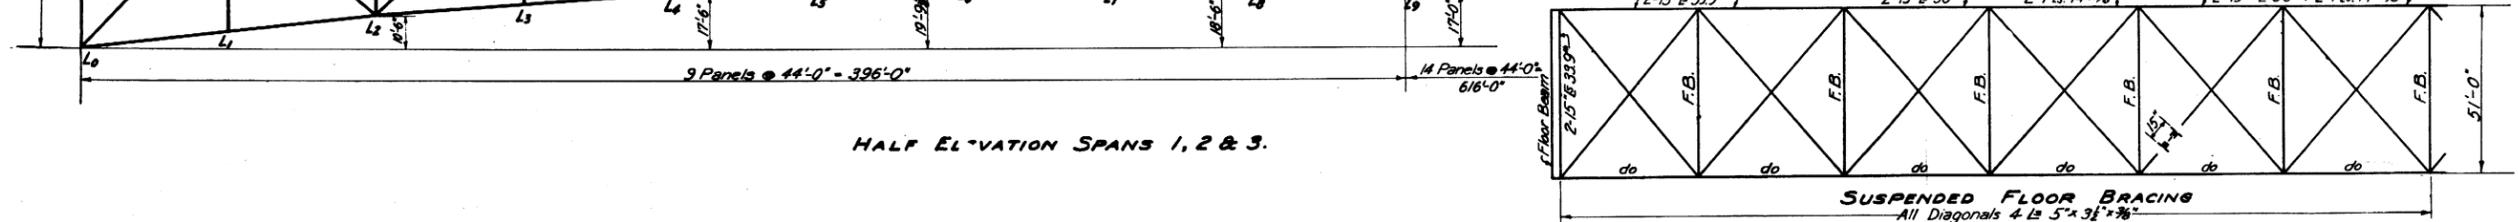
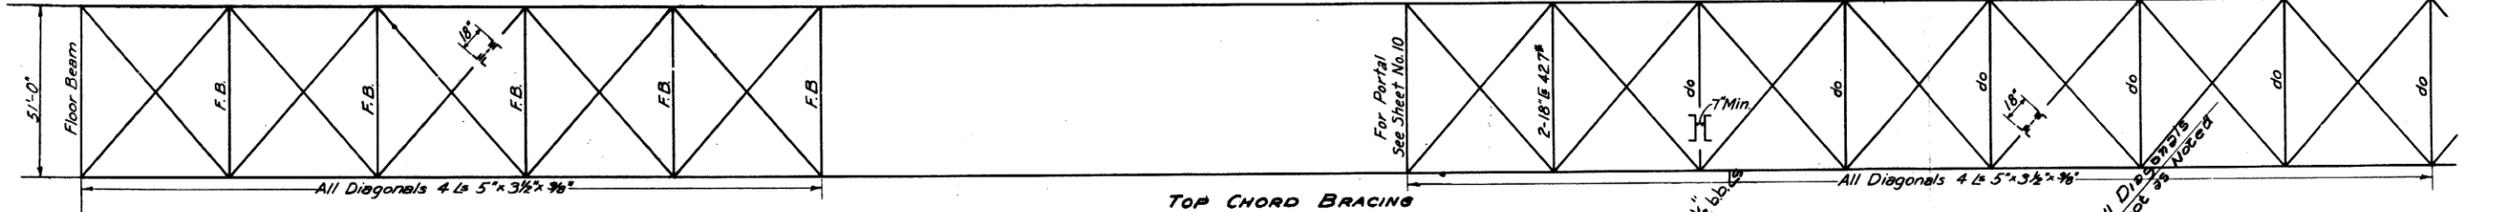
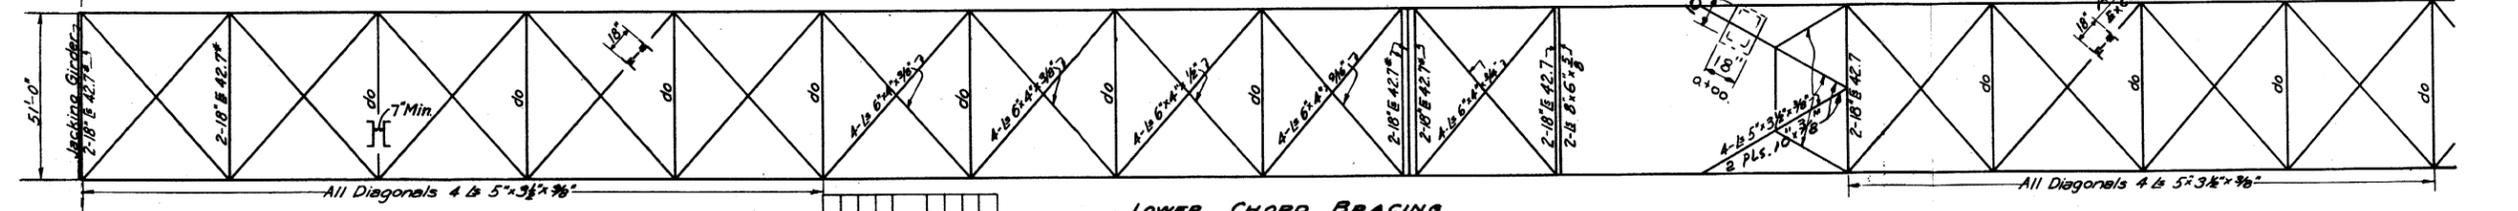
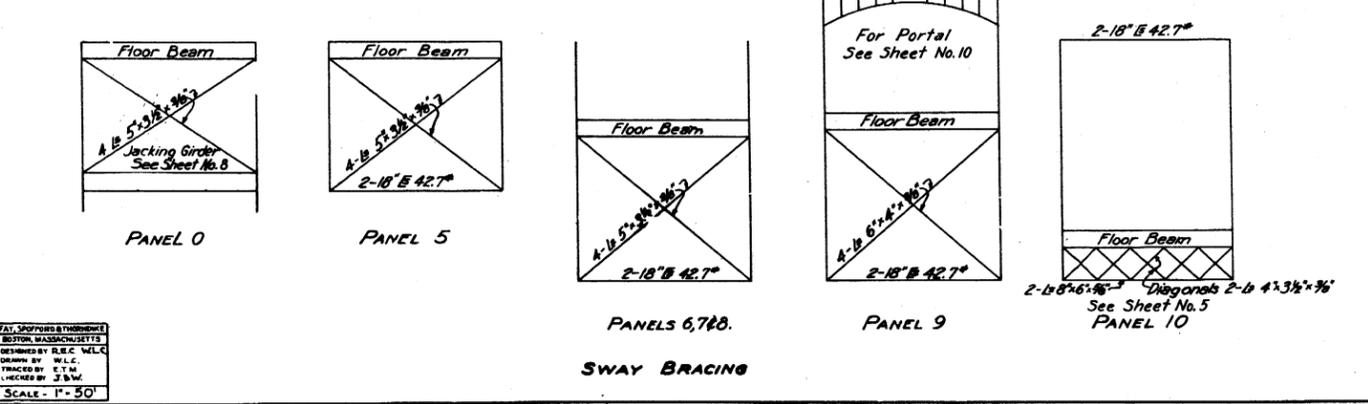
HALF ELEVATION SPANS 1, 2 & 3.

Note:
In the truss diagrams the vertical dimensions shown are computed to the center of the side plates of the top chord members and not to the neutral axes or working lines which are to be used in the detailing in accordance with the specifications.
(The vertical dimensions are such as to keep the top of the cover plates of the top chord at a definite distance from the crown of the roadway in spans 2 and 3 from panel U₆ to U₃ inclusive.)

Notes:
For General Elevations - see Sheets No. 2 and 3
For Deck Sections and Details see Sheets No. 4 and 5
For Stress Sheet see Sheet No. 7
For Truss Details (Spans 1, 2 and 3) see Sheets No. 8 to 11 inclusive.
For Truss Bearings (Spans 1, 2 and 3) see Sheet No. 16
For Detail of Jacking Girder see Sheet No. 8
All elevations are referred to a datum 100 feet below Mean Sea Level.

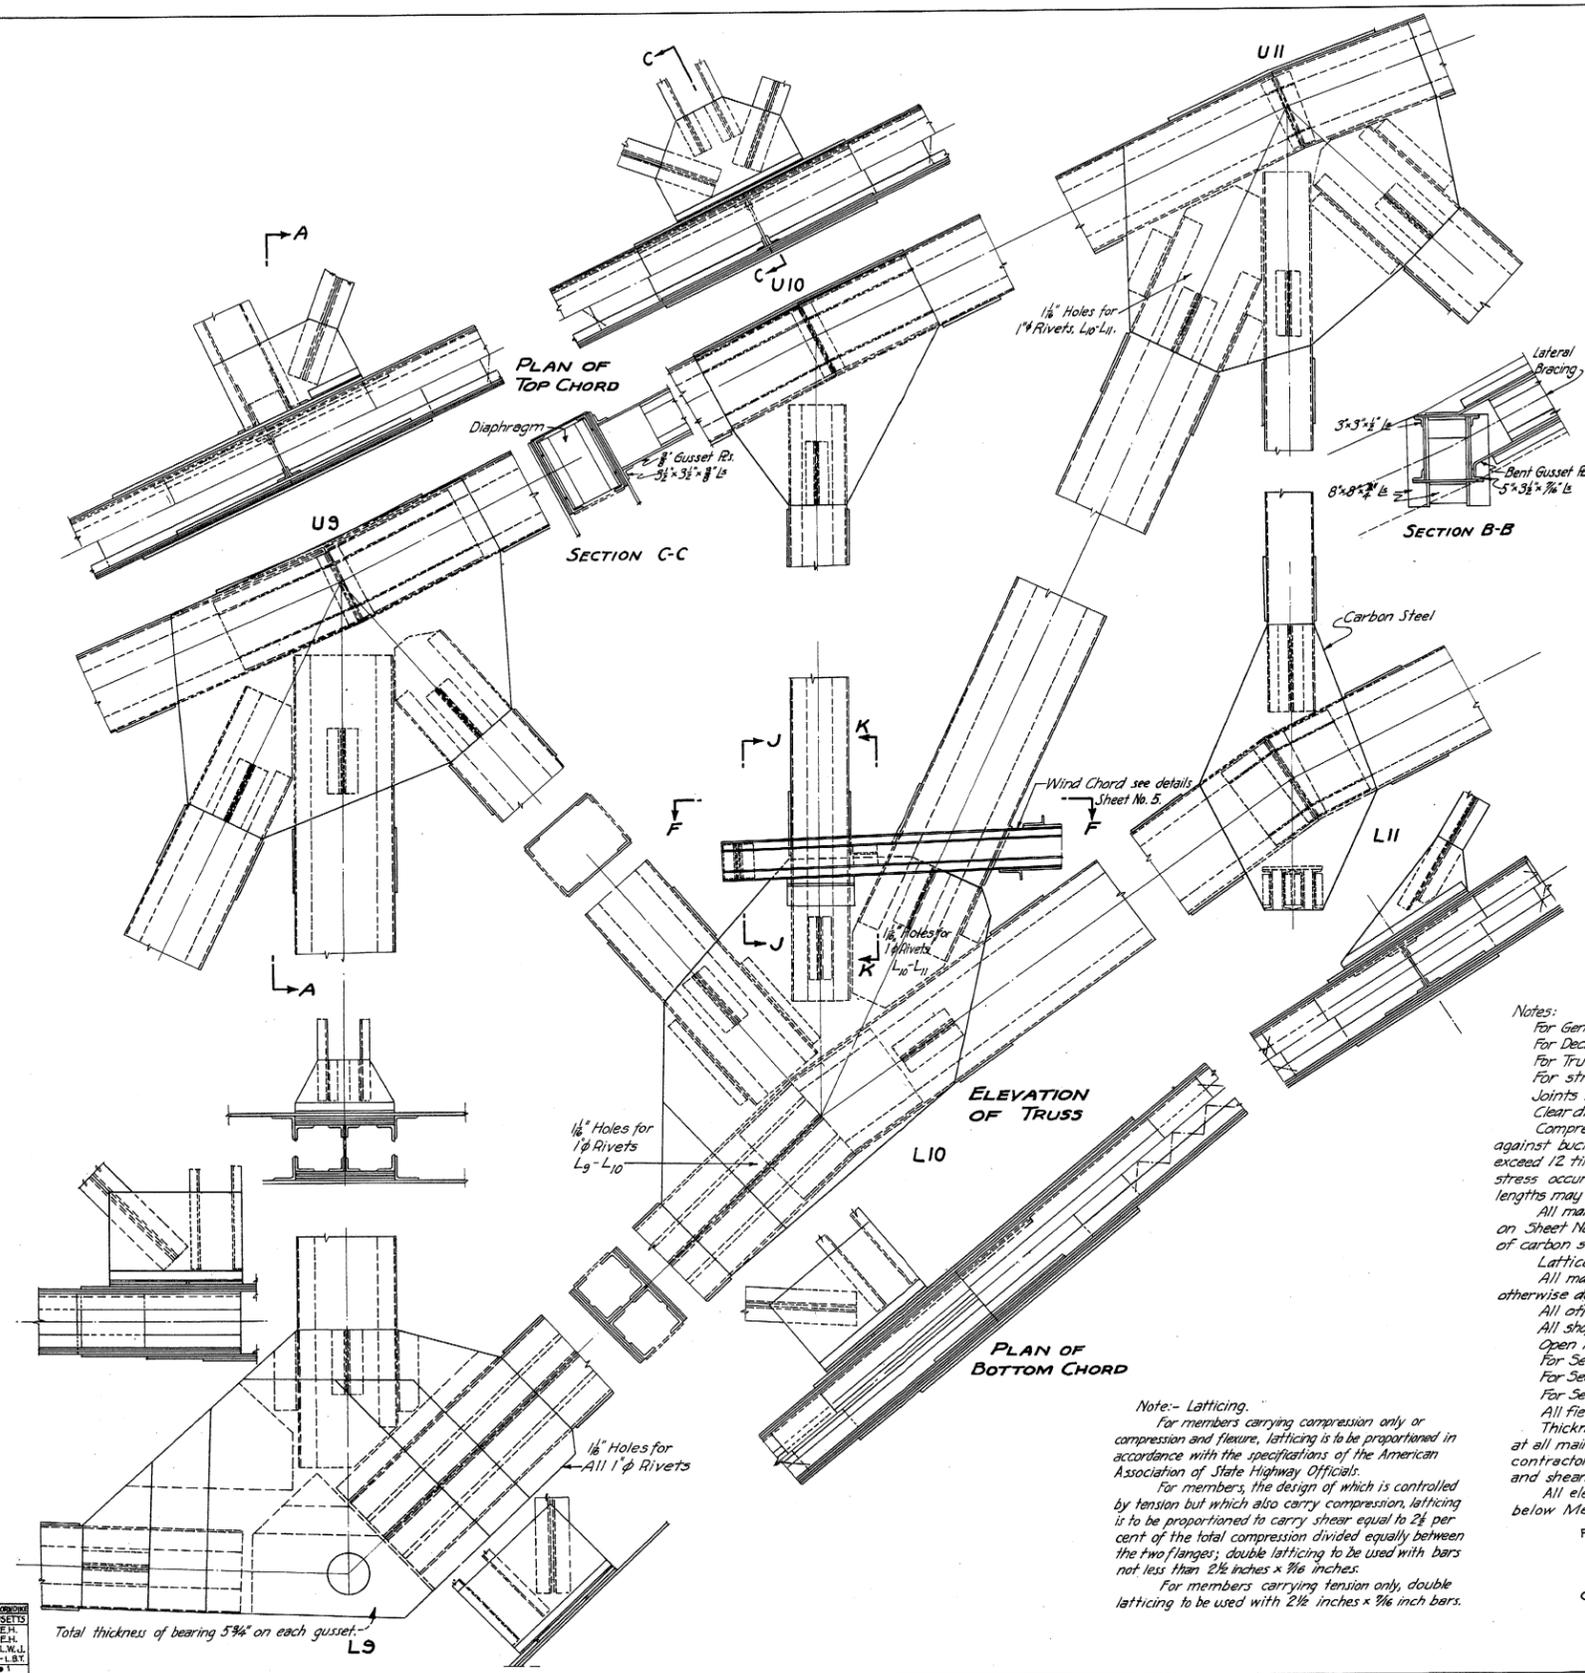
SAGAMORE AND BOURNE BRIDGES
TRUSS DETAILS SPANS 1, 2 AND 3.

Notes:
For General Plan and Elevation - see Sheets Nos. 2 and 3
For Deck Sections and Deck Details - see Sheets Nos. 4 and 5
For Truss Bearings - see Sheet No. 17
For stresses and make-up of members - see Sheet No. 7
Joints in compression members shall be faced to bear.
Clear distance between gusset plates 24 1/2 inches.
Compression edges of main gusset plates to be stayed against buckling by angles or plates where unsupported lengths exceed 12 times the plate thickness wherever maximum allowable stress occurs at edge. For stresses less than maximum, unstayed lengths may be increased proportionally.
All main truss members listed under "MAKE-UP OF SECTION" on Sheet No. 7 to be of silicon steel where so designated, otherwise of carbon steel.
Lattice bars, Stay plates, etc are to be of carbon steel.
All main truss gusset plates to be of silicon steel unless otherwise designated on plan.
All other material carbon steel.

All shop rivets 3/4" carbon steel except as noted.
Open holes for field rivets to be 3/16" except as noted.
For Section F-F see Sheet No. 5
For Section J-J see Sheet No. 5
For Section K-K see Sheet No. 5
All field rivets 3/4" except as noted.
Thickness, number and size of gusset plates at all main truss joints to be determined by contractor to carry flexure, direct stress and shear.
All elevations are referred to a datum 100 feet below Mean Sea Level.

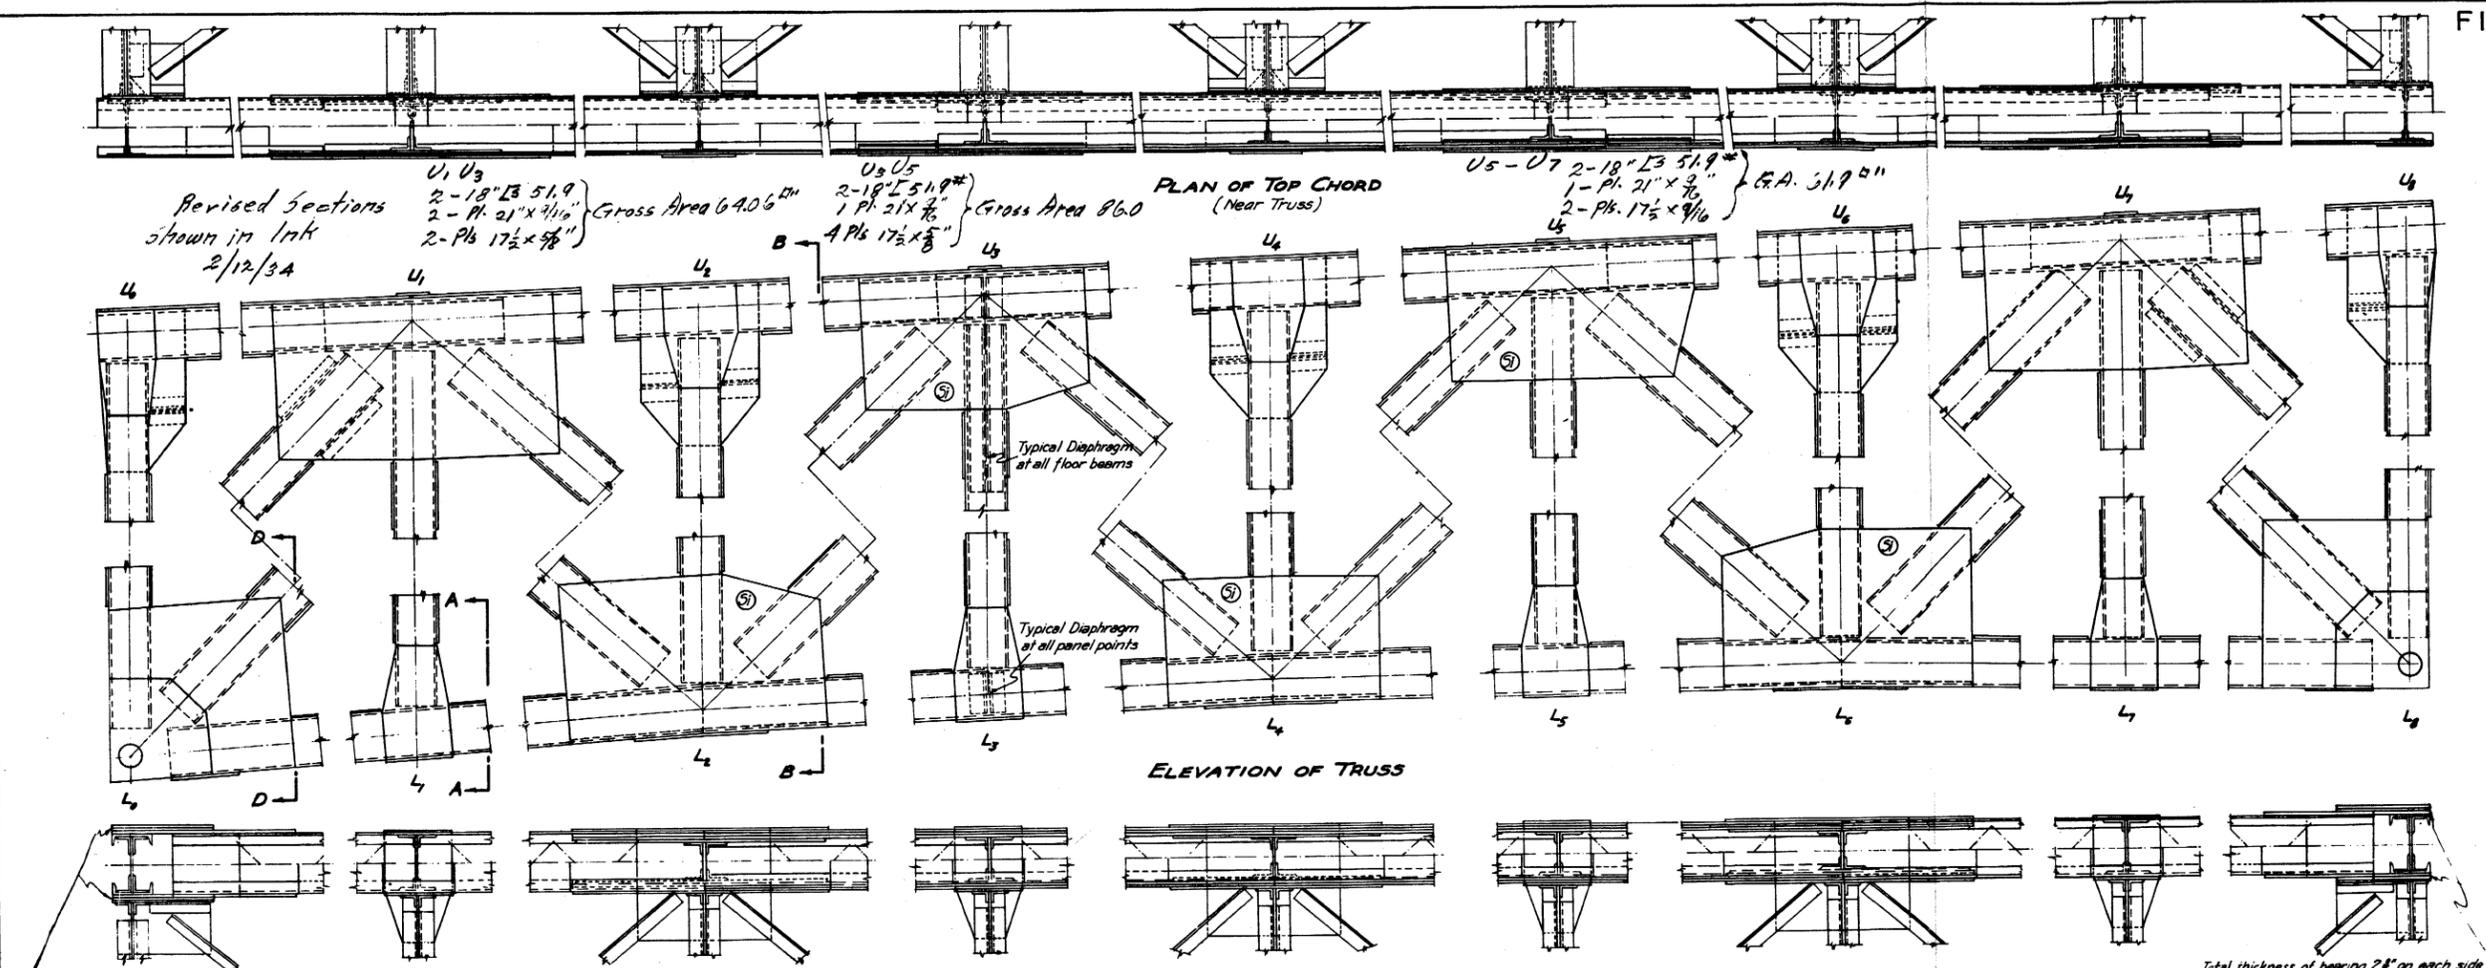
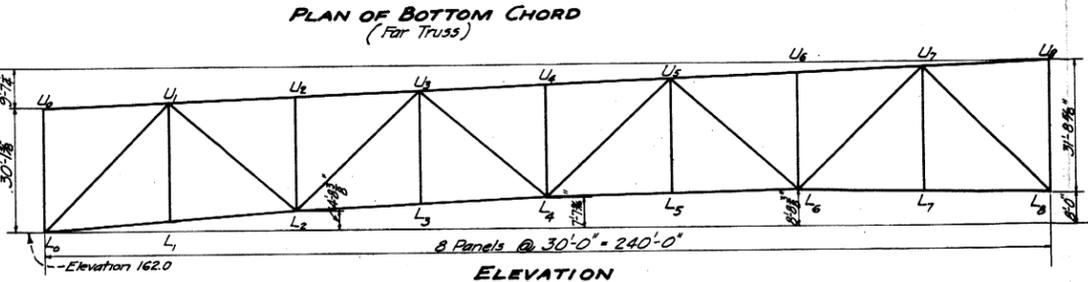
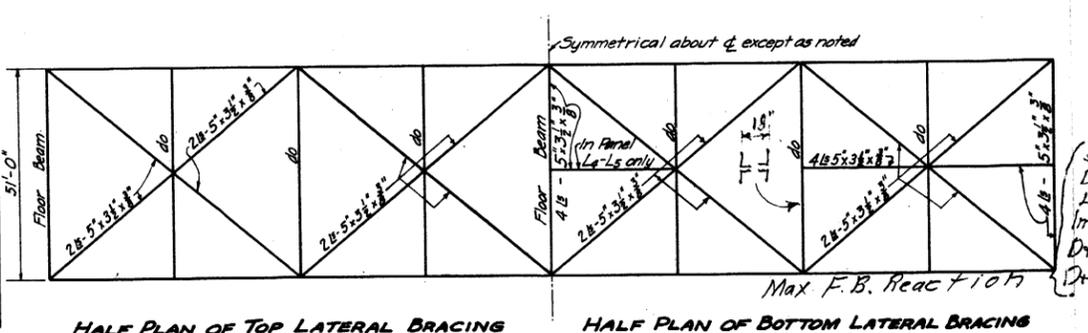
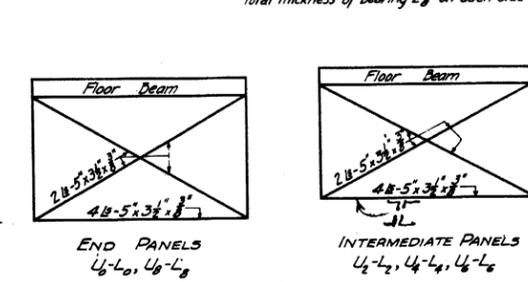
HALF PLAN OF TOP LATERAL BRACING HALF PLAN OF BOTTOM LATERAL BRACING

Note: In the truss diagrams the vertical dimensions shown are computed to the center of the channels of the top chord members and not to the neutral axes or working lines which are to be used in the detailing in accordance with the specifications.
 (The vertical dimensions are such as to keep the top of the cover plates of the top chord at a definite distance from the crown of the roadway.)

Notes:
 The stress in the column marked "Design Stress" equals for each member, the largest of the following two values: $\frac{1}{2}(D+L+I)$; $D+2(L+I)+W$. See specifications.
 Material listed under "Make-up of Section" and marked (S) to be of silicon steel. Main truss gusset plates to be of carbon steel unless otherwise designated on the plans. All other material including rivets to be of carbon steel.

SWAY BRACING

Note: See Sheet No. 14 for additional notes.
 Thickness, number and size of gusset plates at all main truss joints to be determined by contractor to carry flexure, direct stress and shear.
 30' Panel
 D.L. = 100.7
 L.L. = 66.2
 Imp = 21.5
 D+L = 188.4
 D+L = 216.1

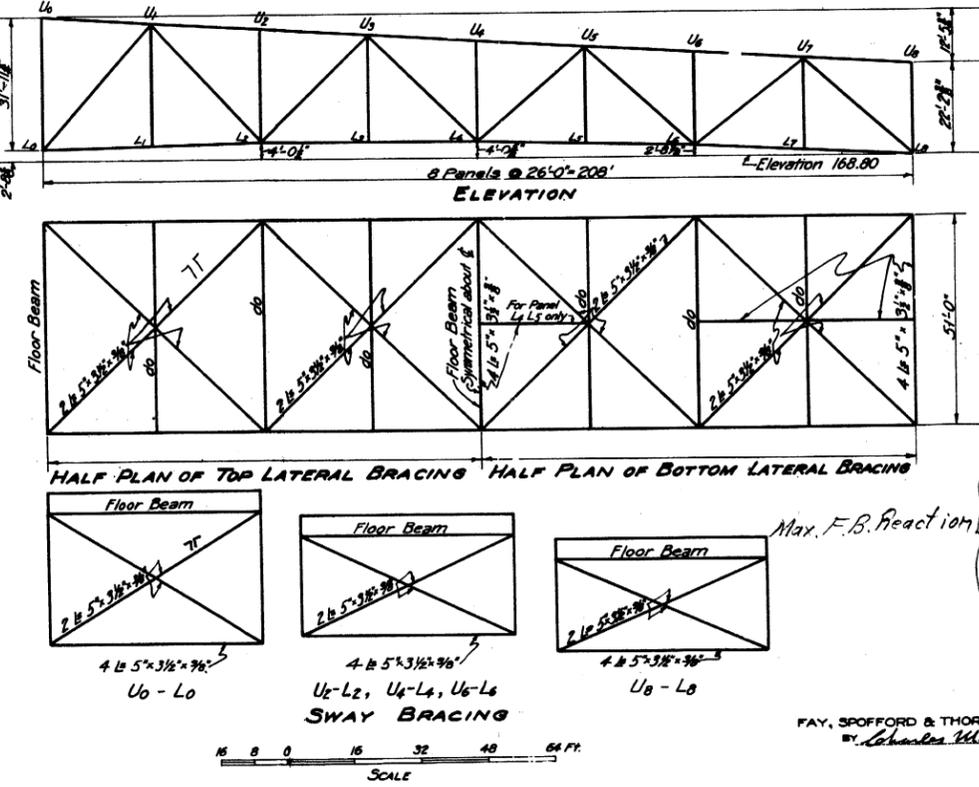
MEMBER	STRESSES IN KIPS			DESIGN STRESS	MAKE-UP OF SECTION	AREA		ASSEMBLY	RADIUS OF GYRATION
	DEAD	LIVE + IMPACT	WIND			GROSS	NET		
U ₆ -U ₁			-48	-48	2-18" I ₂₀ @ 42.7 ⁵ Cover R 21 x 3/4		36.8		r _x =6.8
U ₁ -U ₆	-651	-269	-63	-1252	2-18" I ₂₀ @ 58 ⁵ Cover R 21 x 3/4 17 1/2 x 7/8	51	45.8		r _x =6.8
U ₆ -U ₅	-981	-401	-63	-1846	2-18" I ₂₀ @ 58 ⁵ Cover R 21 x 3/4 2 R 18 x 3/4 @ 51	51	70.5		r _x =6.3
U ₅ -U ₆	-791	-326	-63	-1506	2-18" I ₂₀ @ 58 ⁵ Cover R 21 x 3/4 2 R 15 x 3/4 @ 51	51	57.0		r _x =6.4
U ₅ -U ₄			-48	-48	2-18" I ₂₀ @ 42.7 ⁵ Cover R 21 x 3/4 17 1/2 x 7/8	51	36.8		
L ₆ -L ₅	+348	+144		+657	2-18" I ₂₀ @ 42.7 ⁵	51	25.0	20.5	r _x =5.7
L ₅ -L ₆	+859	+355	+13	+1620	2-18" I ₂₀ @ 58 ⁵ 2 R 18 x 3/4 @ 51	51	58.7	50.4	
L ₅ -L ₄	+951	+393	+13	+1795	2-18" I ₂₀ @ 58 ⁵ 4 R 18 x 3/4 @ 51	51	64.3	55.0	
L ₄ -L ₅	+462	+192		+873	2-18" I ₂₀ @ 58 ⁵	51	34.0	27.0	
L ₄ -L ₃	-536	-242		-1038	2-18" I ₂₀ @ 58 ⁵ 2 R 15 x 3/4 @ 51	51	50.8		r _x =5.7

L ₃ -L ₄	+455	+220		+901	2-18" I ₂₀ @ 42.7 ⁵ 2 R 15 x 3/4 @ 51	51	36.2	31.1	
L ₂ -L ₃	-294	-174		-642	2-18" I ₂₀ @ 45.8 ⁵	51	26.8		r _x =6.5
U ₅ -L ₄	+175	+139		+453	2-15" I ₁₆ @ 33.9 ⁵	51	19.8	16.6	
L ₄ -L ₅	+43	+85		+173	2-15" I ₁₆ @ 33.9 ⁵	51	19.8	16.6	
U ₆ -L ₆	-219	-154		-527	2-18" I ₂₀ @ 51.5 ⁵	51	30.4		r _x =6.4
L ₆ -L ₅	+424	+209		+845	2-18" I ₂₀ @ 58 ⁵	51	34.0	27.0	
U ₇ -L ₆	-626	-282		-1210	2-18" I ₂₀ @ 58 ⁵ 2 R 18 x 3/4 @ 51	51	52.0		r _x =5.9
L ₆ -L ₆	-49	-84	-37	-254	2-15" I ₁₆ @ 33.9 ⁵ L ₄ -L ₅ L ₅ -L ₆ L ₆ -L ₆ L ₆ -L ₇ L ₇ -L ₆	51	19.8		r _x =5.6
L ₆ -L ₆	-101	-84	-9	-270	2-15" I ₁₆ @ 33.9 ⁵ L ₄ -L ₅ L ₅ -L ₆ L ₆ -L ₆ L ₆ -L ₇ L ₇ -L ₆	51	19.8		
R₆ Gross	448	205	57						
R₆ Net	448	205	27

Note:
 In the truss diagrams the vertical dimensions shown are computed to the center of the channels of the top chord members and not to the neutral axes or working lines which are to be used in the detailing in accordance with the specifications. (The vertical dimensions are such as to keep the top of the cover plates of the top chord at a definite distance from the crown of the roadway.)

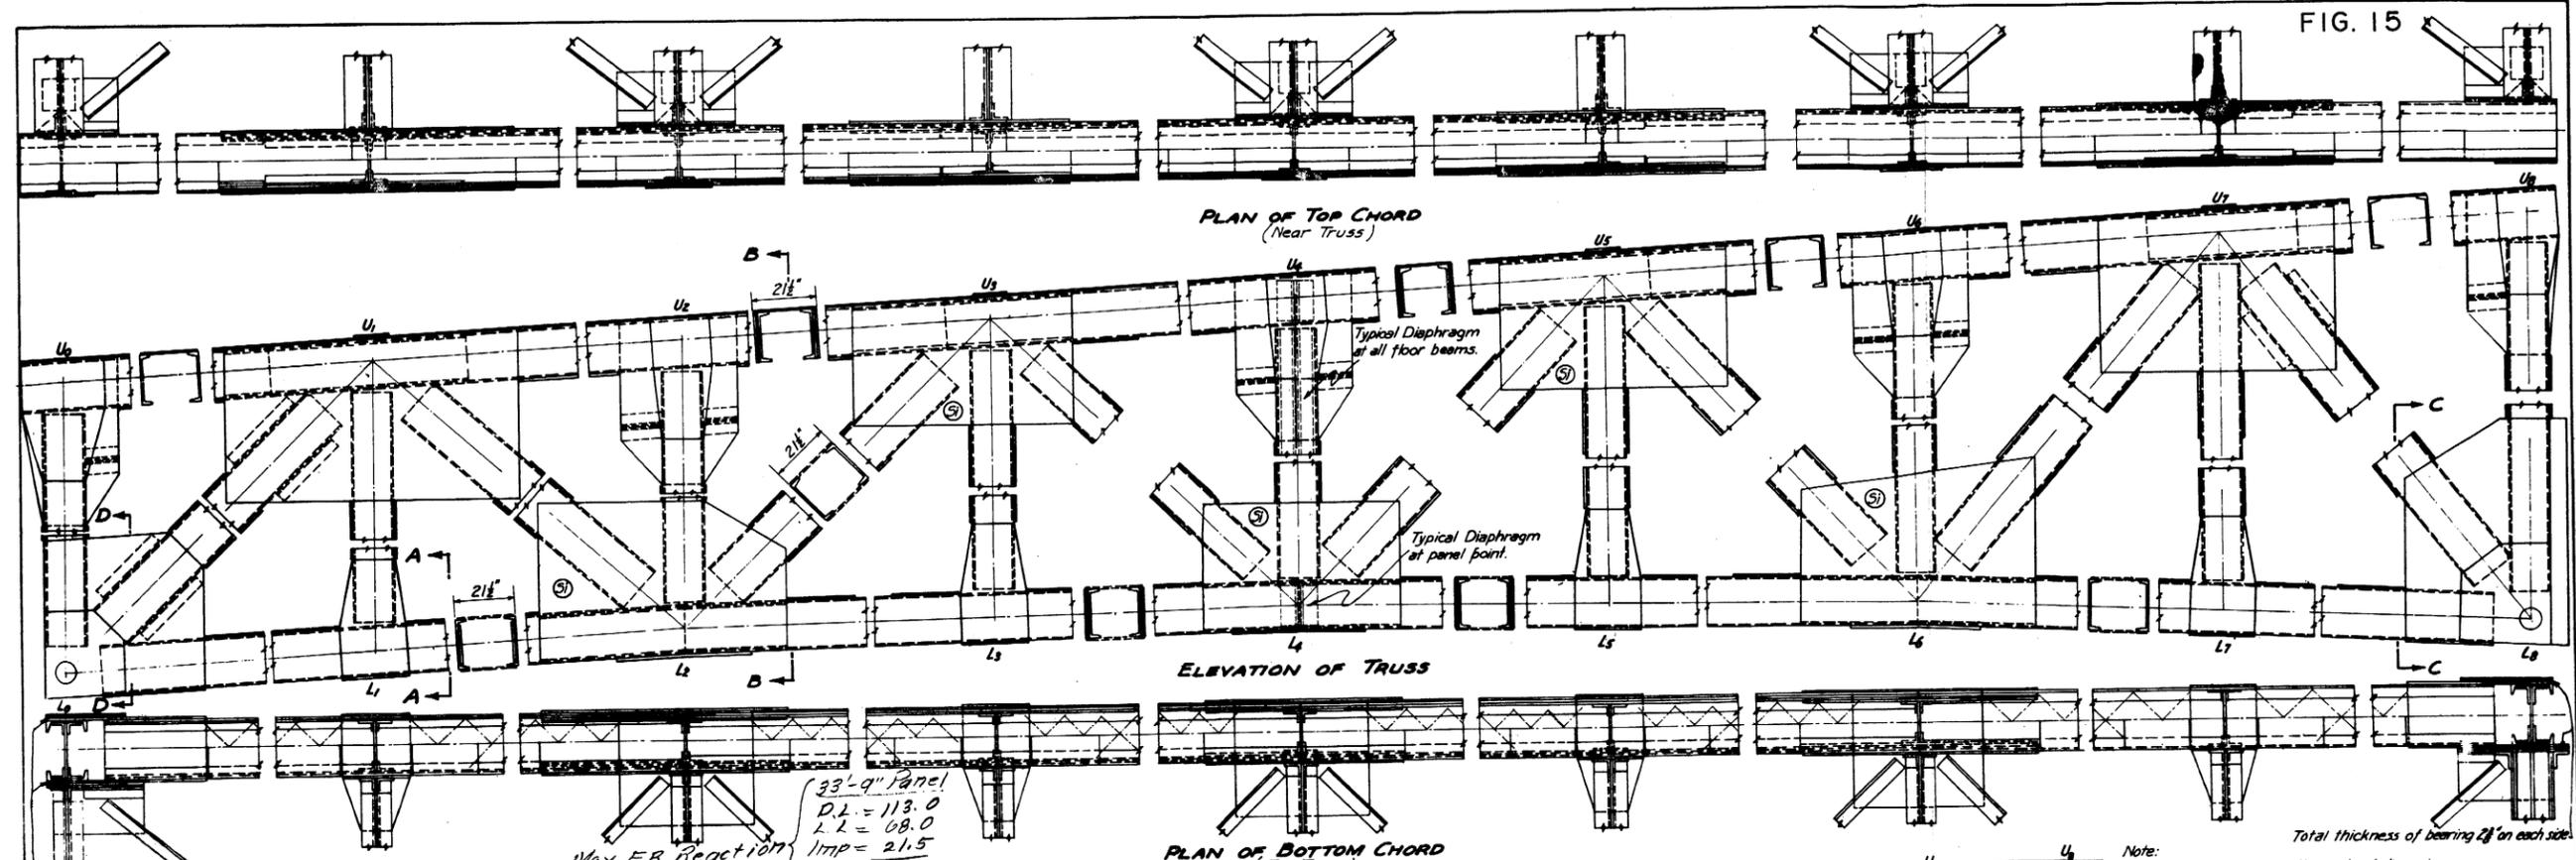
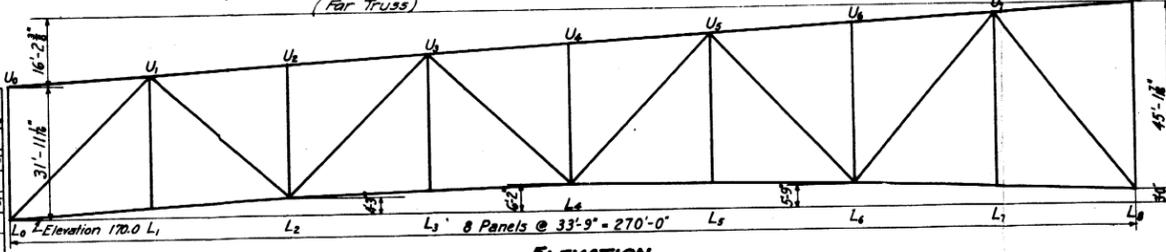
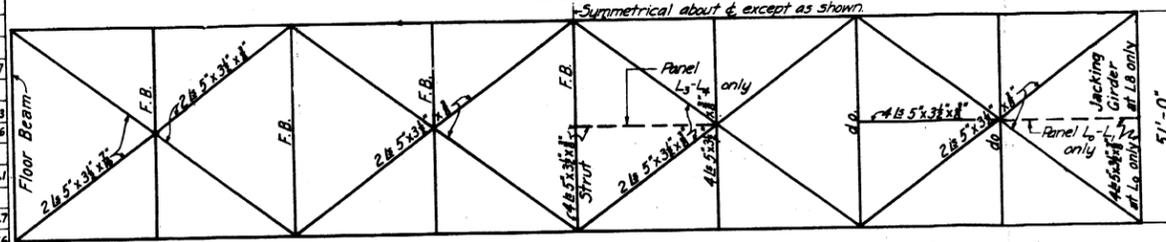
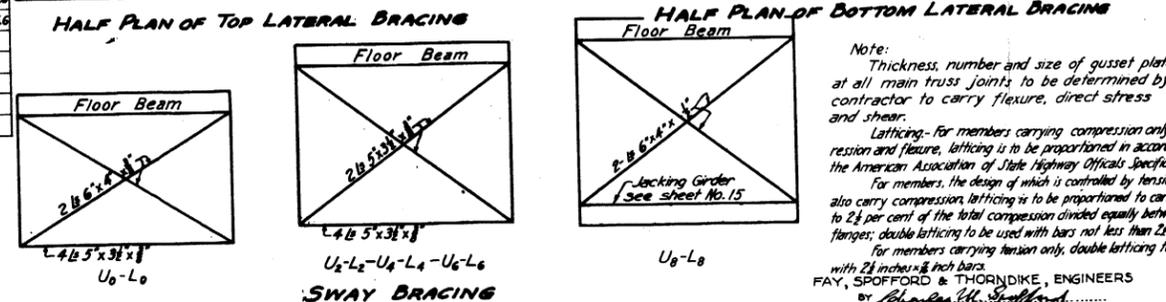
33'-9" Panel
 D.L. = 113.0
 L.L. = 68.0
 Imp = 21.5
 D+L = 202.5
 D+L = 292.0

Notes:
 The stress in the column marked "Design Stress" equals for each member, the largest of the following two values: $\frac{1}{4}(D+L+I)$; $D+2(L+I)+W$. See specifications.
 Material listed under "Make-up of Section" and marked (S) to be of silicon steel. Main Truss gusset plates to be of carbon steel unless otherwise designated on the plans. All other material including rivets to be of carbon steel.

Note:
 In the truss diagrams the vertical dimensions shown are computed to the center of the channels of the top chord members and not to the neutral axes or working lines which are to be used in the detailing in accordance with the specifications.
 (The vertical dimensions are such as to keep the top of the cover plates of the top chord at a definite distance from the crown of the roadway.)

Where consistent with shipping requirements, two or more panel lengths of chord members shall be fabricated as one member.
 Joints in compression members shall be faced to bear. Open holes for field rivets to be 7/16" unless otherwise noted. 1/8" P for all Truss Joints.
 Compression edges of main gusset plates to be stayed against buckling by angles or plates where unsupported lengths exceed 12 times the plate thickness wherever maximum allowable stress occurs at edge. For stresses less than maximum, unstayed lengths may be increased proportionally.
 All rivets 3/4" φ.
 All elevations are referred to a datum 100 feet below Mean Sea Level.
