MAJOR REHABILITATION PROJECT

CAPE COD CANAL BRIDGES

CAPE COD CANAL
BOURNE, MASSACHUSETTS

DESIGN MEMORANDUM

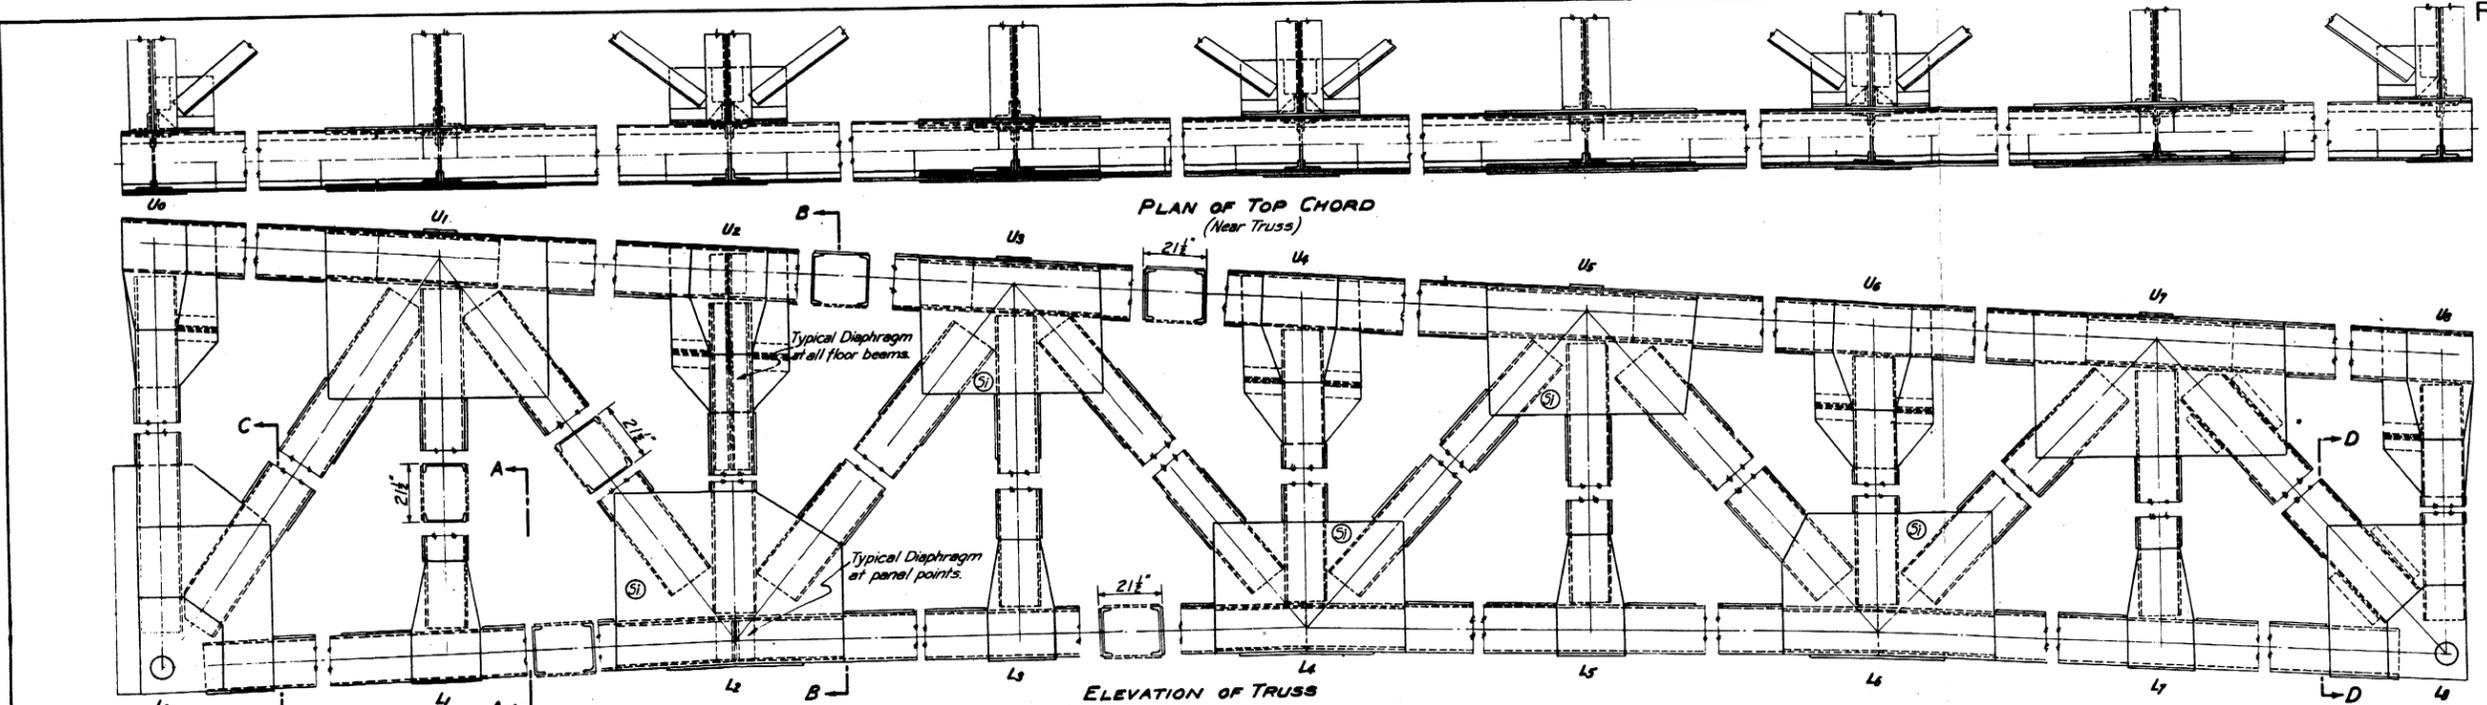
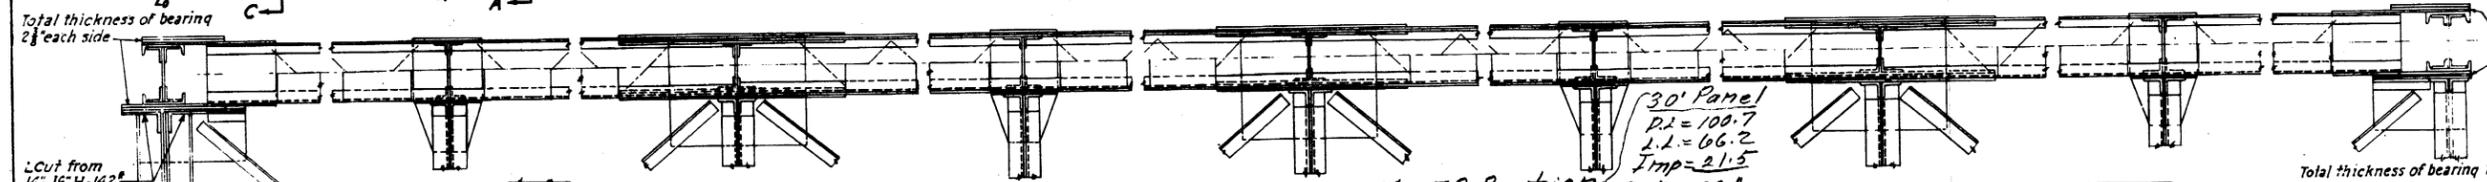
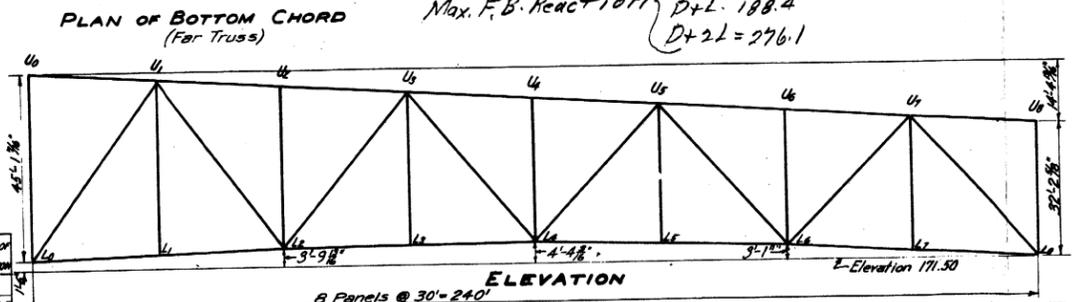
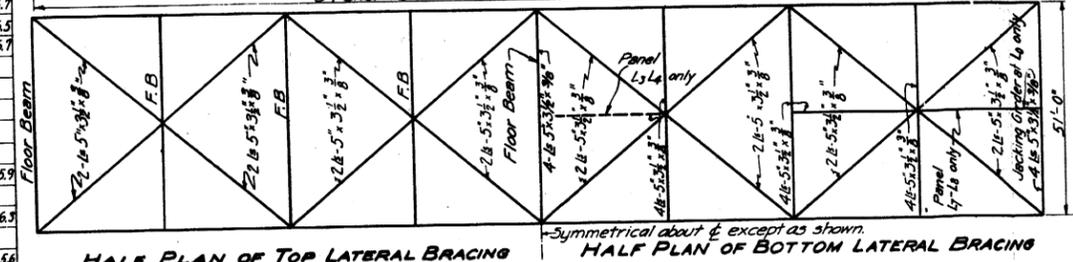
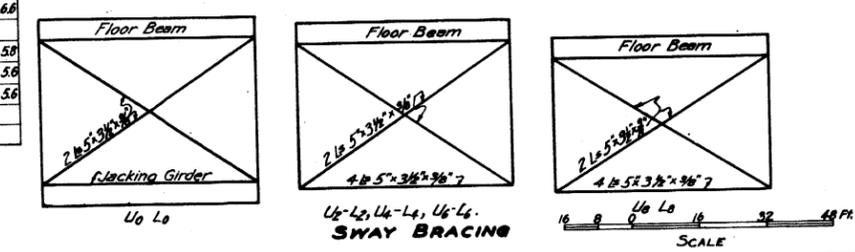
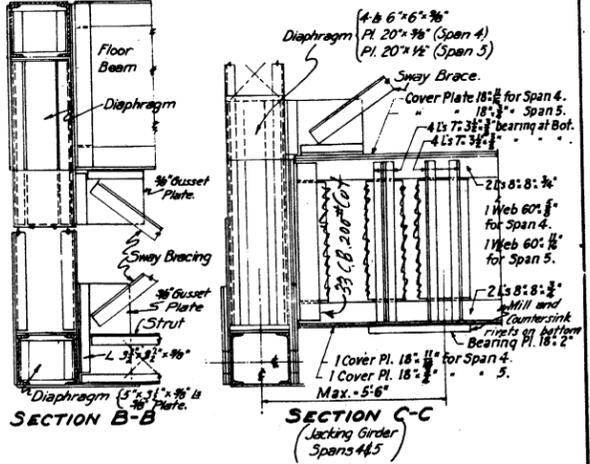
Note: In the truss diagrams the vertical dimensions shown are computed to the center of the channels of the top chord members and not to the neutral axes or working lines which are to be used in the detailing in accordance with the specifications. (The vertical dimensions are such as to keep the top of the cover plates of the top chord at a definite distance from the crown of the roadway.)

MEMBER	STRESSES IN KIPS			DESIGN STRESS	MAKE-UP OF SECTION	AREA	DIAMETER OF STRUT
	DEAD	LIVE + WIND	WIND				
U0 U1			-56	-56	2-18" E @ 42.7" Cover Pl. 21" x 9/16"	36.76	
U1 U2	-600	-239	-93	-1171	2-18" E @ 58" Cover Pl. 21" x 9/16"	42.76	6" x 6.7"
U2 U3	-856	-358	-93	-1665	2-18" E @ 58" Cover Pl. 21" x 9/16" 2 PL 17 1/2 x 5/8"	63.76	6" x 6.5"
U3 U4	-686	-288	-93	-1355	2-18" E @ 42.7" Cover Pl. 21" x 9/16" 2 PL 17 1/2 x 5/8"	30.26	6" x 6.7"
U4 U5			-56	-56	2-18" E @ 42.7" Cover Pl. 21" x 9/16"	36.76	
L0 L1	+310	+130		+587	2-18" E @ 42.7"	24.96	6" x 5.9"
L1 L2	+758	+317	+16	+1432	2-18" E @ 58" 2-PL 18" x 3/4"	56.46	6" x 5.9"
L2 L3	+814	+343	+16	+1542	2-18" E @ 58" 2-PL 18" x 3/4"	60.96	6" x 5.9"
L3 L4	+417	+175		+790	2-18" E @ 51.9"	30.36	6" x 5.9"
L4 L5	-570	-247		-1090	2-18" E @ 58" 4-PL 18" x 3/4"	65.48	6" x 5.9"
L5 L6	+448	+220		+891	2-18" E @ 58"	33.96	6" x 5.9"
L6 L7	-289	-171		-631	2-18" E @ 58"	33.96	6" x 5.9"

U0 L0	+157	+137		+491	2-15" E @ 33.9"	20.46	6" x 5.6"
U1 L1	+60	+100		+382	2-15" E @ 33.9"	19.80	6" x 5.6"
U2 L2	-194	-156		-506	2-18" E @ 42.7"	24.96	6" x 6.8"
U3 L3	+426	+198		+833	2-18" E @ 58"	33.96	6" x 5.9"
U4 L4	-620	-259		-1172	2-18" E @ 58" 4-PL 18" x 3/4"	60.96	6" x 5.9"
U5 L5	-63	-112	-60	-347	2-15" E @ 33.9"	19.80	6" x 5.6"
U6 L6	-125	-112	-19	-362	2-15" E @ 33.9"	19.80	6" x 5.6"
U7 L7	520	227	60		2-15" E @ 33.9" U1 L1, U2 L2, U3 L3, U4 L4, U5 L5, U6 L6, U7 L7		
NO							
GROSS	516	227	44

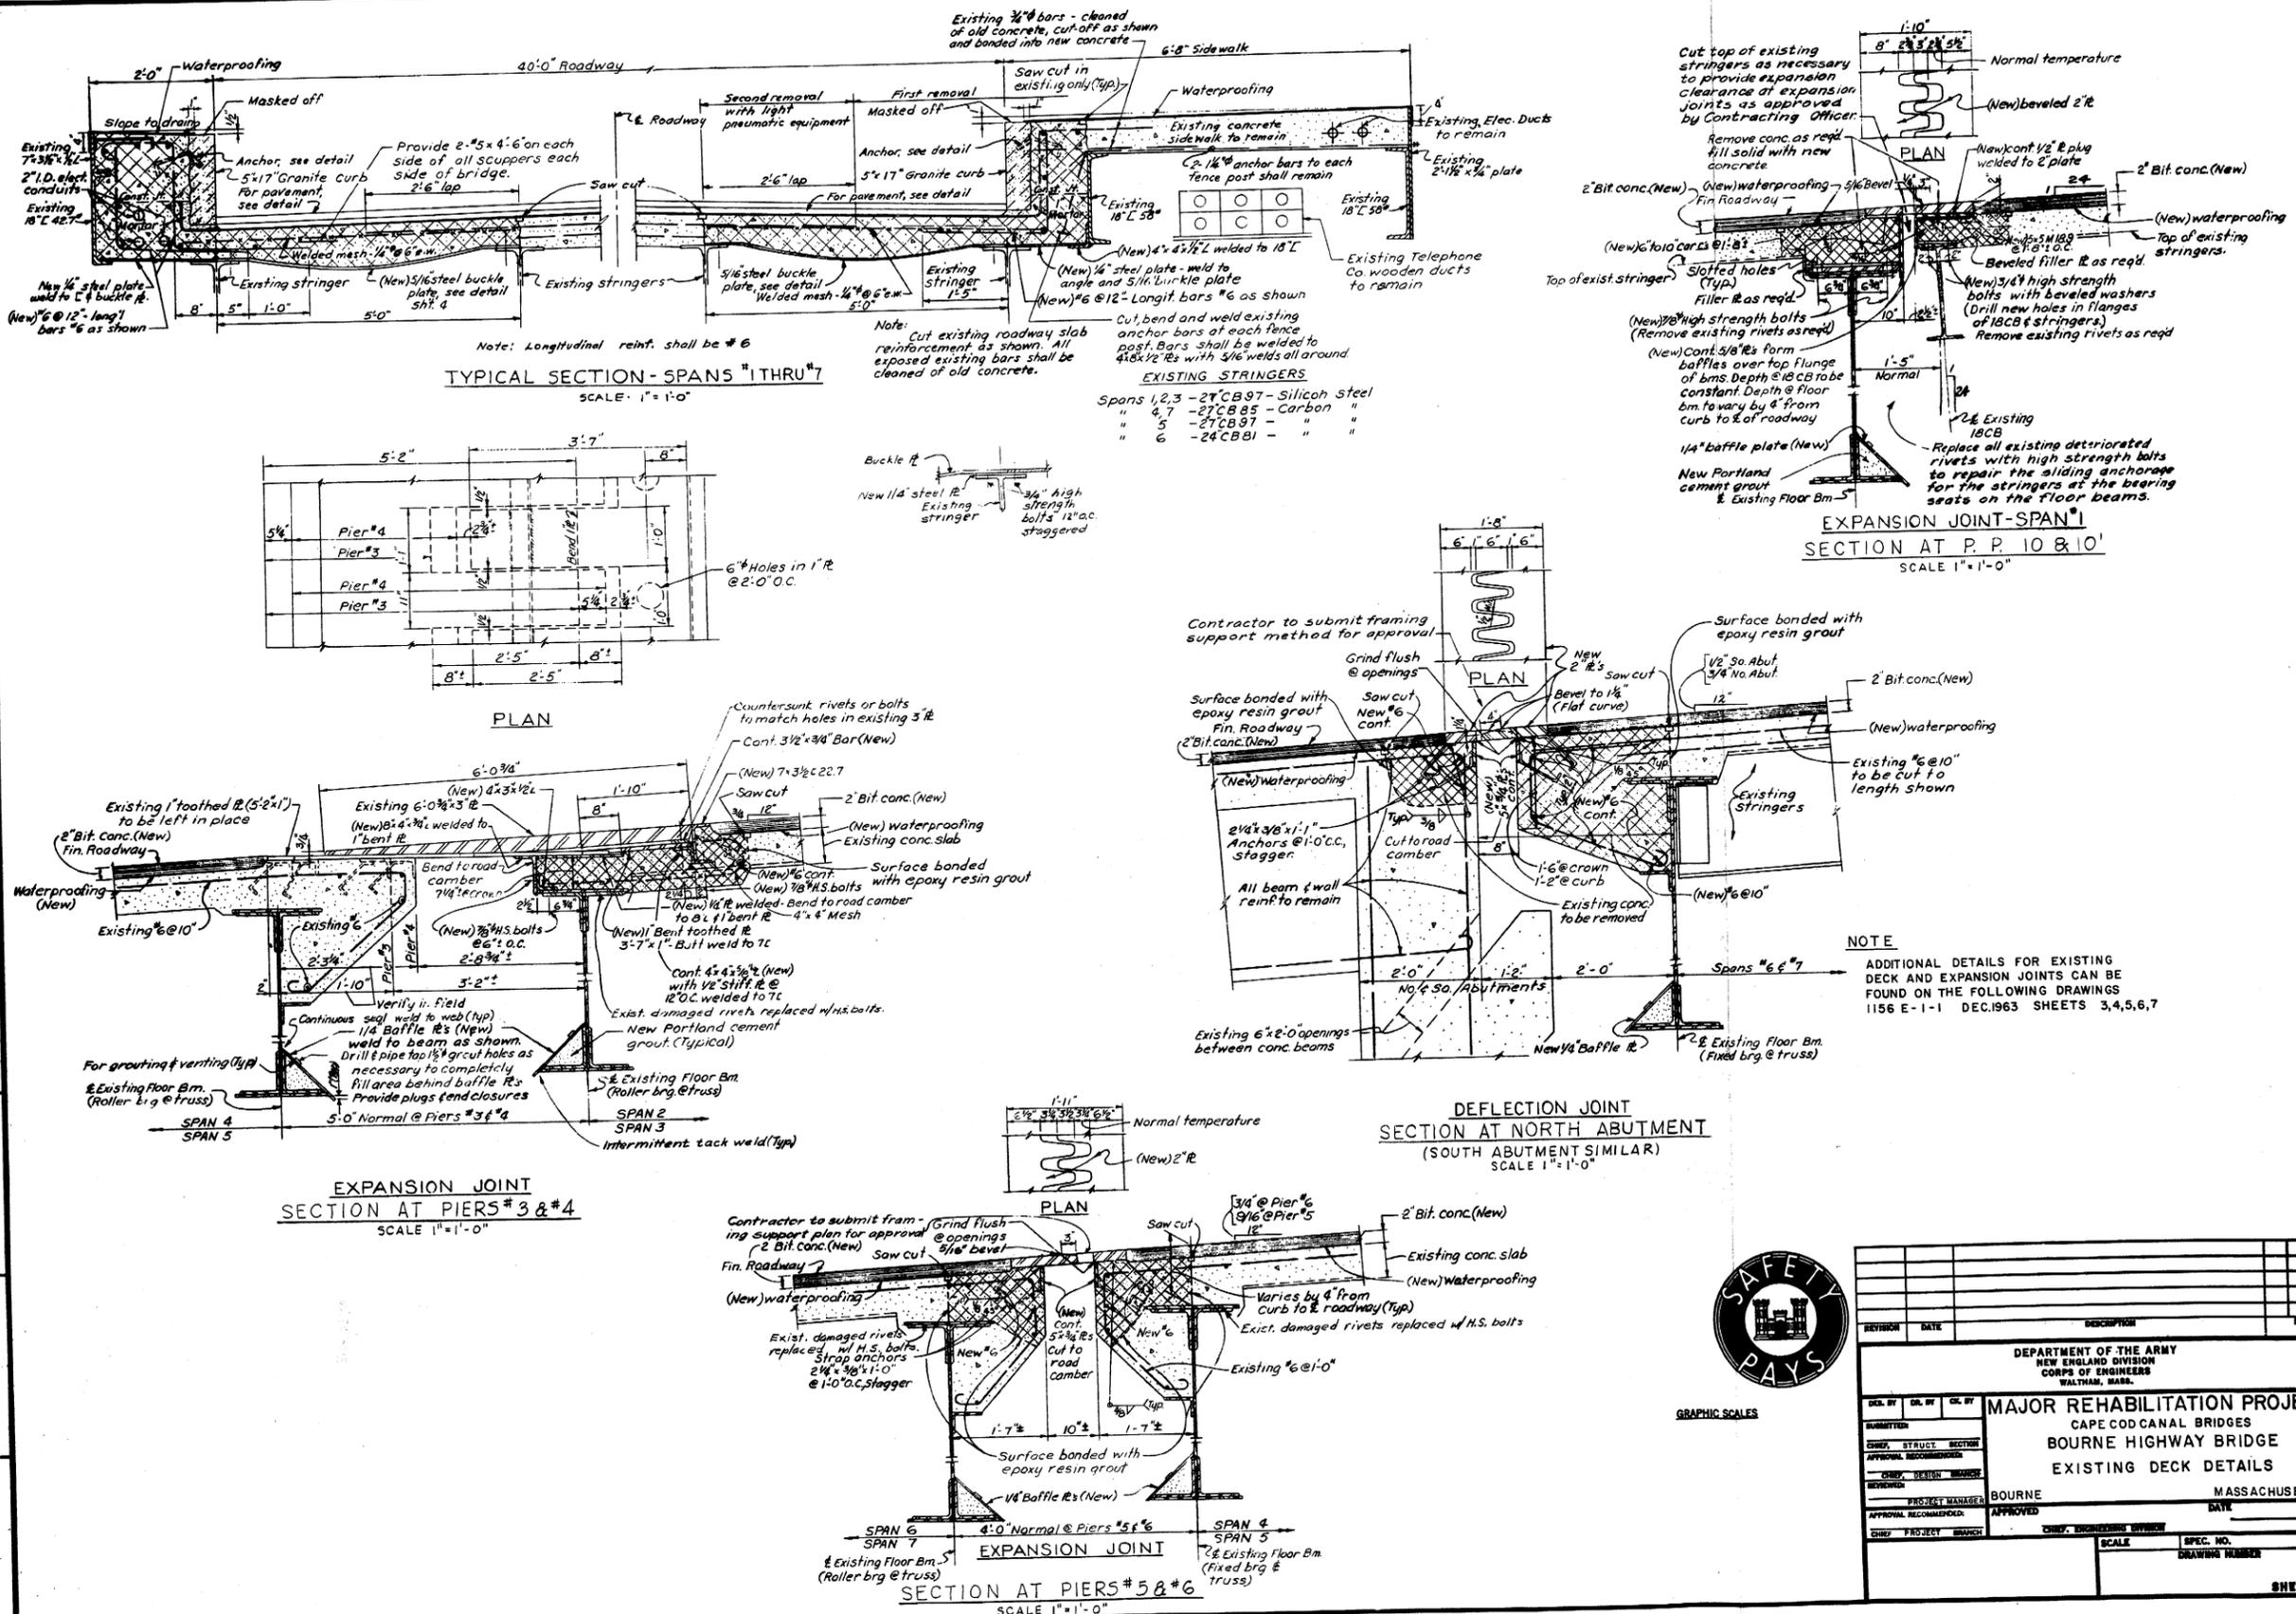
EXISTING STRINGERS

Spans 1,2,3	- 2" CB 97 - Silicon steel
" 4,7	- 2" CB 85 - carbon "
" 5	- 2" CB 97 - " "
" 6	- 2" CB 81 - " "

NOTE
 ADDITIONAL DETAILS FOR EXISTING DECK AND EXPANSION JOINTS CAN BE FOUND ON THE FOLLOWING DRAWINGS 1156 E-1-1 DEC.1963 SHEETS 3,4,5,6,7

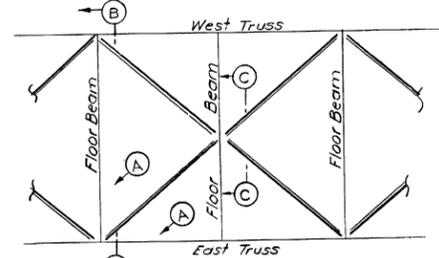
TYPICAL PLAN OF TOP LATERAL BRACING
SCALE 1/16"=1'-0"

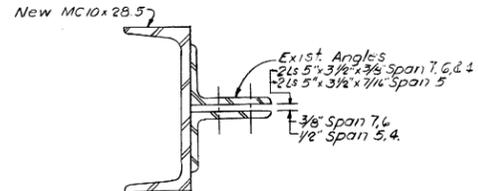
SECTION A-A
SCALE 3/4"=1'-0"

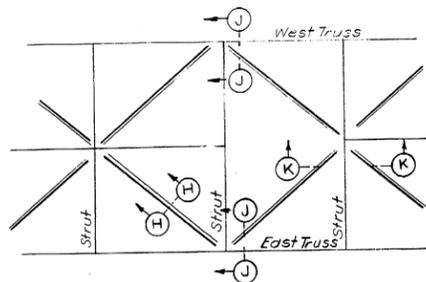
TYPICAL PLAN OF TOP LATERAL BRACING
SCALE 1/16"=1'-0"

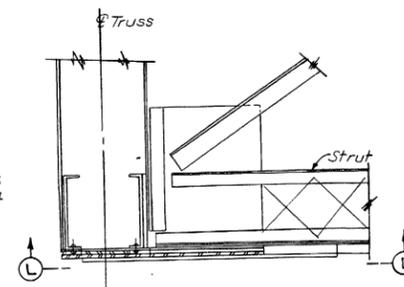
SECTION J-J
SECTION J'-J'
SCALE 3/4"=1'-0"

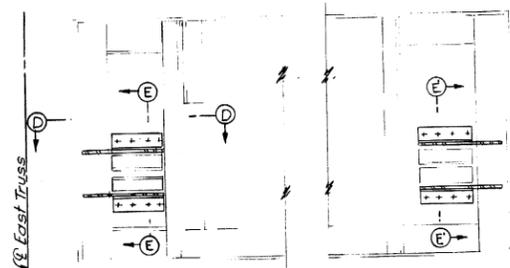
SECTION B-B
SCALE 3/4"=1'-0"

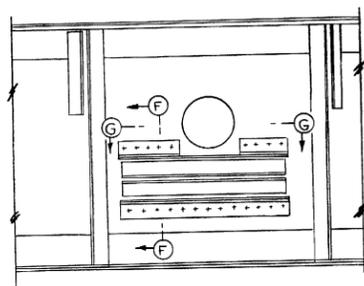
SECTION C-C
SCALE 3/4"=1'-0"

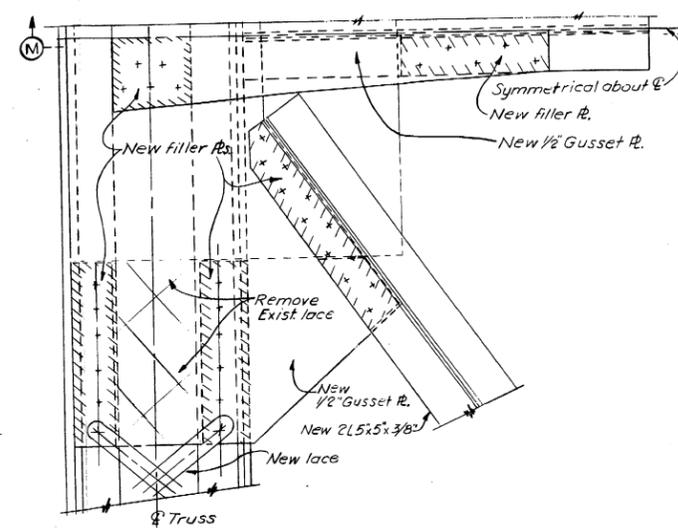
SECTION L-L
SCALE 1 1/2"=1'-0"

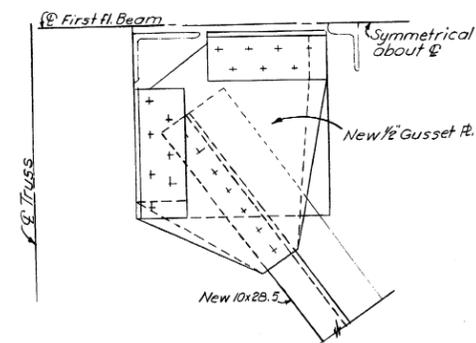
SECTION D-D
SCALE 1 1/2"=1'-0"

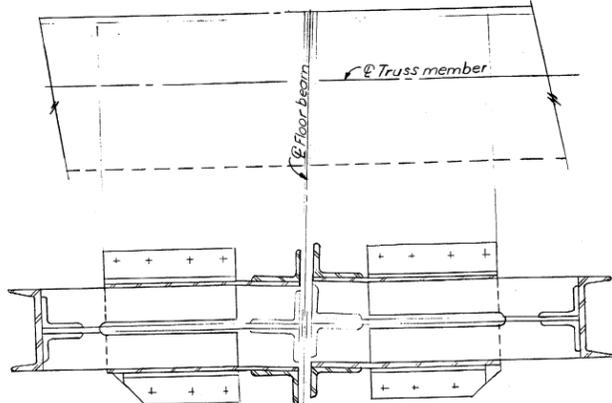
SECTION E-E
SCALE 1 1/2"=1'-0"

NOTE
Section E'-E' (opposite hand)
Section F-F (similar)

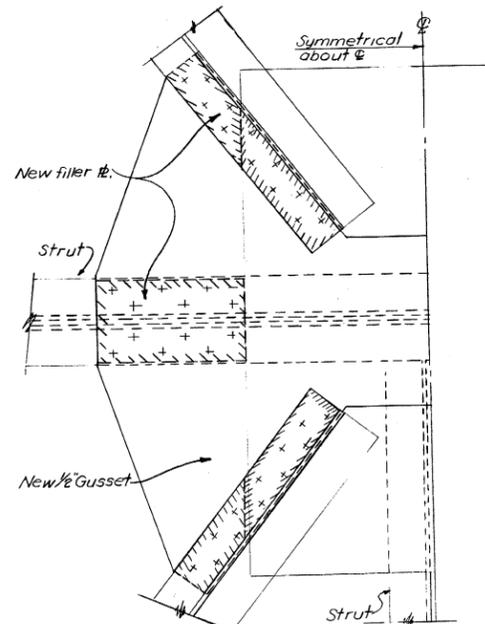
SECTION N-N
SCALE 1 1/2"=1'-0"

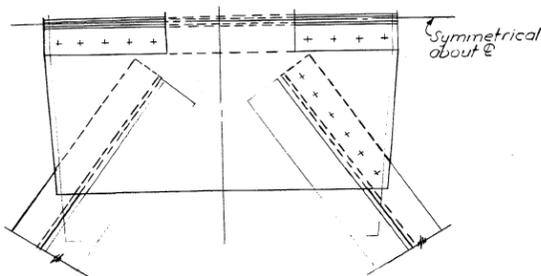
SECTION G-G
SCALE 1 1/2"=1'-0"

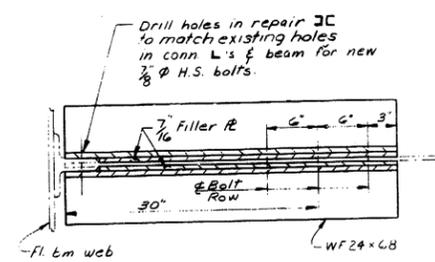
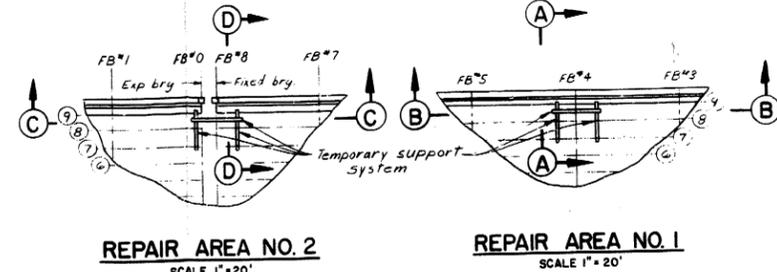
REPAIR AREA NO. 1
SCALE 1" = 20"

REPAIR AREA NO. 2
SCALE 1" = 20"

Bottom cross struts may be removed to install support system. They must be reconnected prior to using support system and after completion of work.

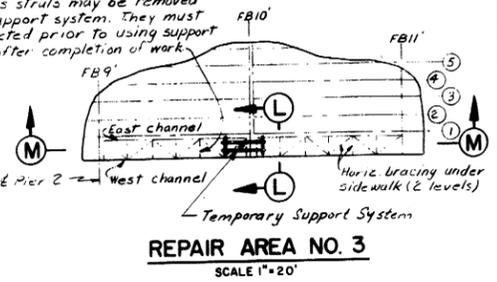
REPAIR AREA NO. 3
SCALE 1" = 20"

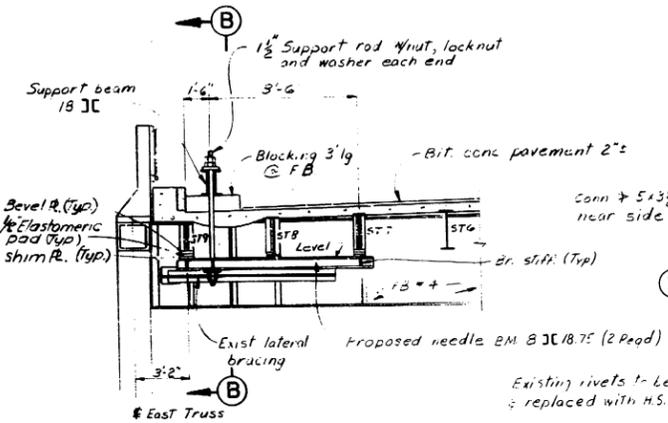
SECTION A-A (Section D-D similar)
SCALE 1/4" = 1'-0"

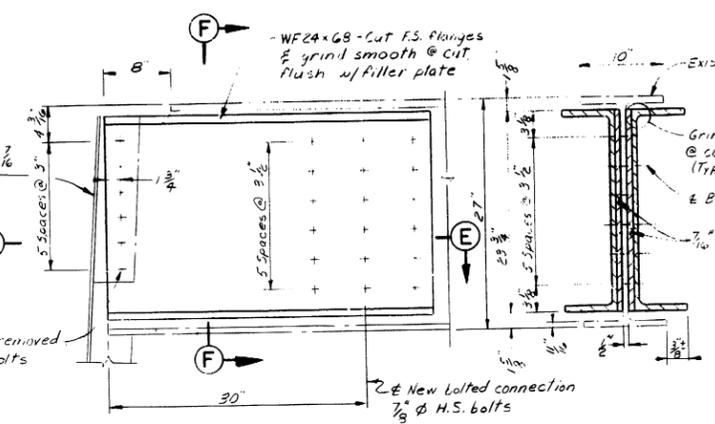
REPAIR DETAILS-AREAS 1 & 2
ELEVATION
SCALE 1 1/2" = 1'-0"

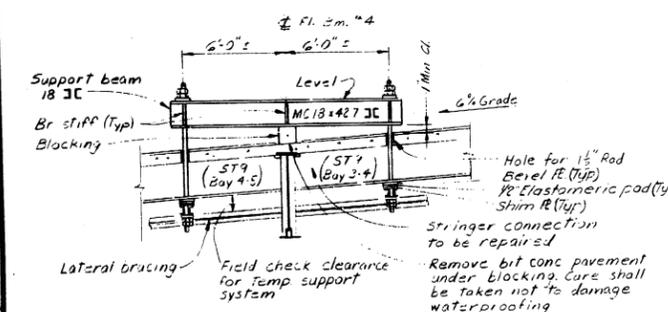
SECTION B-B
SCALE 1/4" = 1'-0"

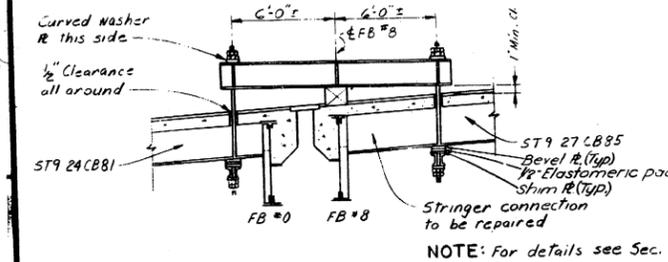
SECTION D-D
SCALE 1/4" = 1'-0"

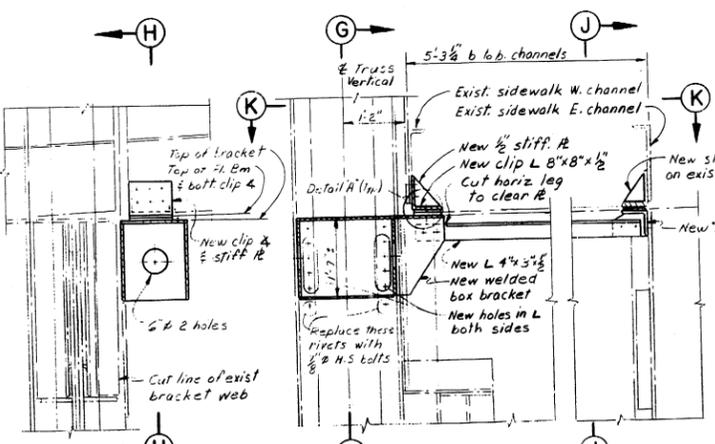
SECTION G-G
SCALE 3/4" = 1'-0"

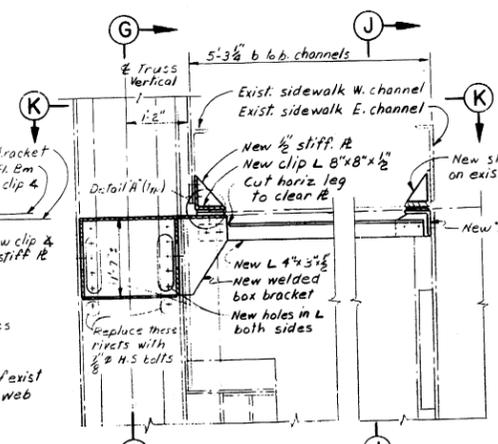
SECTION H-H
SCALE 3/4" = 1'-0"

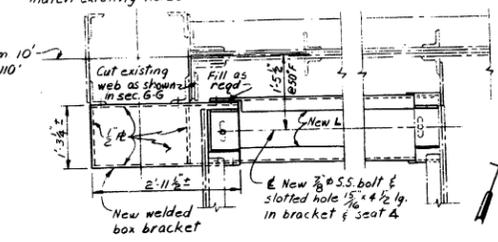
SECTION K-K
SCALE 3/4" = 1'-0"

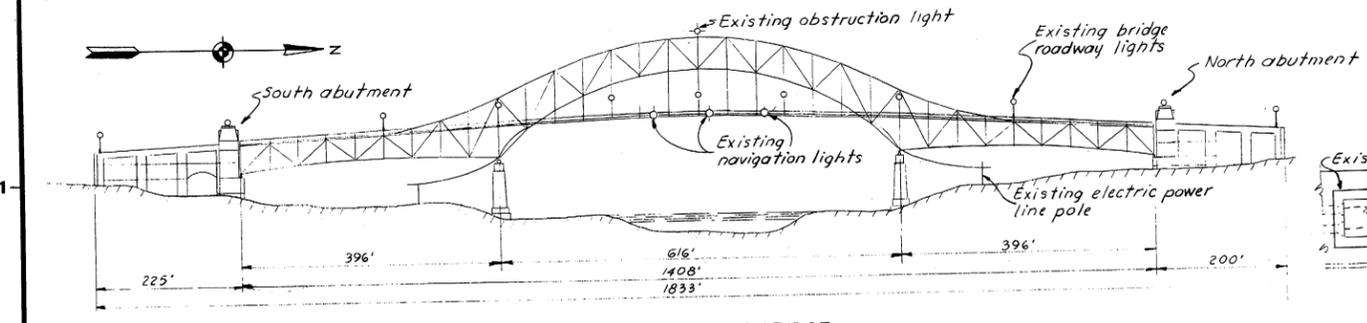
ELEVATION OF BRIDGE
SCALE 1" = 100'

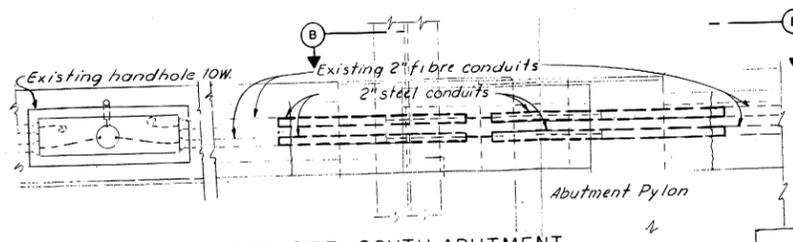
PLAN CURB SIDE - SOUTH ABUTMENT
SCALE 3/4" = 1' - 0"

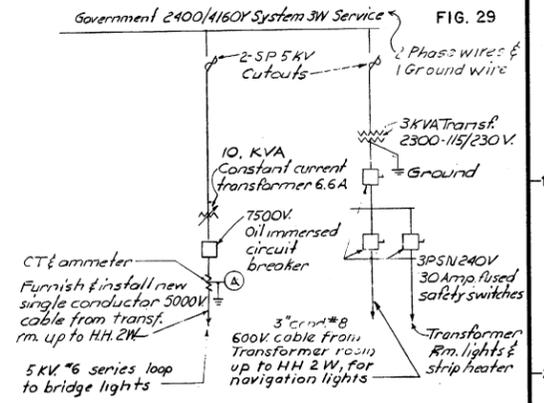
ONE LINE DIAGRAM

Note - All equipment and wiring is located in North Pylon Transformer Room and is existing except as otherwise indicated.
