Dam-Break Flood Analysis Lower Hurricane Reservoir Hartford, Vermont

January 1995

**US Army Corps
of Engineers**
New England Division

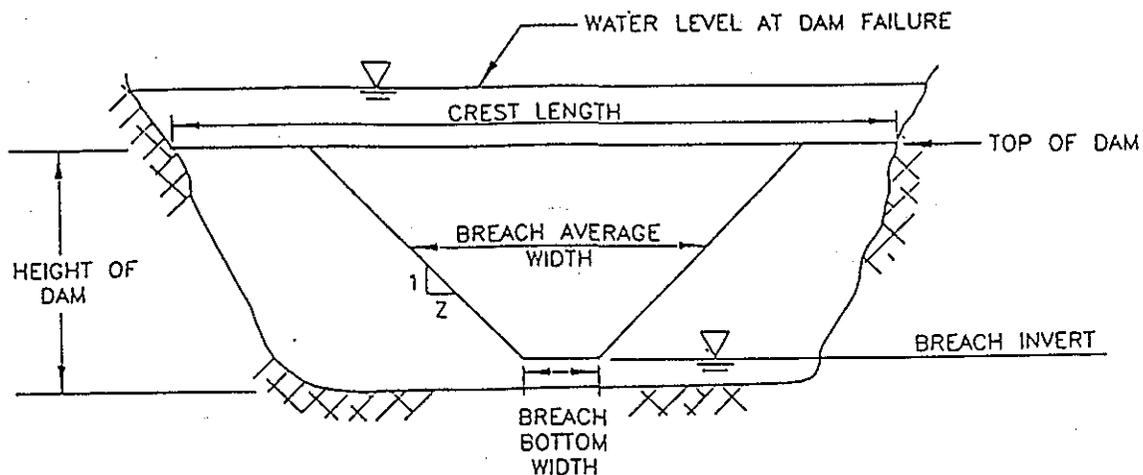
DEFINITION SKETCH OF BREACH PARAMETERS

e. Breach Discharge Hydrograph. The discharge hydrograph of a breach is a function of the inflow hydrograph and breach parameters of a hypothetical dam failure. The sketch below illustrates the various dam breach parameters for a typical earth-fill dam. Total outflow is a combination of flows through the breach and the spillway. As the breach in the dam develops, so does the breach discharge.

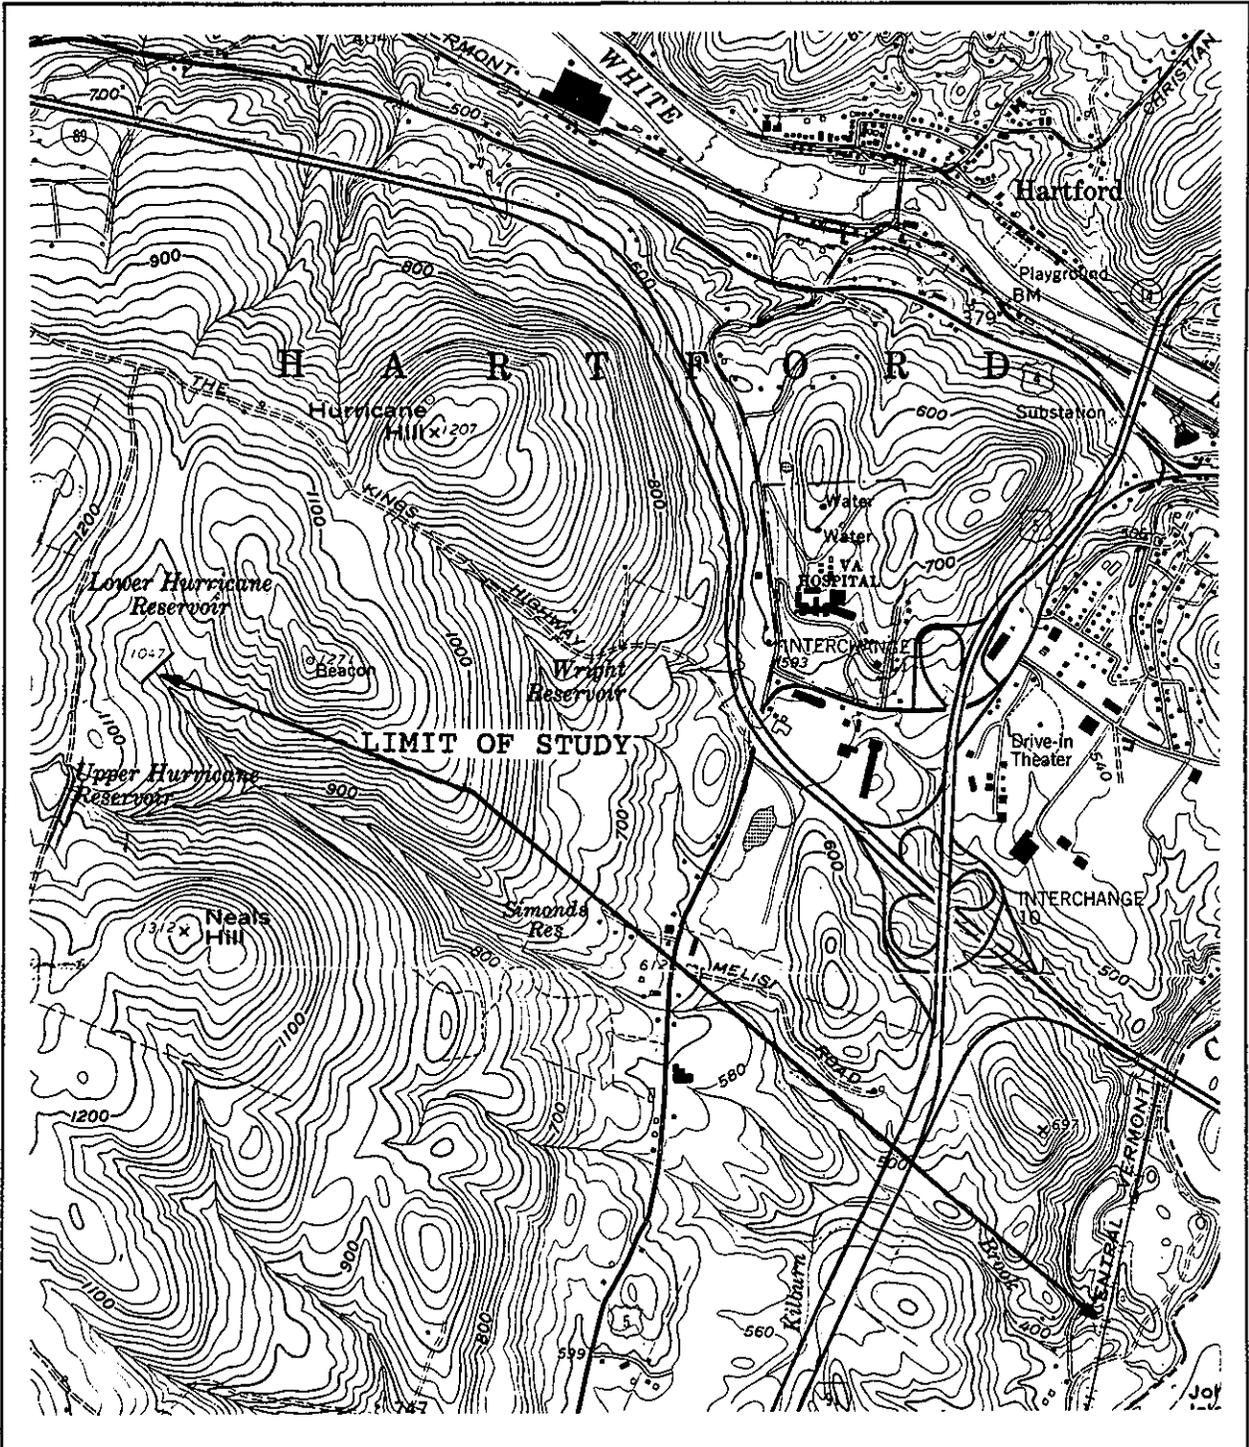
PLATE 1

STUDY AREA

a. General. Lower Hurricane Reservoir is located in the town of Hartford in eastern Vermont (see plate 1). The dam, constructed around the turn of century for water supply purposes, is an earthfill embankment approximately 530 feet long (see plate 2). The maximum height to the down-stream outlet is about 35 feet and the crest width averages about 6 feet. The principal spillway is an earth cut in the right embankment with about an 8-foot top width and a 4-foot bottom width. The spillway channel flows through a swale near the toe of the dike and into the outlet channel. The dam crest averages about elevation 1048.5 feet National Geodetic Vertical Datum (NGVD) and spillway crest is at 1047 feet NGVD. At spillway crest elevation, the normal pool area is about 5 acres.

within the town of Hartford (shown on plate 1). The area is primarily wooded with some open areas and the flood plain is generally very narrow. The downstream limit of the study is the confluence of Kilburn Brook and the Connecticut River, about 2.6 miles below the dam. Analysis of downstream conditions are based on a survey of brook cross sections conducted in May 1994 and a reconnaissance visit performed in August 1994.

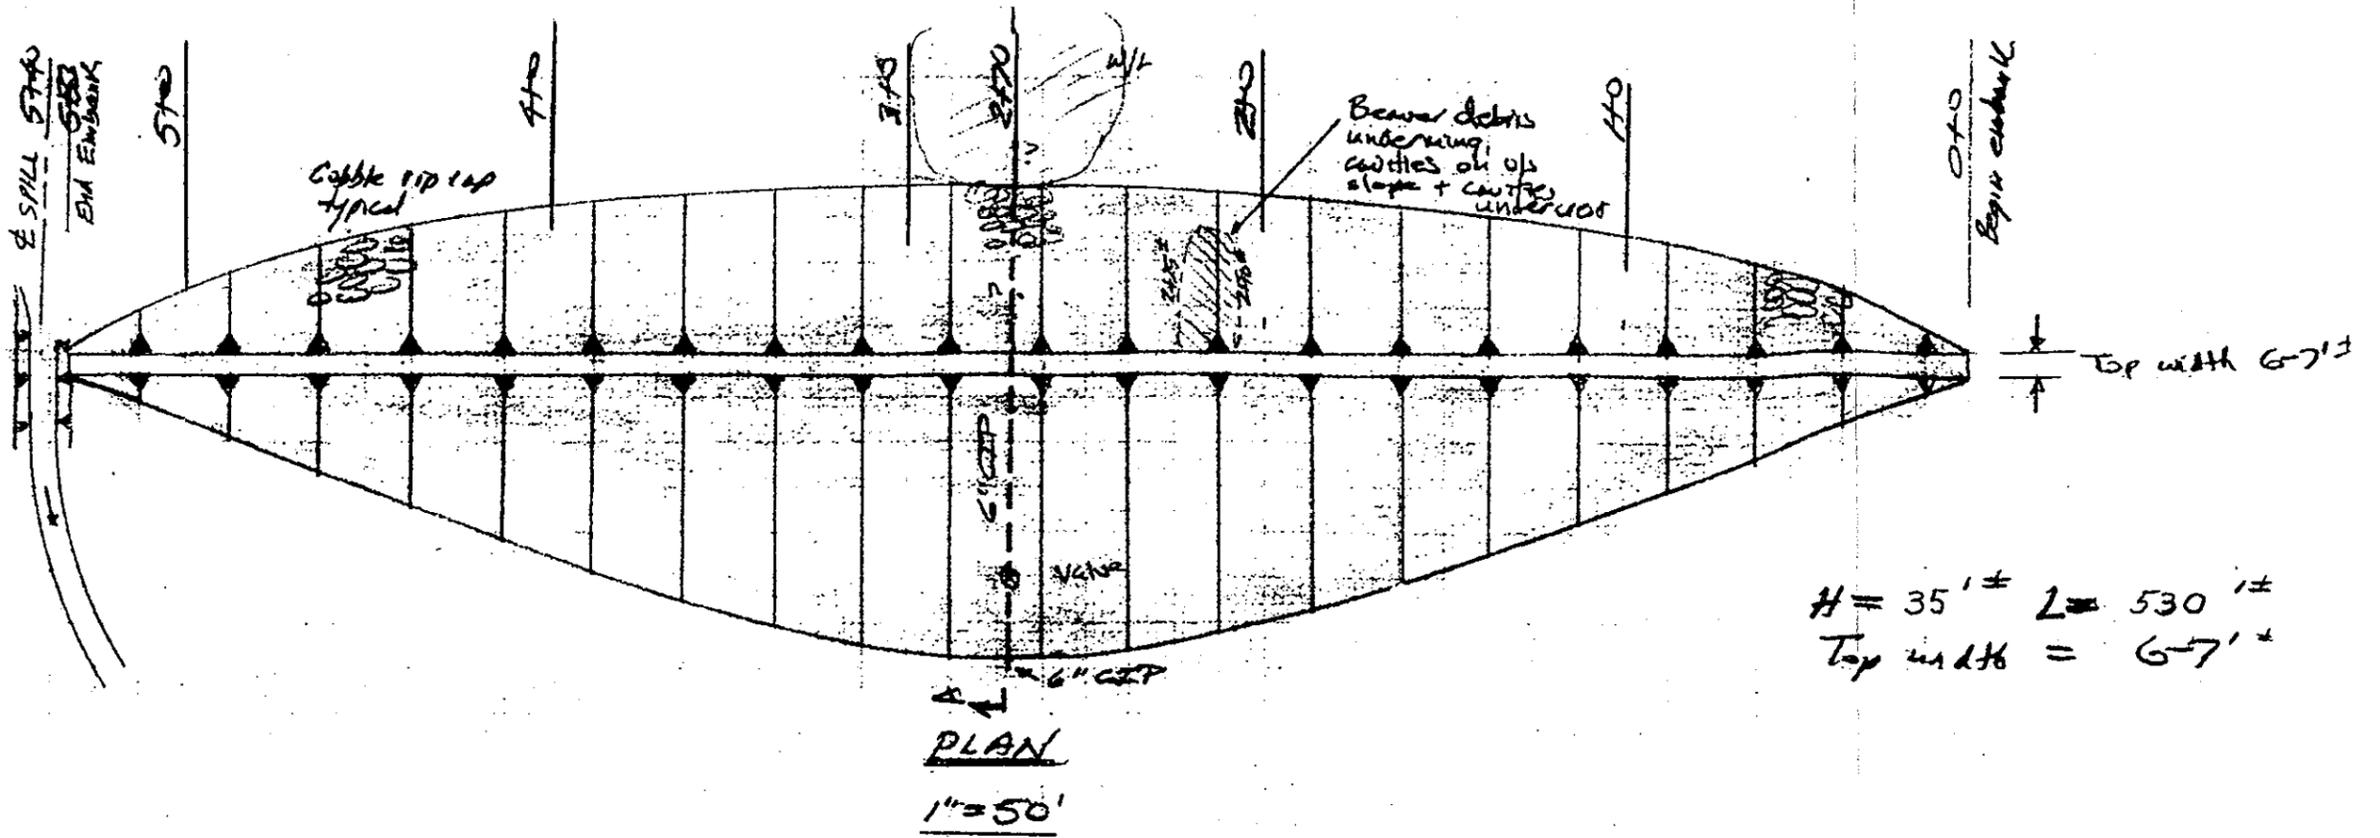
LOWER HURRICANE RES. DAM

H = 35' ± L = 530' ±
Top width = 6-7' ±

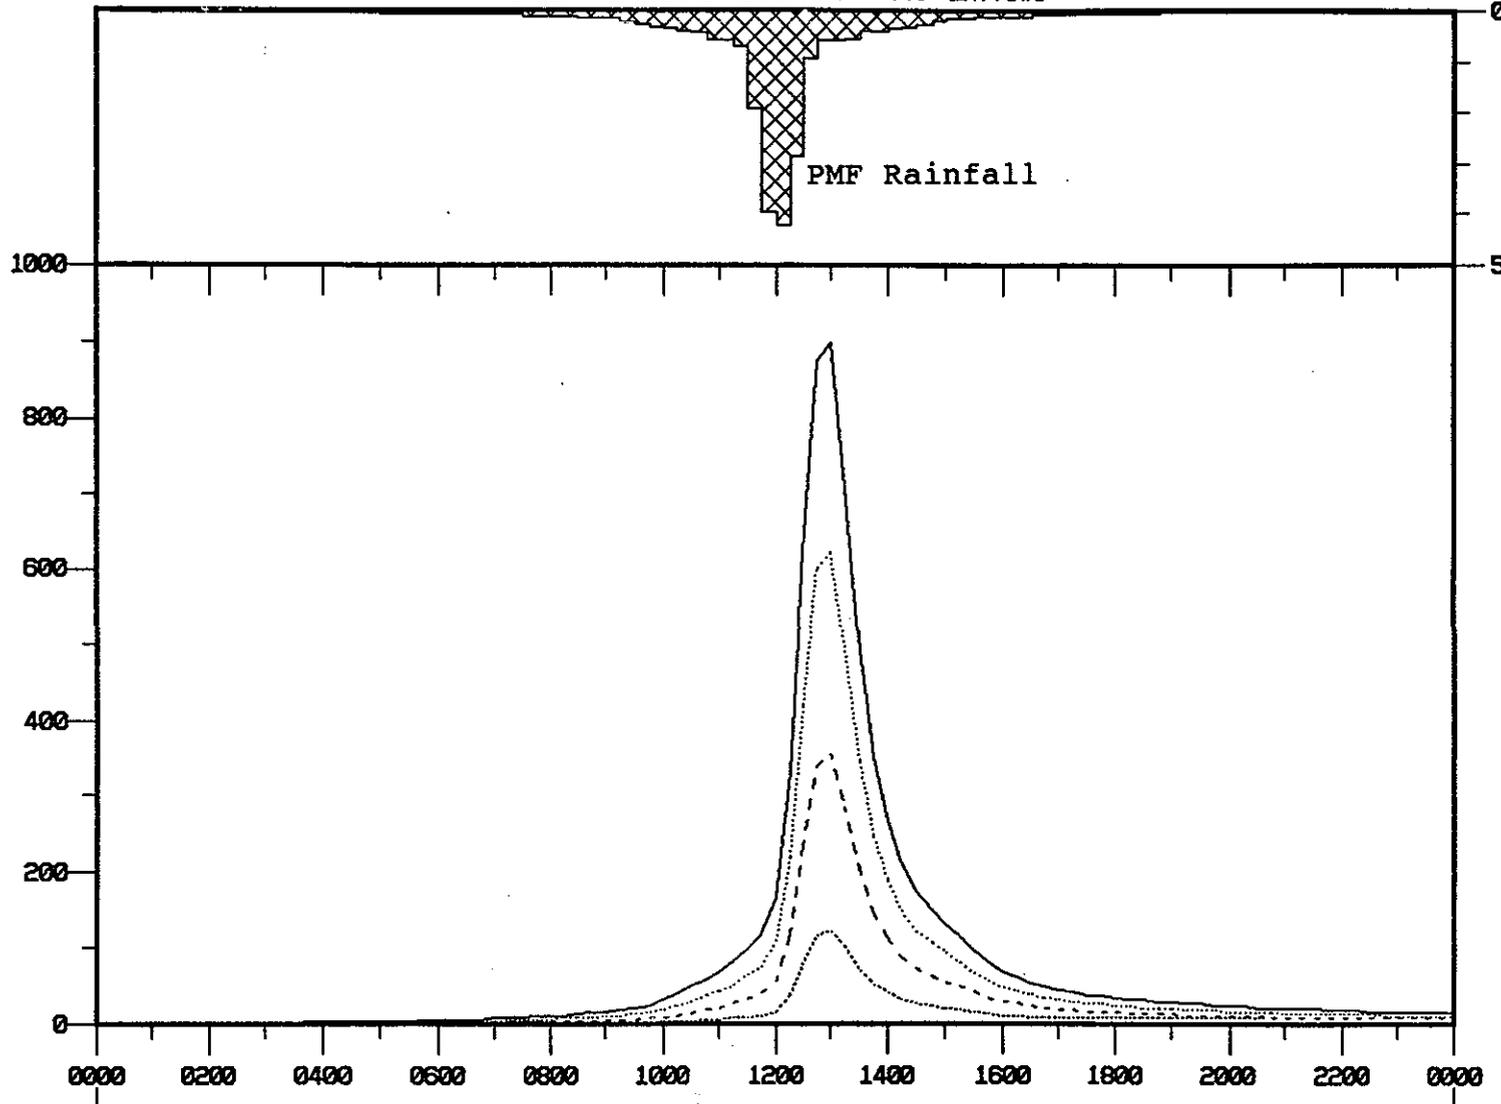
PLATE 4

Lower Hurricane Reservoir - PMF Inflows

- 1/4 PMF
- - - - - 1/2 PMF
- . - . - 3/4 PMF
- Full PMF

a. Inflow Hydrograph. As presented in table 1, the peak inflow resulting from a 100-year storm event was 68 cfs and a 1/4 PMF resulted in a peak inflow of 125 cfs. Plate 3 shows that the 100-year storm inflow hydrograph peaks at 14 hours into a 24-hour storm. Plate 4 shows that the 1/4 PMF peaks at 13.25 hours into a 24-hour storm. These hydrographs were developed using the HEC-1 computer program.

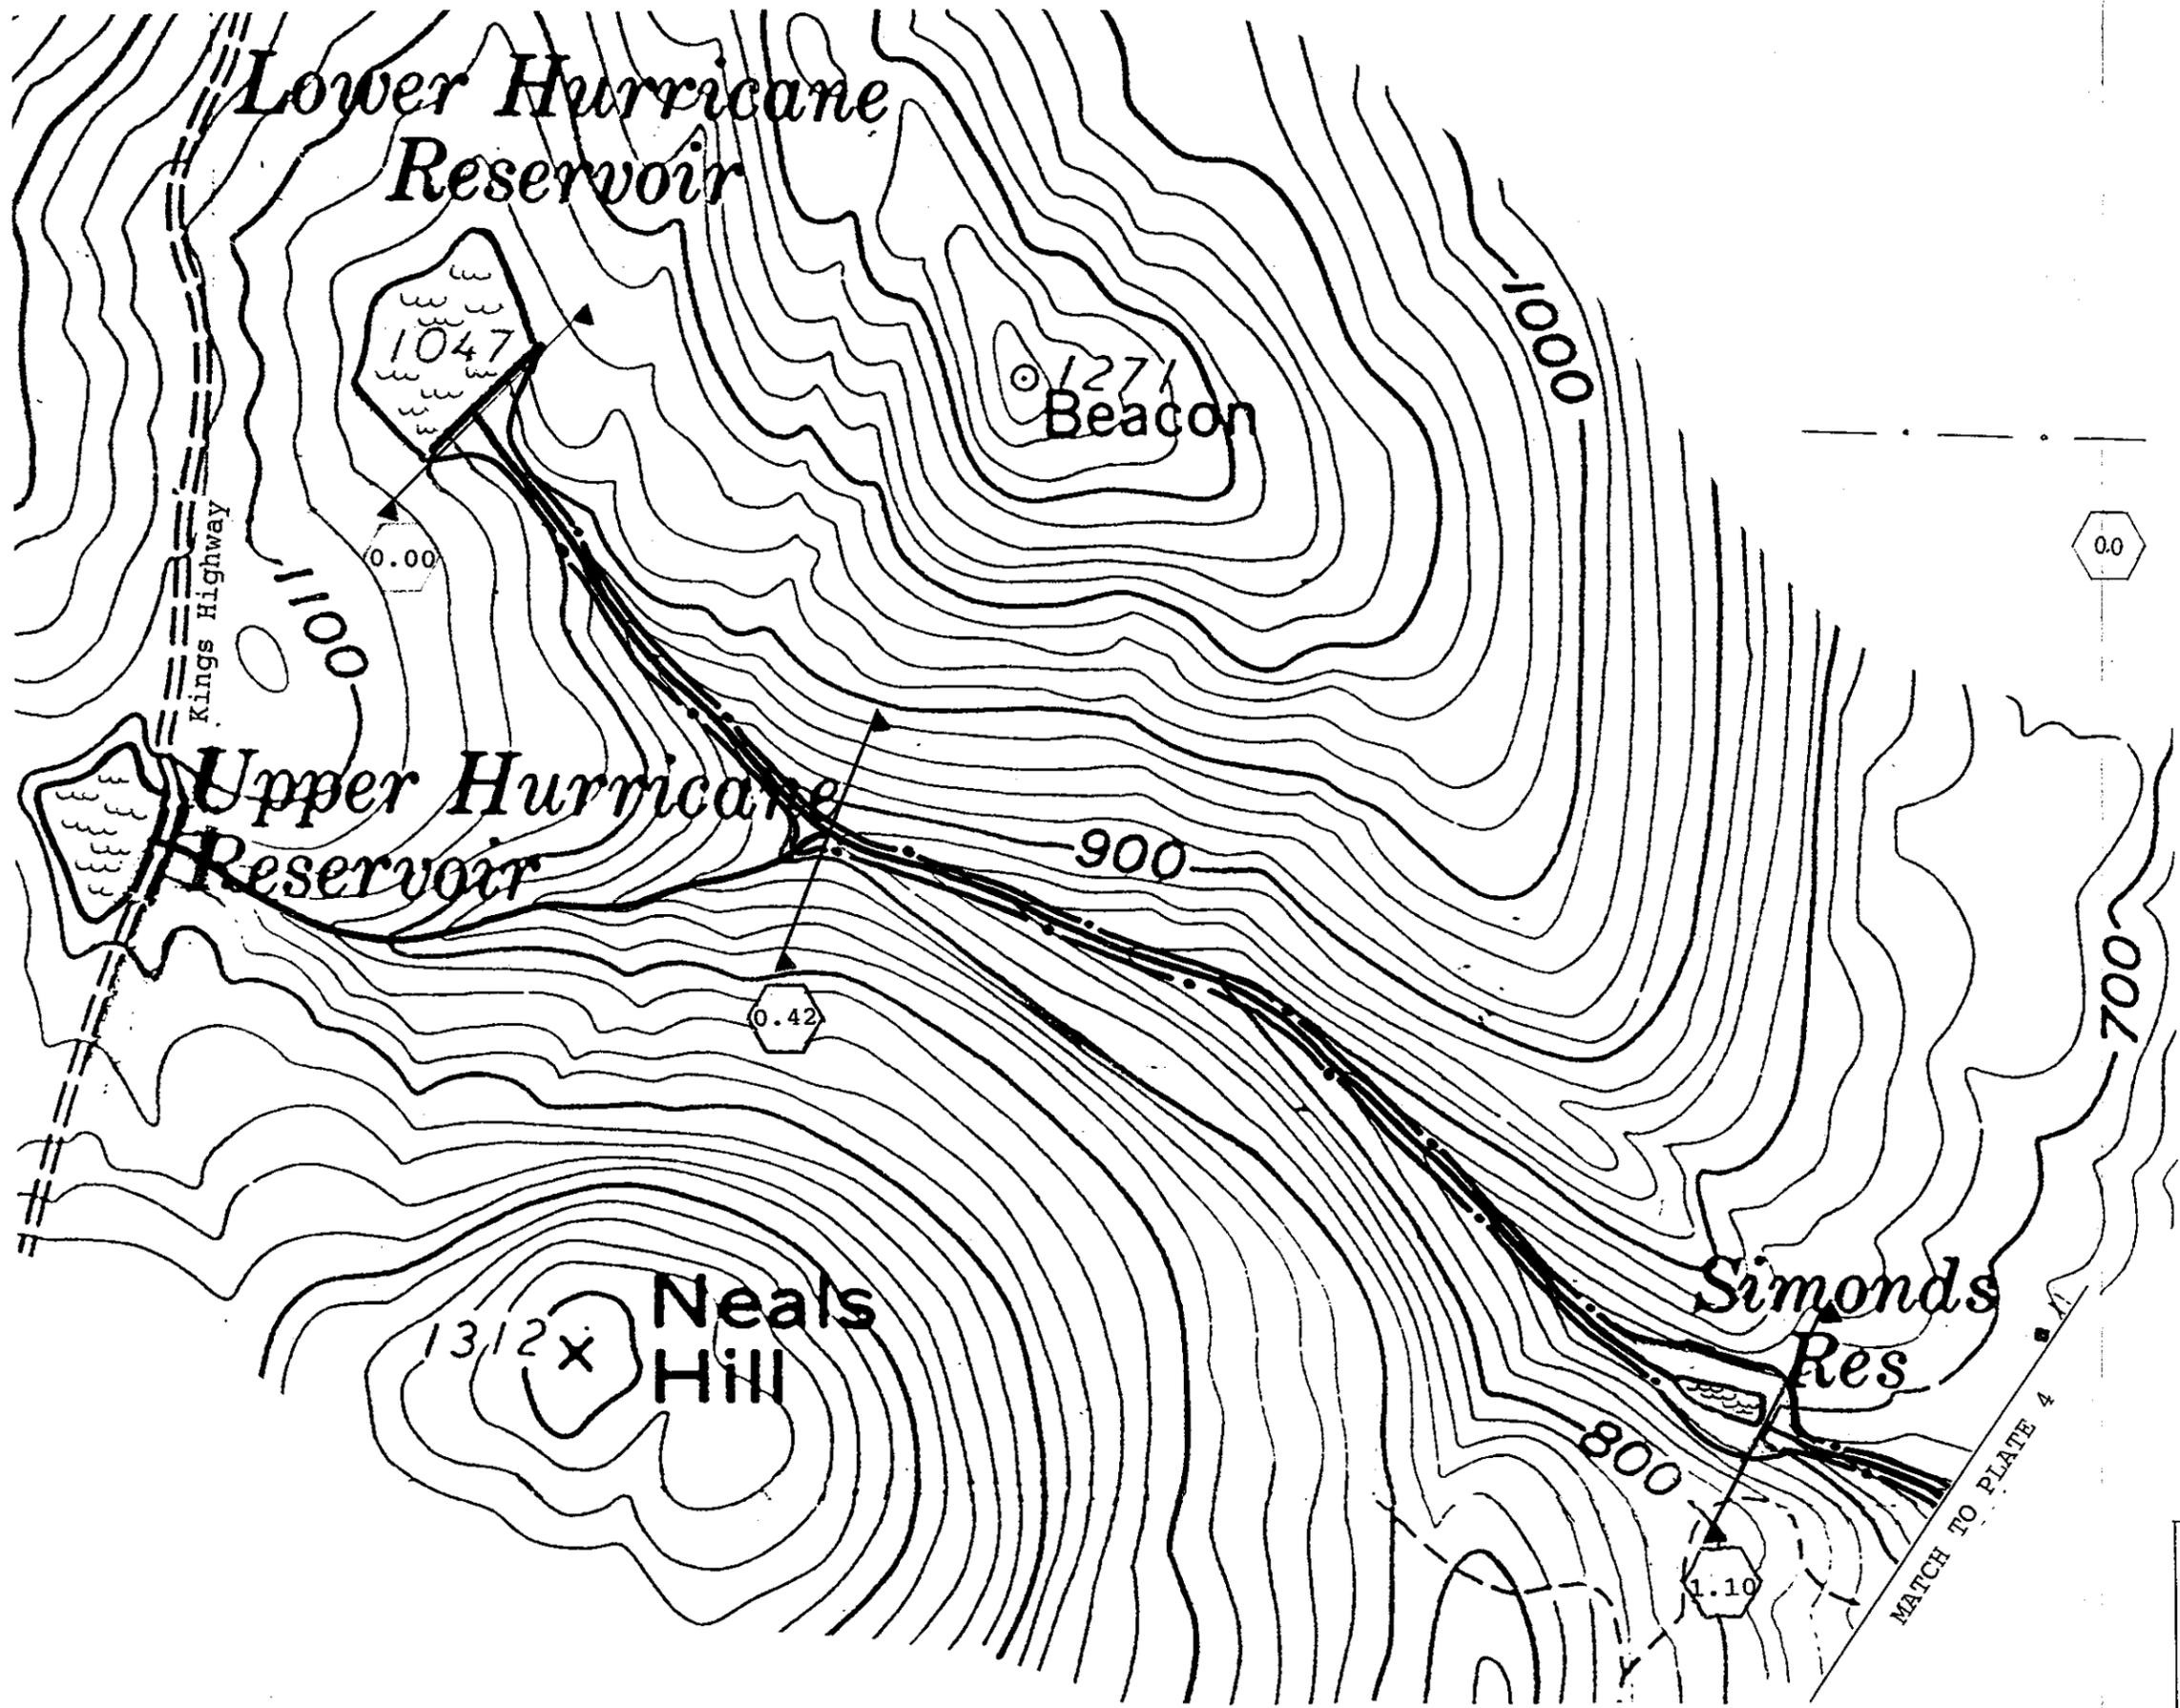
PLATE 5

Limits of Inundation

Distance below Dam in Miles

The base map used is based on a 20-foot contour interval 1:24,000 scale USGS quadrangle, and therefore, inundation limits shown on plates 5 and 6 are only approximate. Although any structures shown within these limits were assumed to be inundated, certain structures may be excluded as a result of local conditions and elevations.

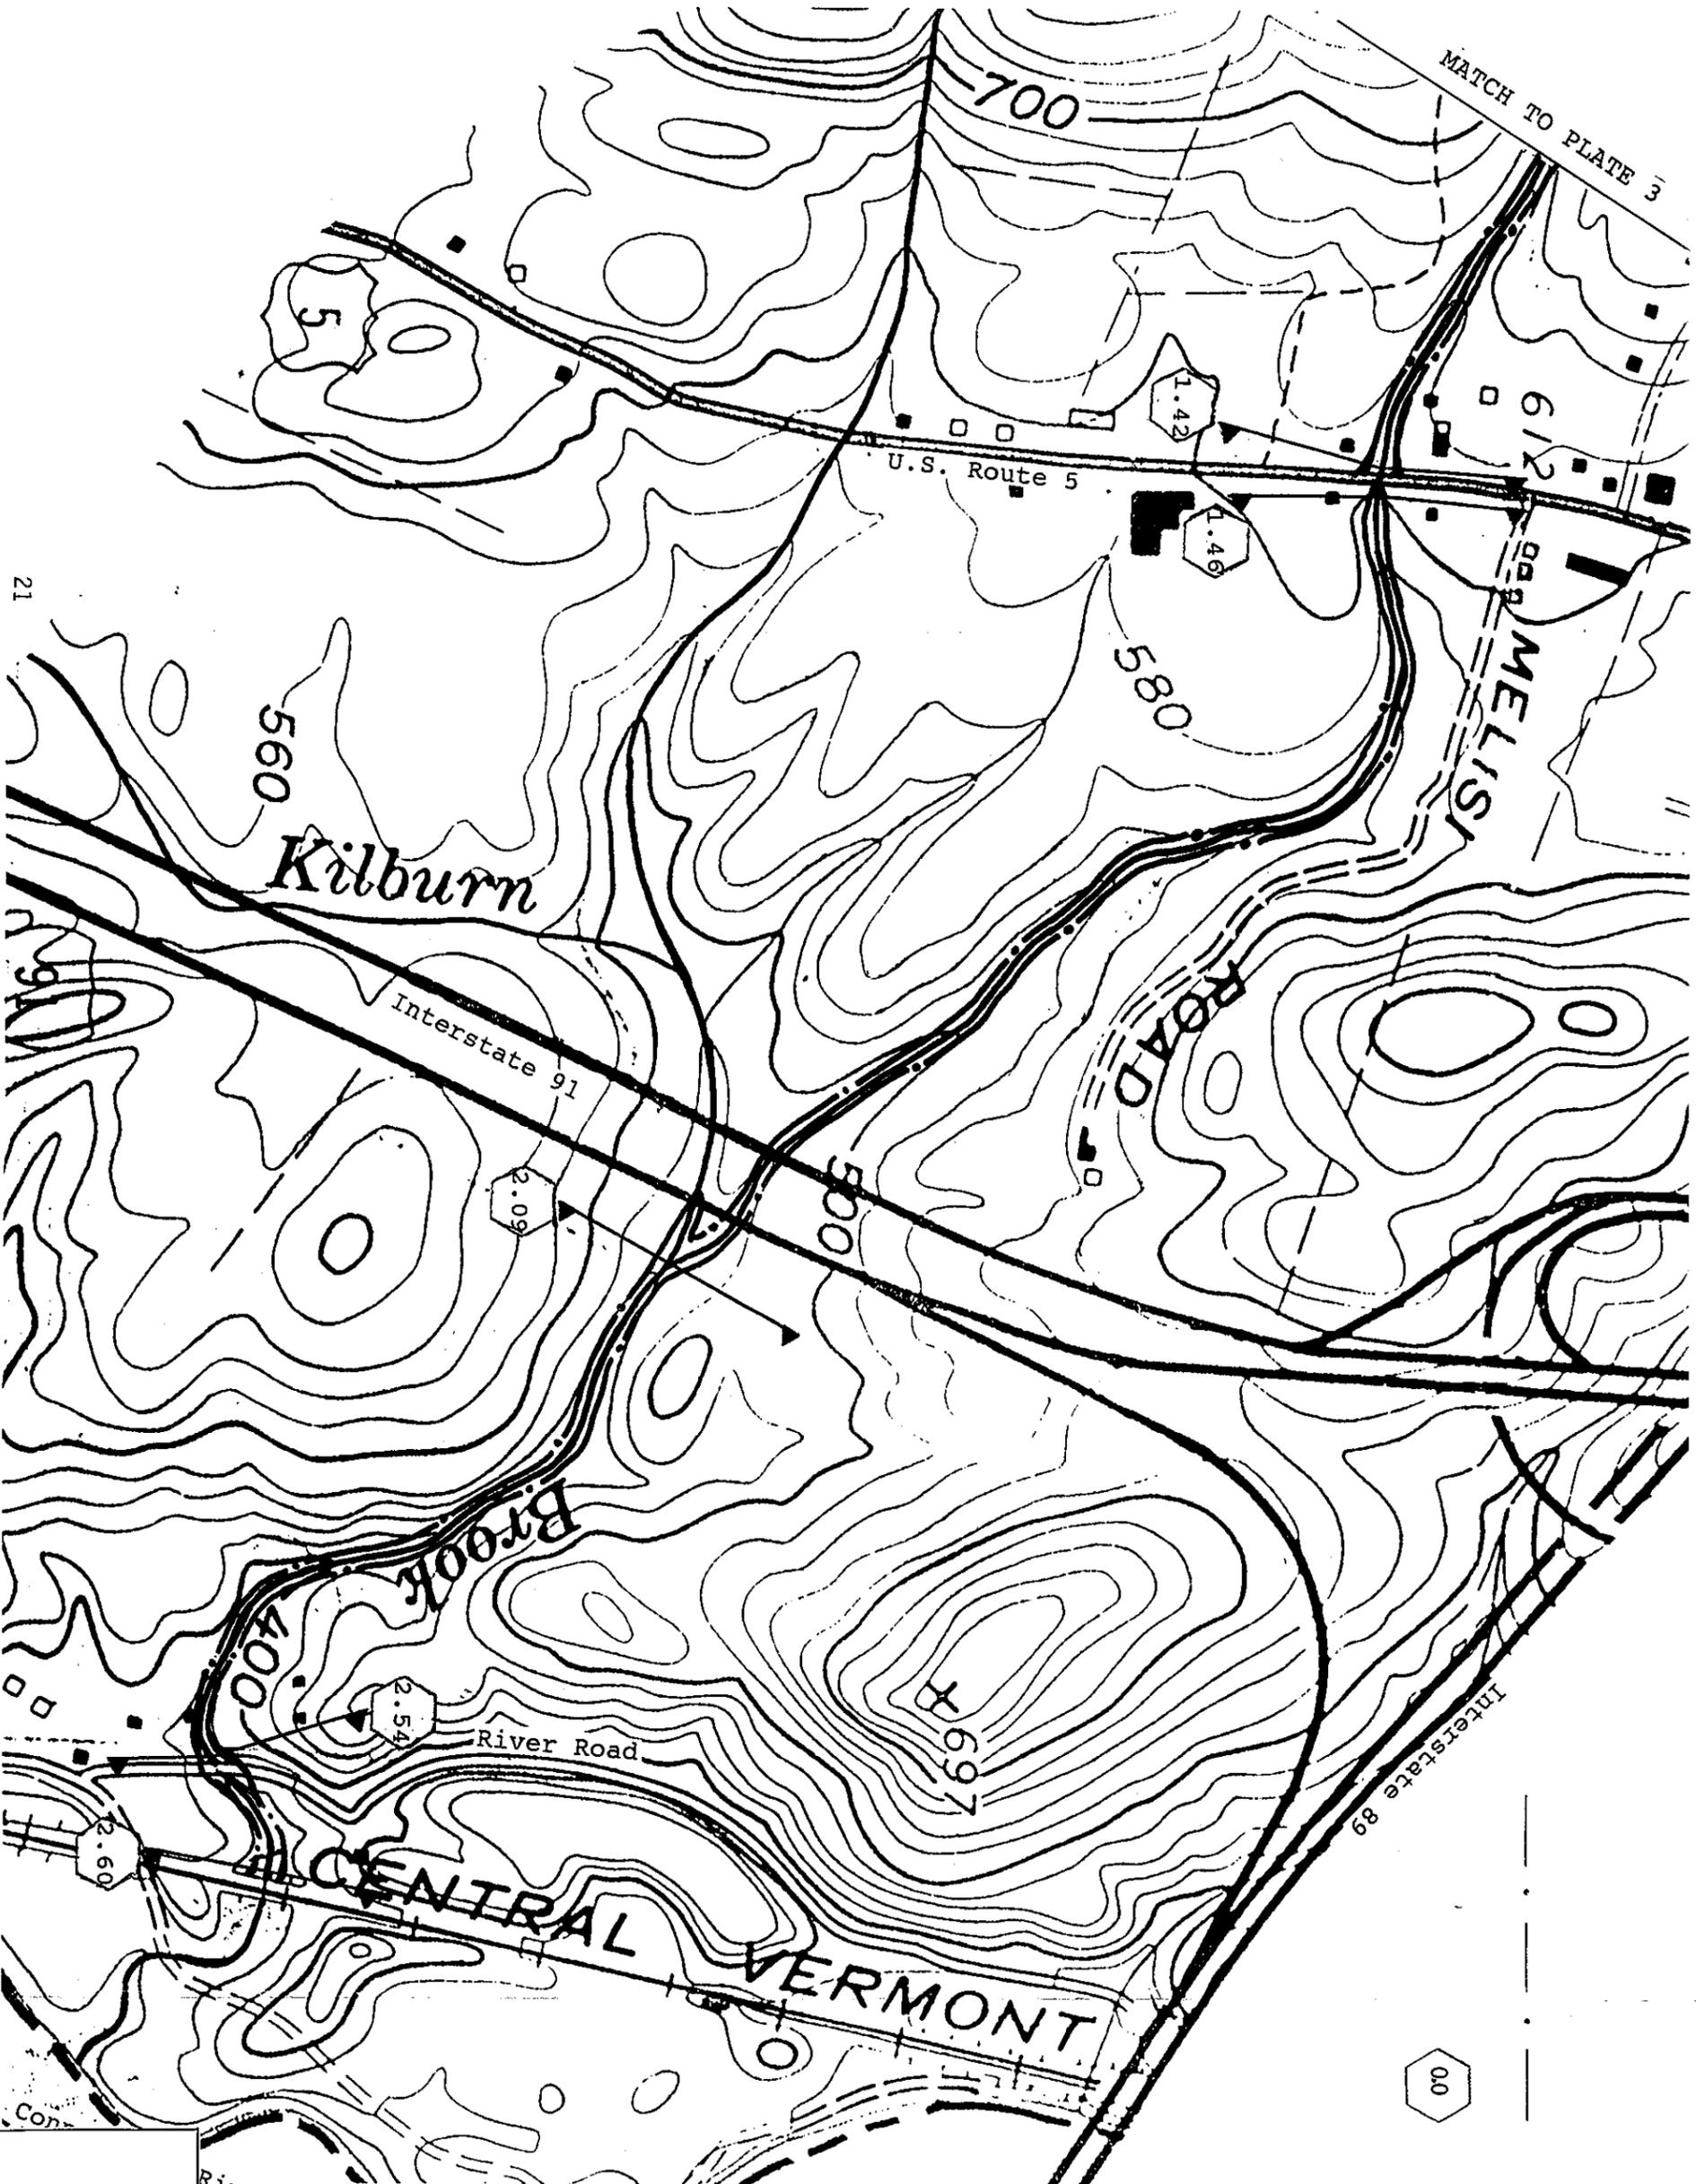
Limits of Inundation
Distance below
Dam in Miles

INUNDATION MAP

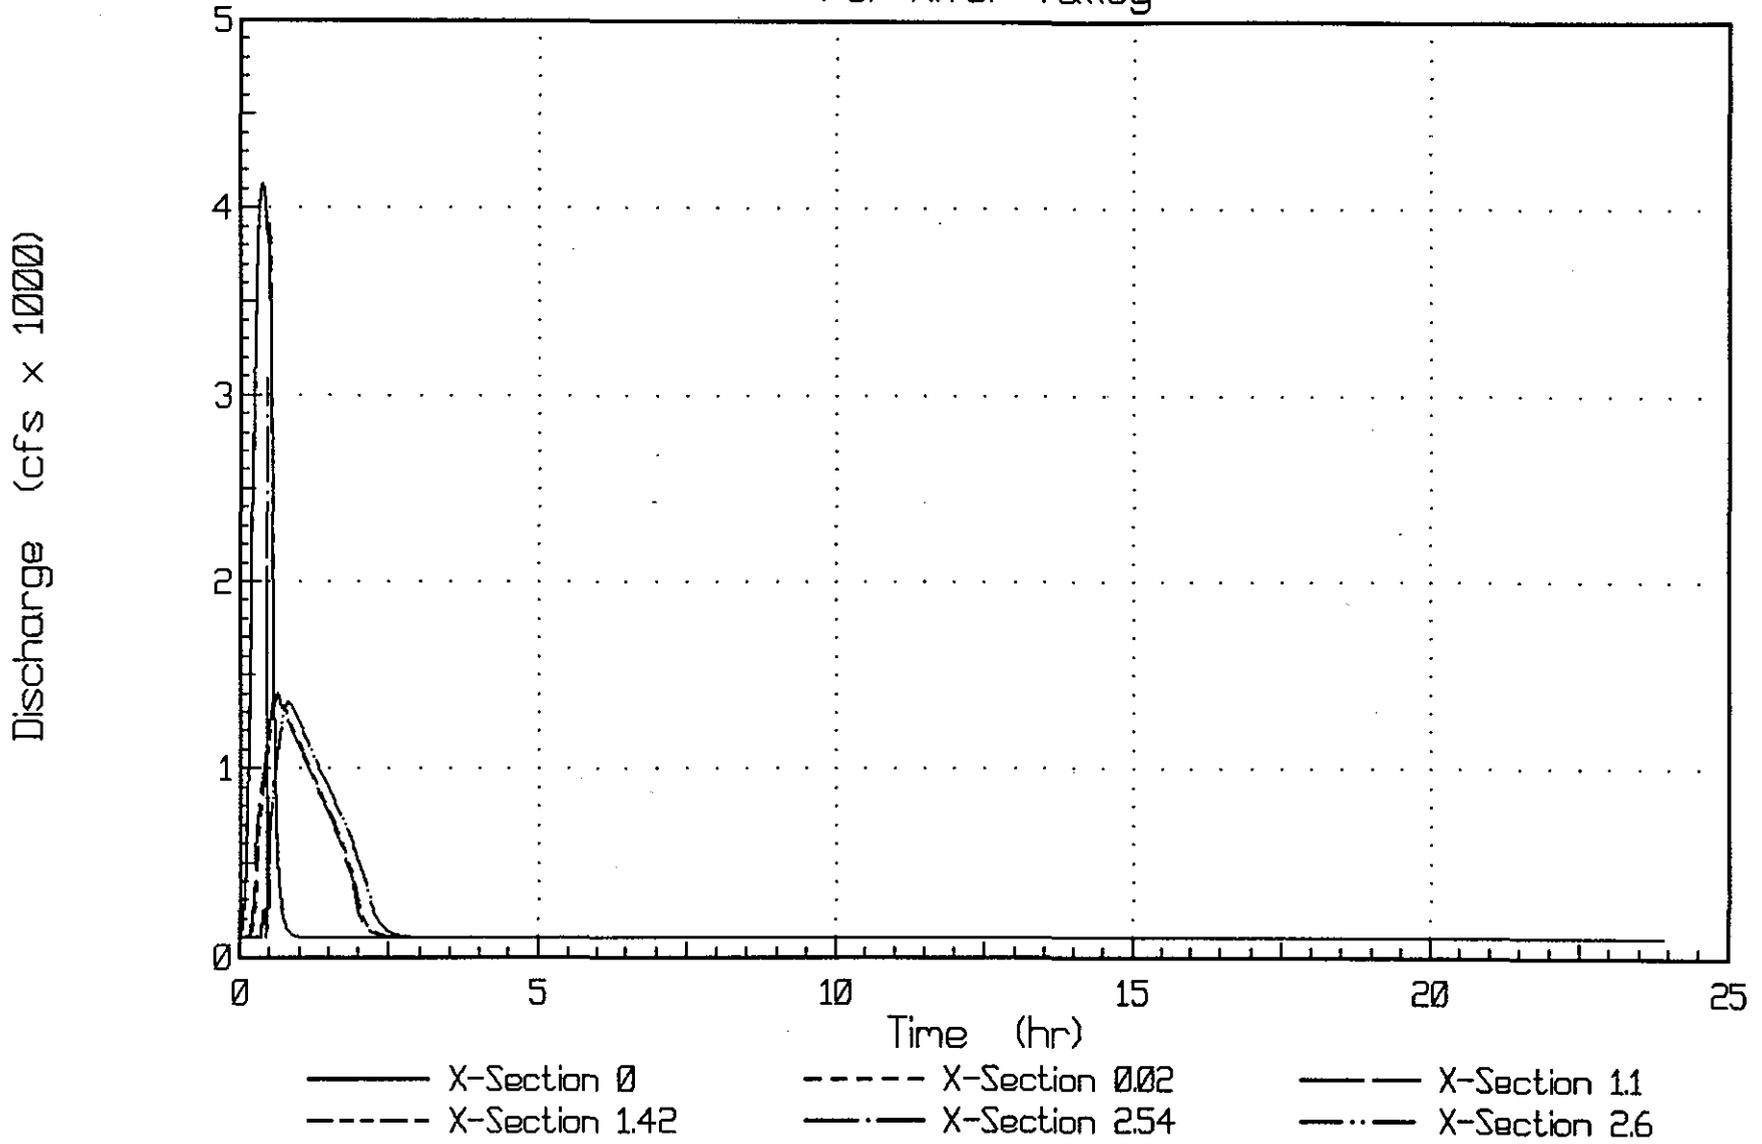
SUNNY-DAY FAILURE

Combined Discharge Hydrographs
For River Valley

Sunny-day failure of Lower Hurricane Reservoir resulted in a peak breach discharge of approximately 4,170 cfs. The water surface was at elevation 1047 feet NGVD when failure began, and the breach was modelled to develop fully within 30 minutes. Plates 10 and 11 show the sunny-day breach discharge over time and distance downstream.

Storm-day failure results in a peak breach discharge of 4,370 cfs with the 1/4 PMF as the inflow. Failure begins once the water reaches the top of dam elevation 1048.3 feet NGVD, and the breach is assumed to develop fully within 30 minutes. Plates 12 and 13 show the storm-day breach discharge over distance and time. Plates 10 through 13 are graphical outputs from the Boss DAMBRK computer model.

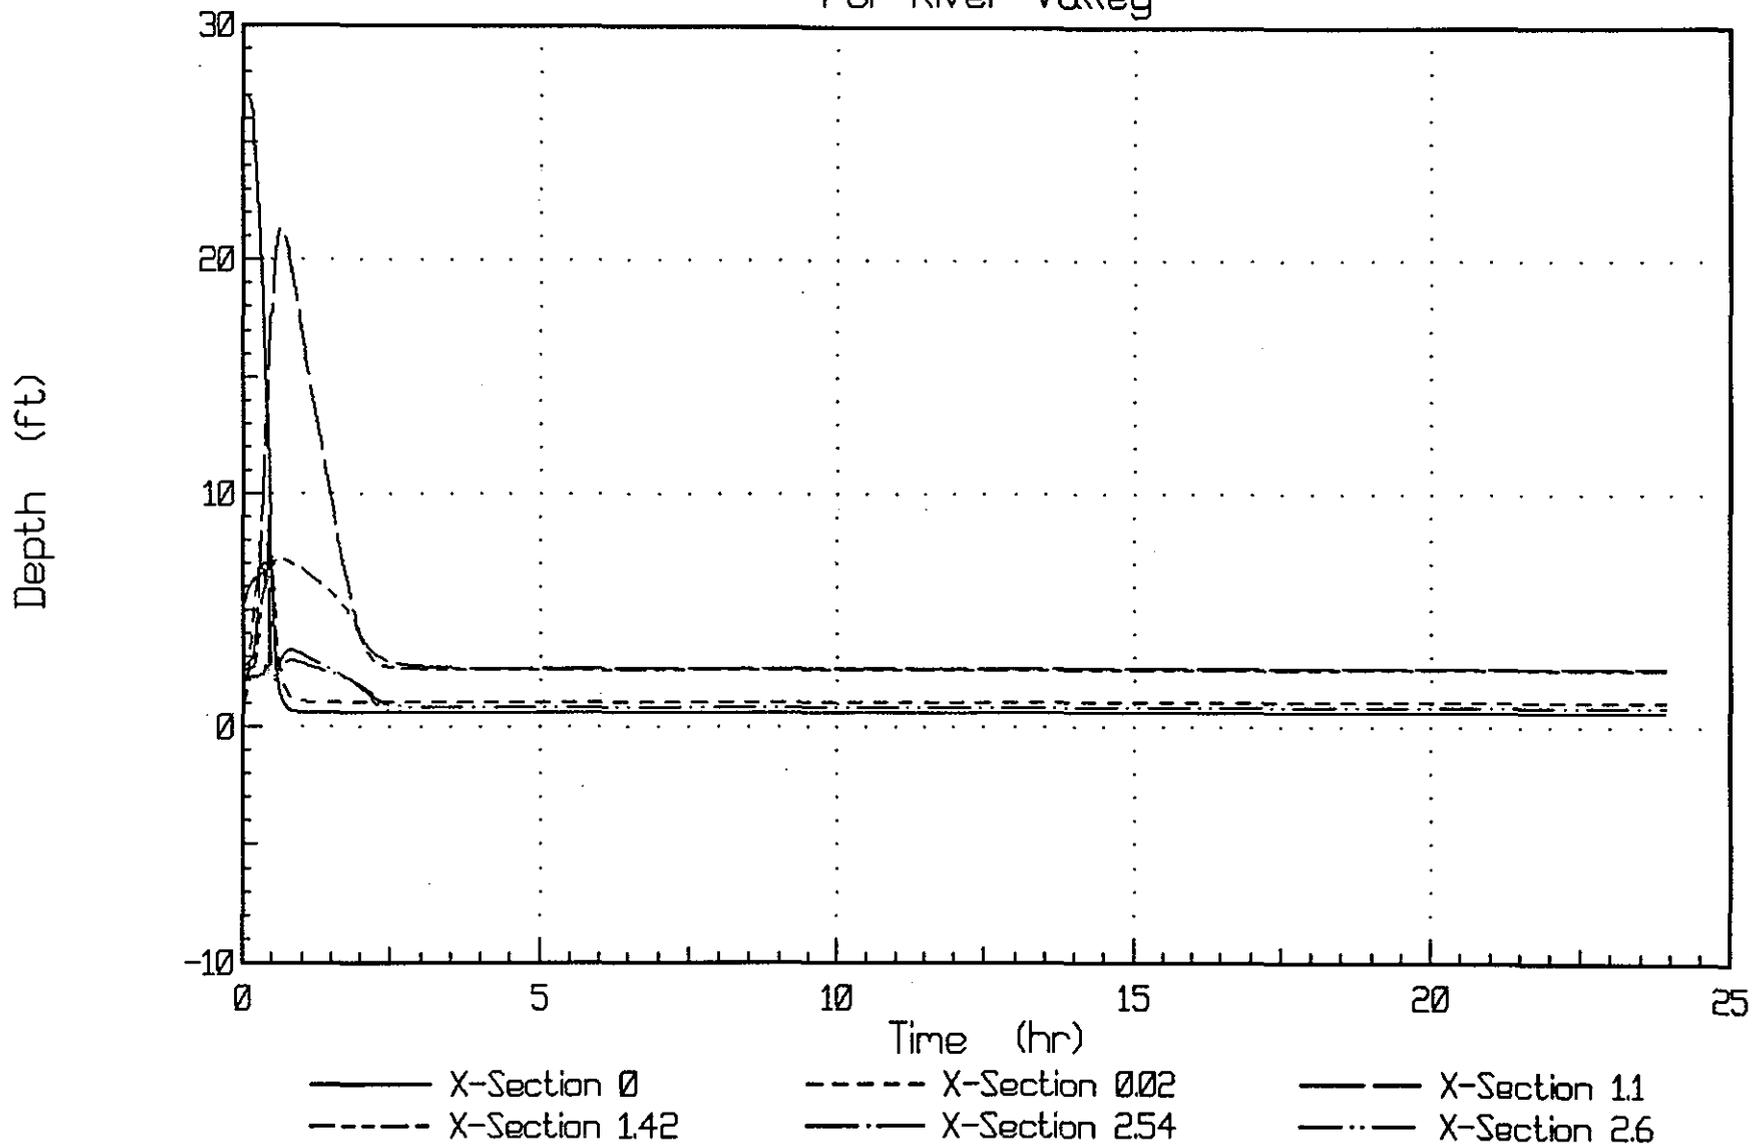
SUNNY-DAY FAILURE

Combined Flow Depth Hydrographs
For River Valley

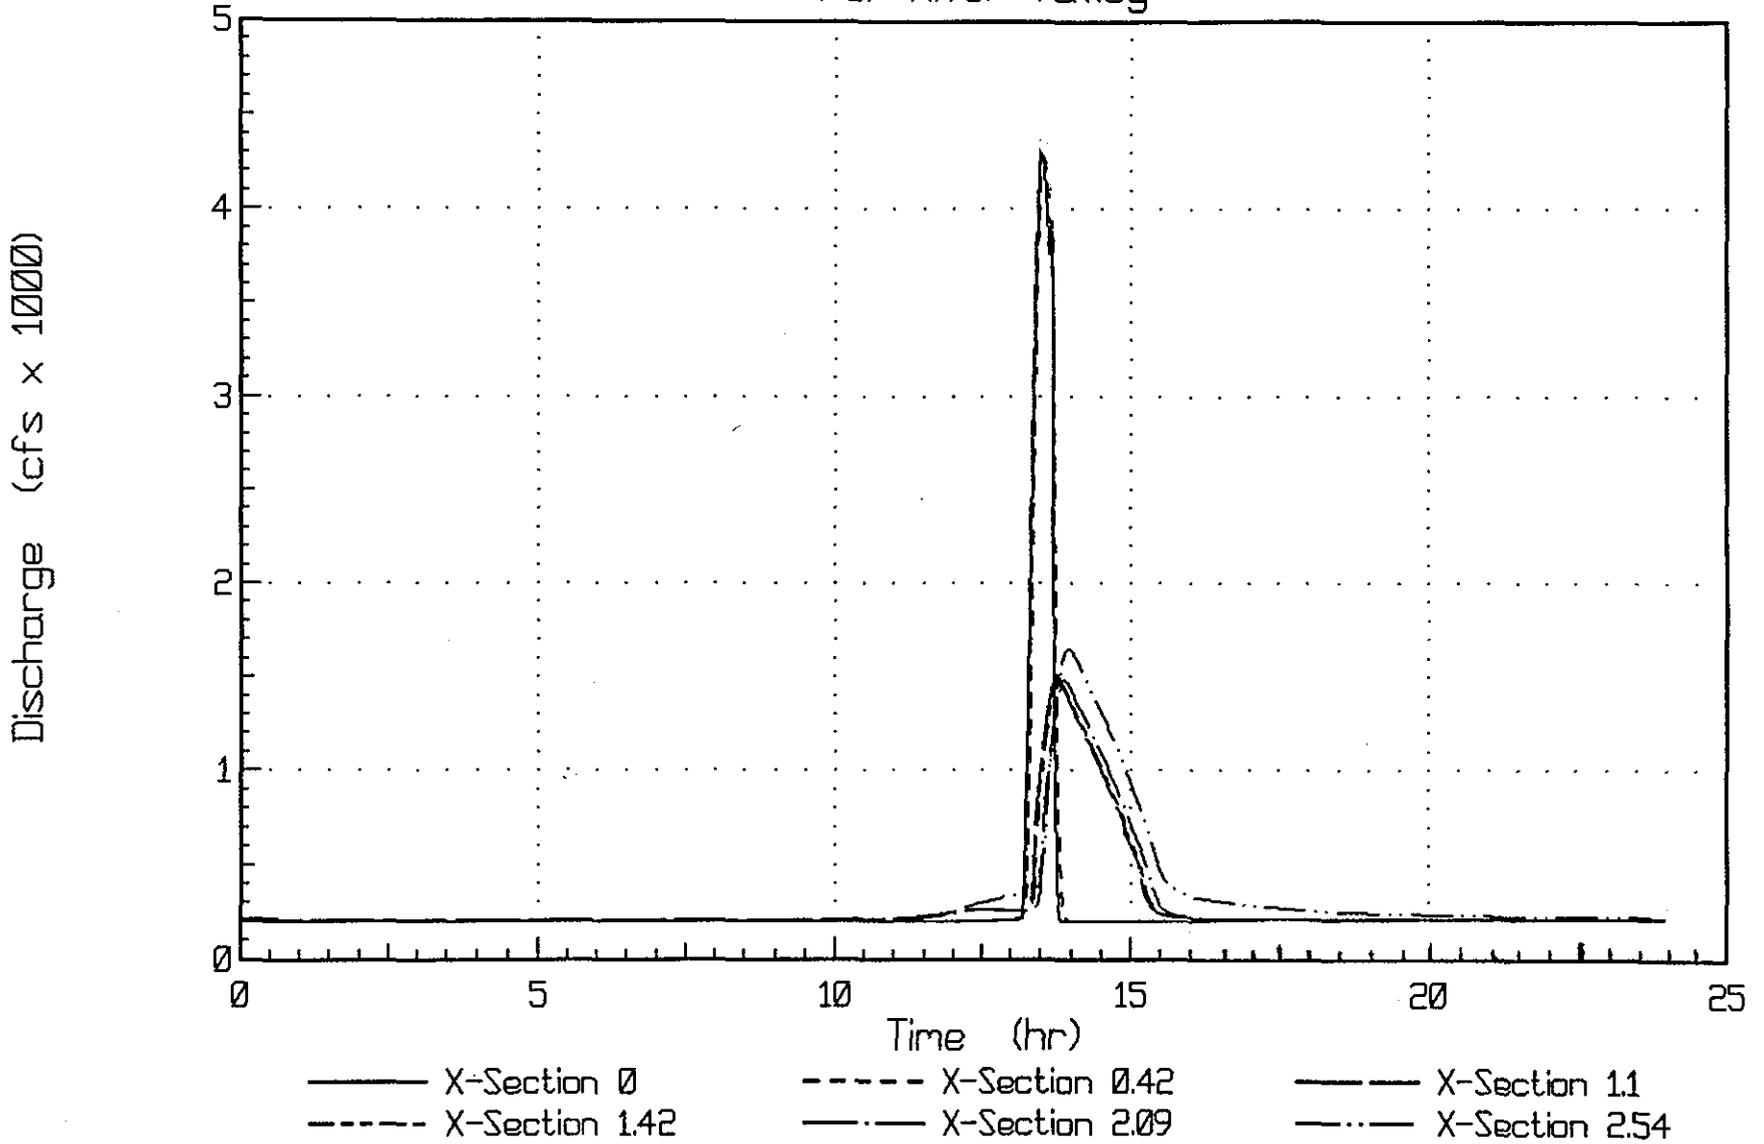
STORM-DAY FAILURE

Combined Discharge Hydrographs
For River Valley

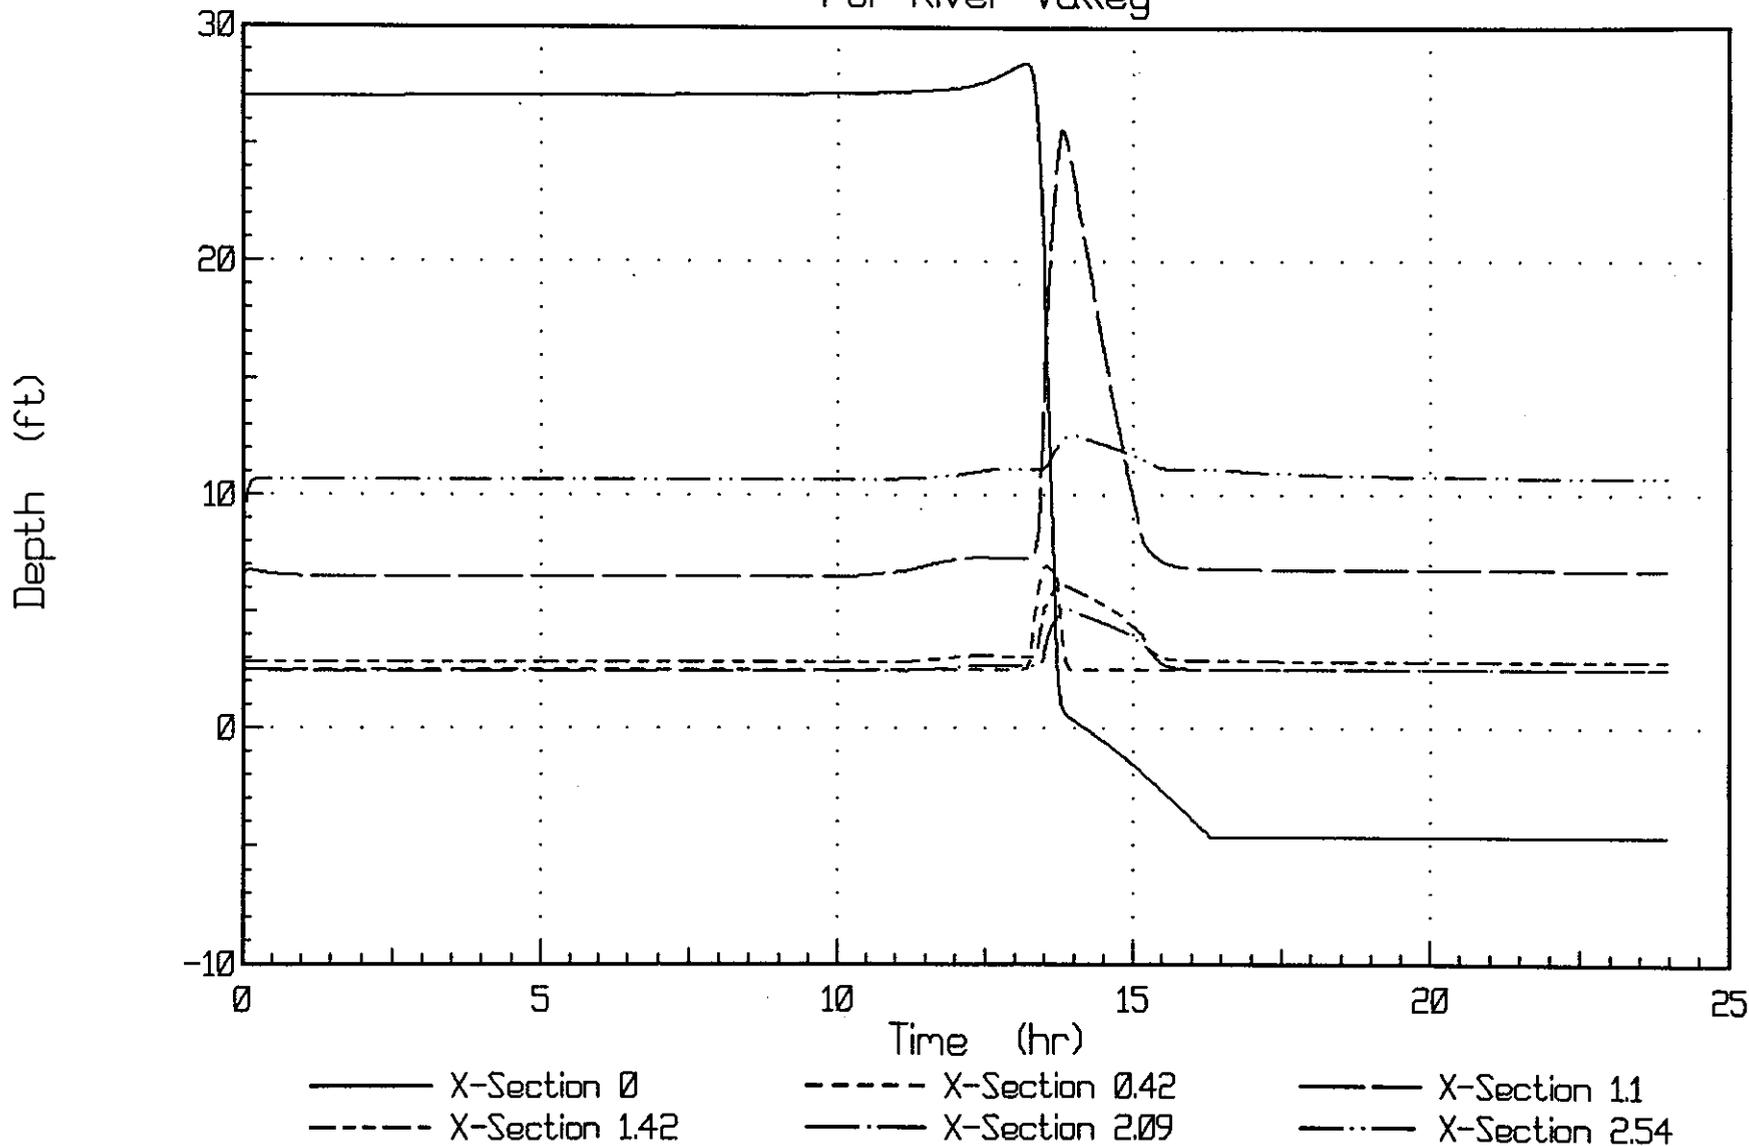
STORM-DAY FAILURE

Combined Flow Depth Hydrographs
For River Valley
