FLOOD EMERGENCY PLAN

Hancock Brook Lake

FLOOD EMERGENCY PLAN
FOR
HANCOCK BROOK LAKE

KASPER ASSOCIATES
Engineers • Surveyors • Planners

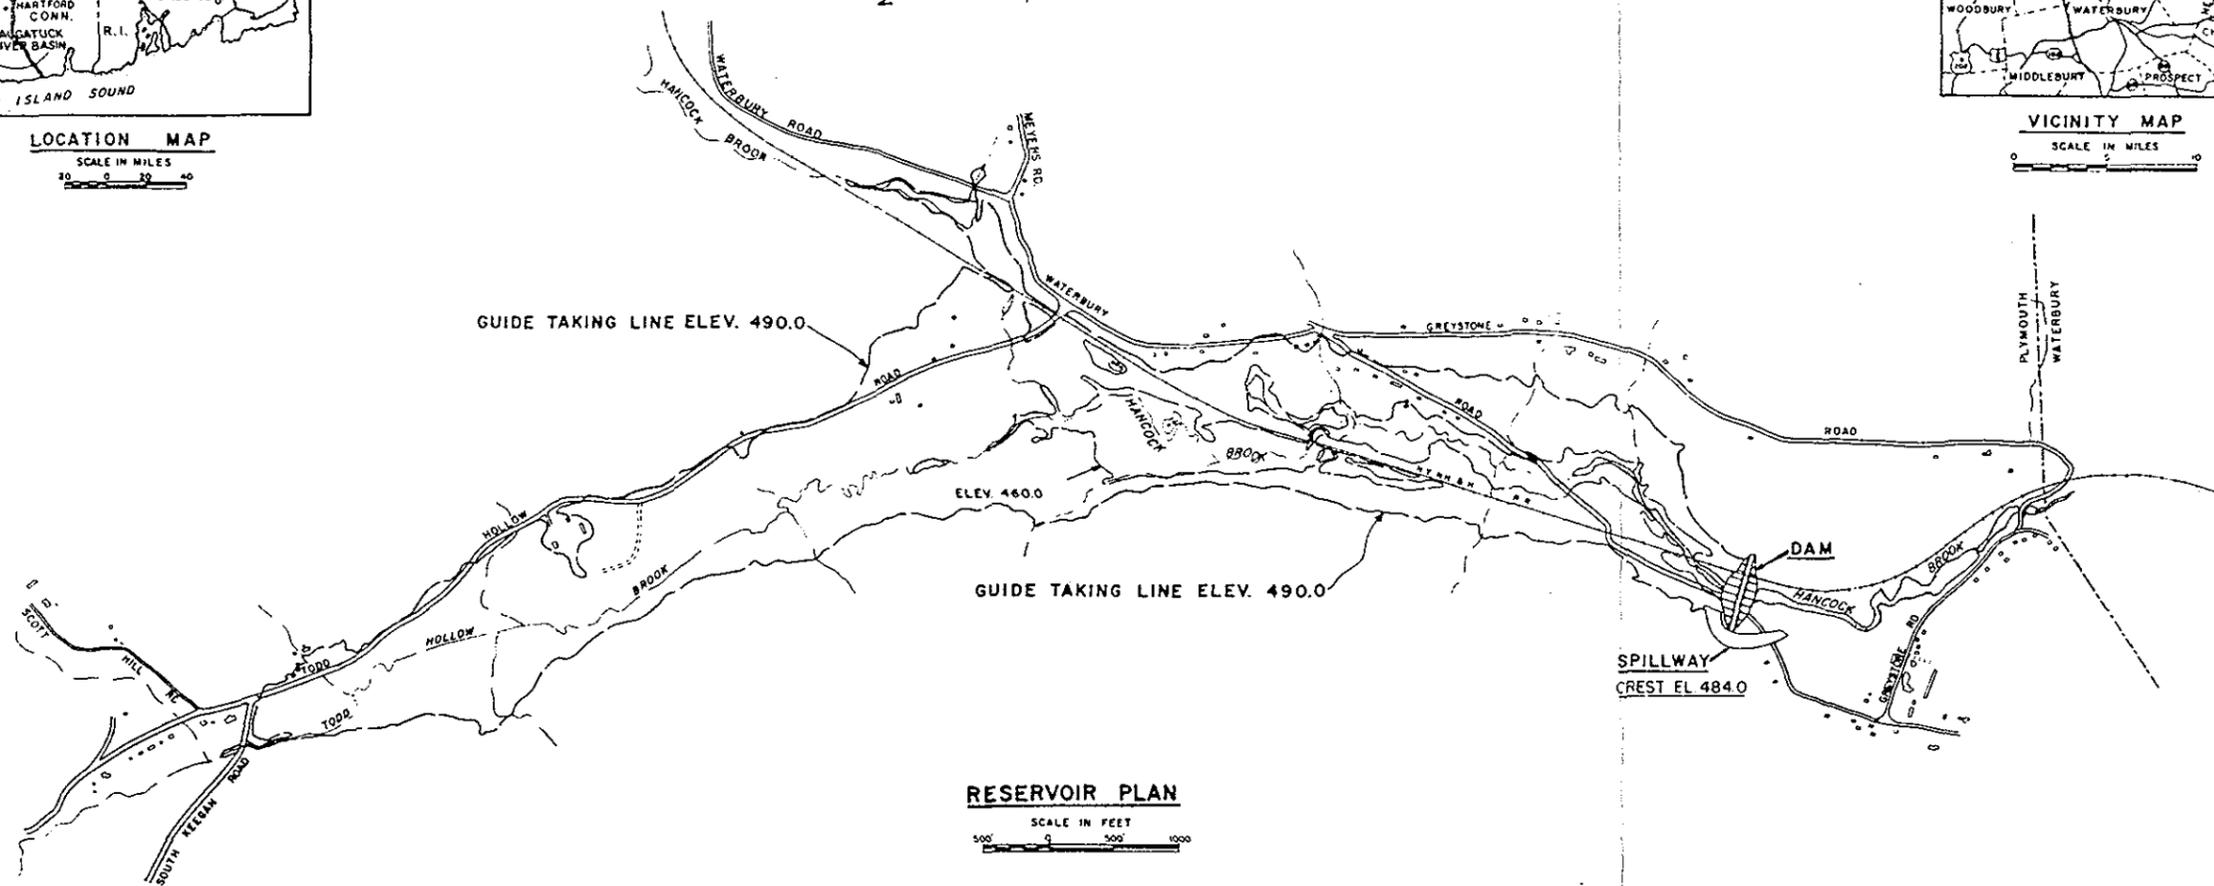
PROJECT ENGINEER	HOUSATONIC RIVER FLOOD CONTROL	
	HANCOCK BROOK DAM	
	RESERVOIR MAP	
CHEF	SECTION	HANCOCK BROOK CONNECTICUT
SUBMITTED BY	APPROVED	DATE DEC. 1961
CHEF PLANS & SPEC. BRANCH	CHEF ENGINEERING DIV.	SCALE SPEC. NO. CIV. ENGR. 10-016
		DRAWING NUMBER
		SHEET

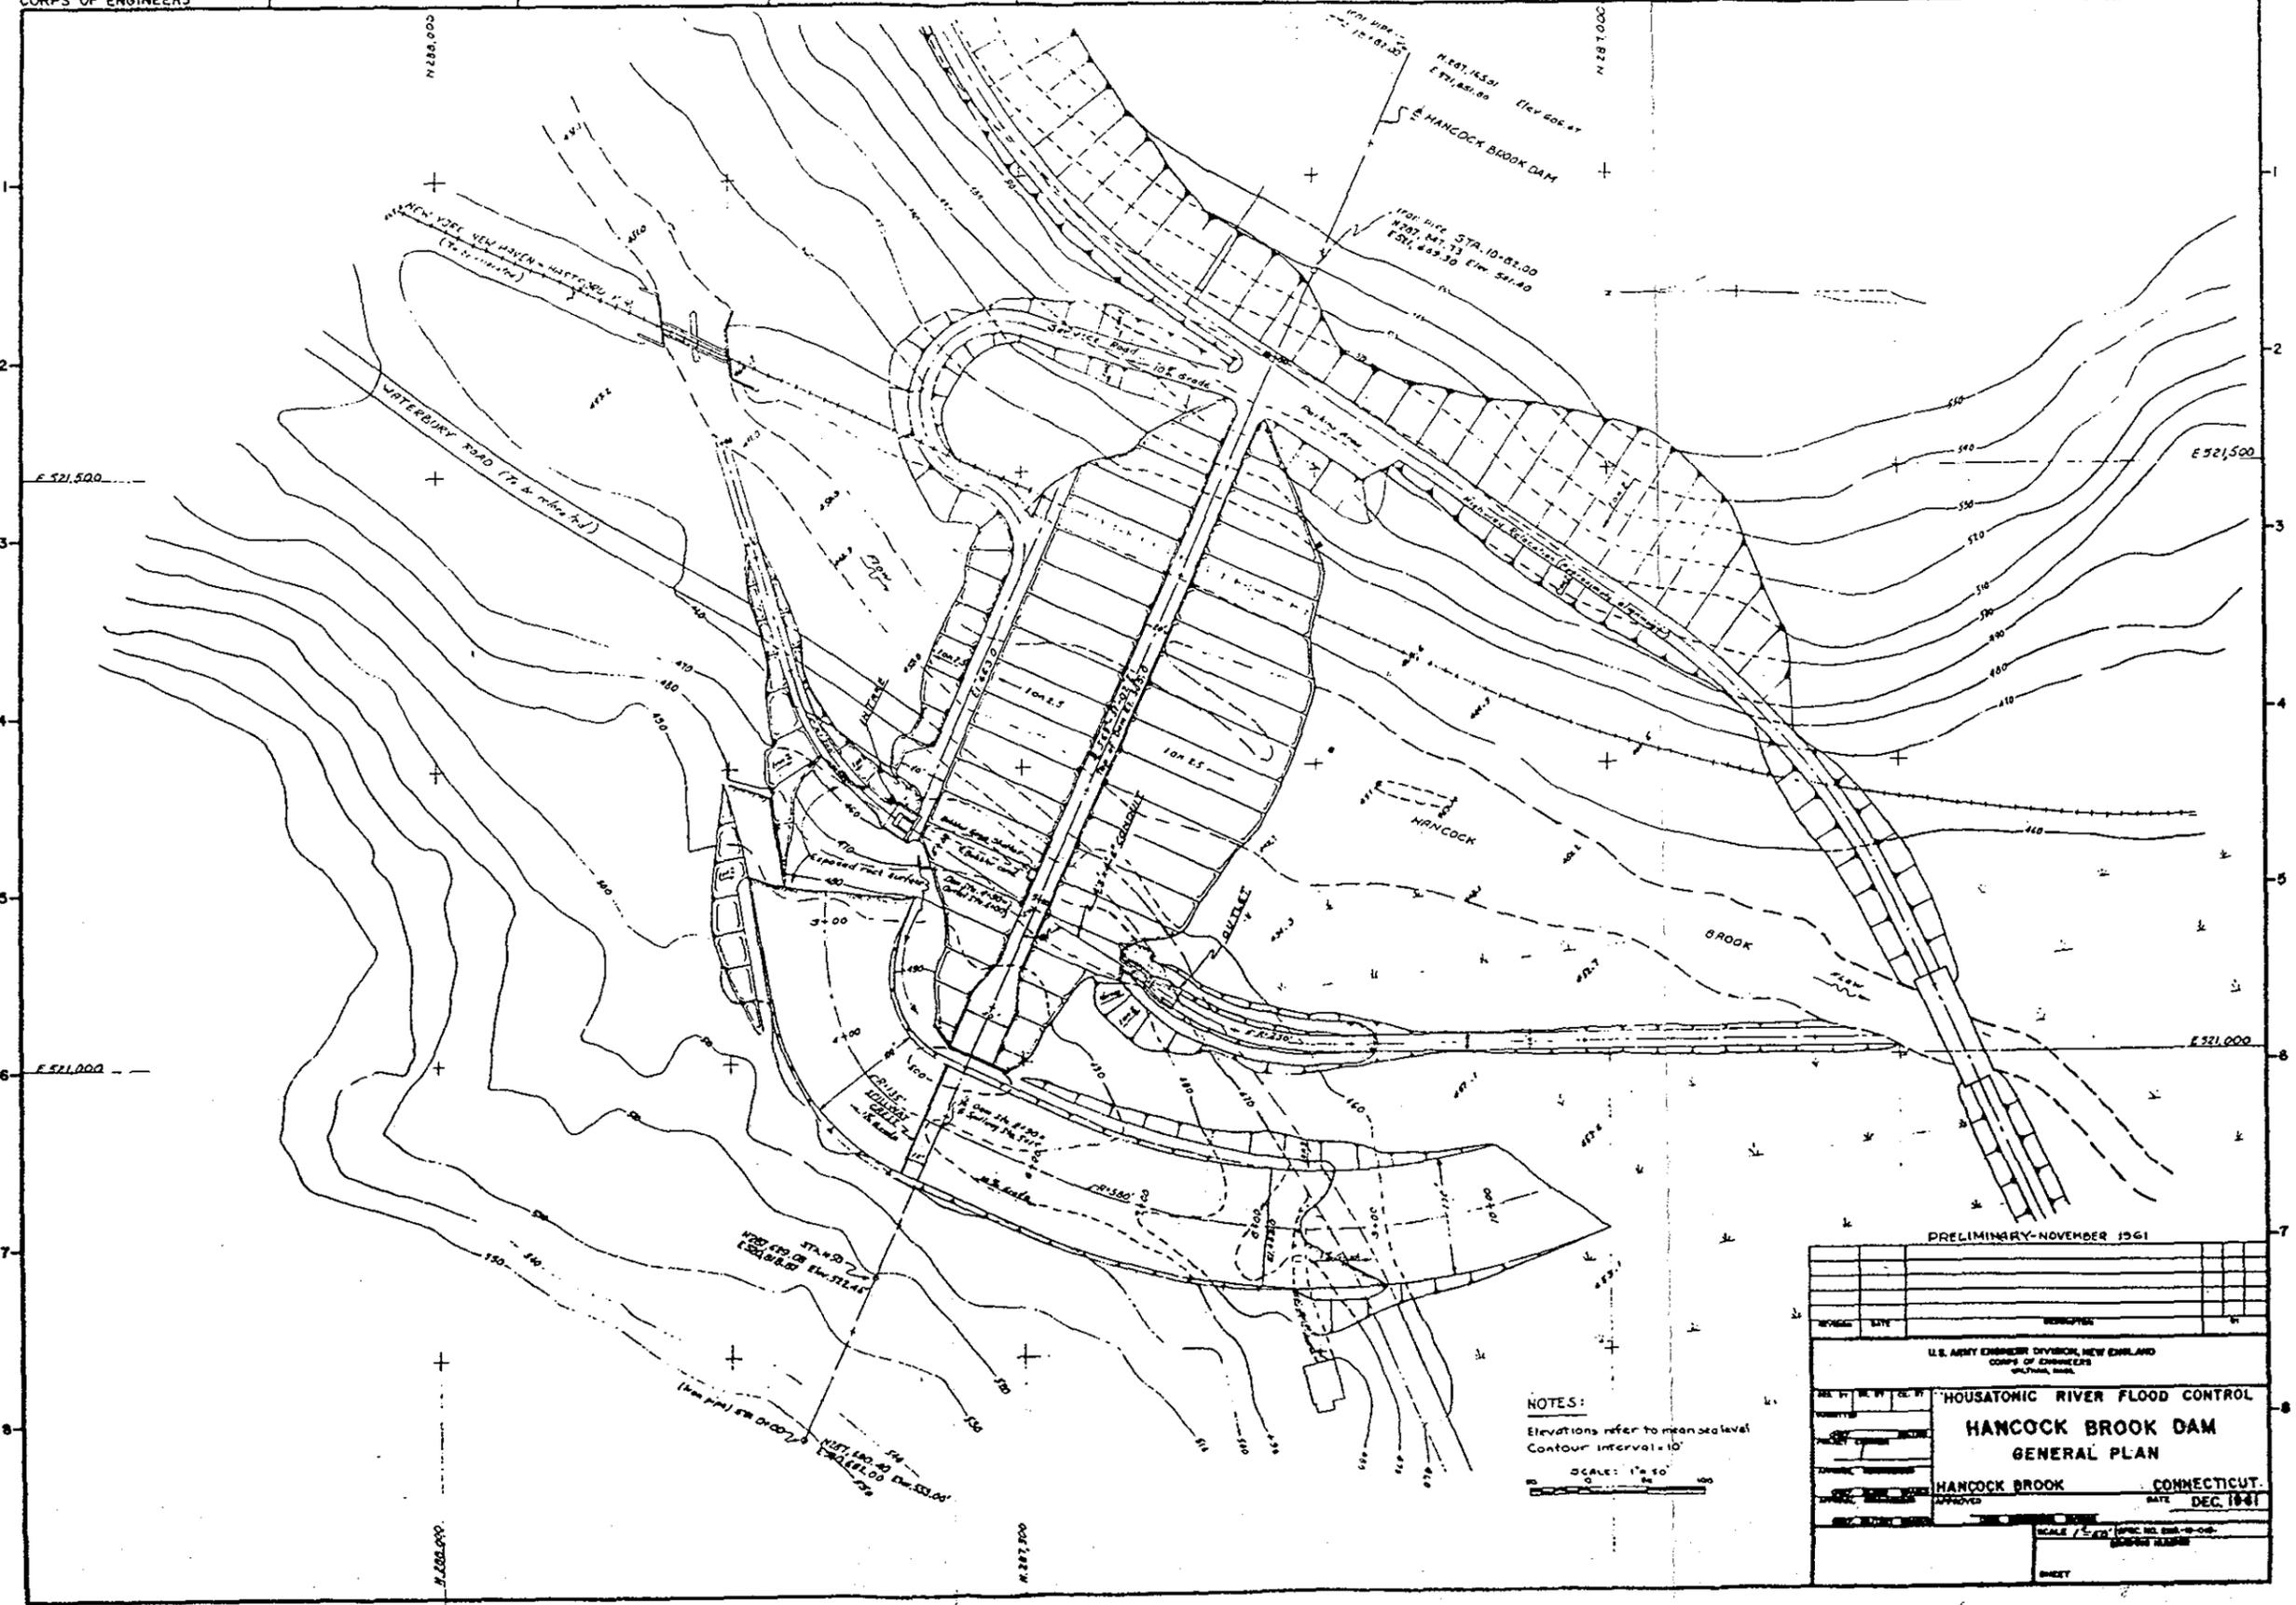
NOTES:
 Elevations refer to mean sea level
 Contour interval = 10'
 SCALE: 1" = 50'

NO.	DATE	DESCRIPTION
U. S. ARMY ENGINEER DIVISION, NEW ORLEANS CORPS OF ENGINEERS		
HOUSATONIC RIVER FLOOD CONTROL HANCOCK BROOK DAM GENERAL PLAN		
HANCOCK BROOK		CONNECTICUT
APPROVED	DATE	DEC. 1961
SCALE: 1" = 50'		SHEET

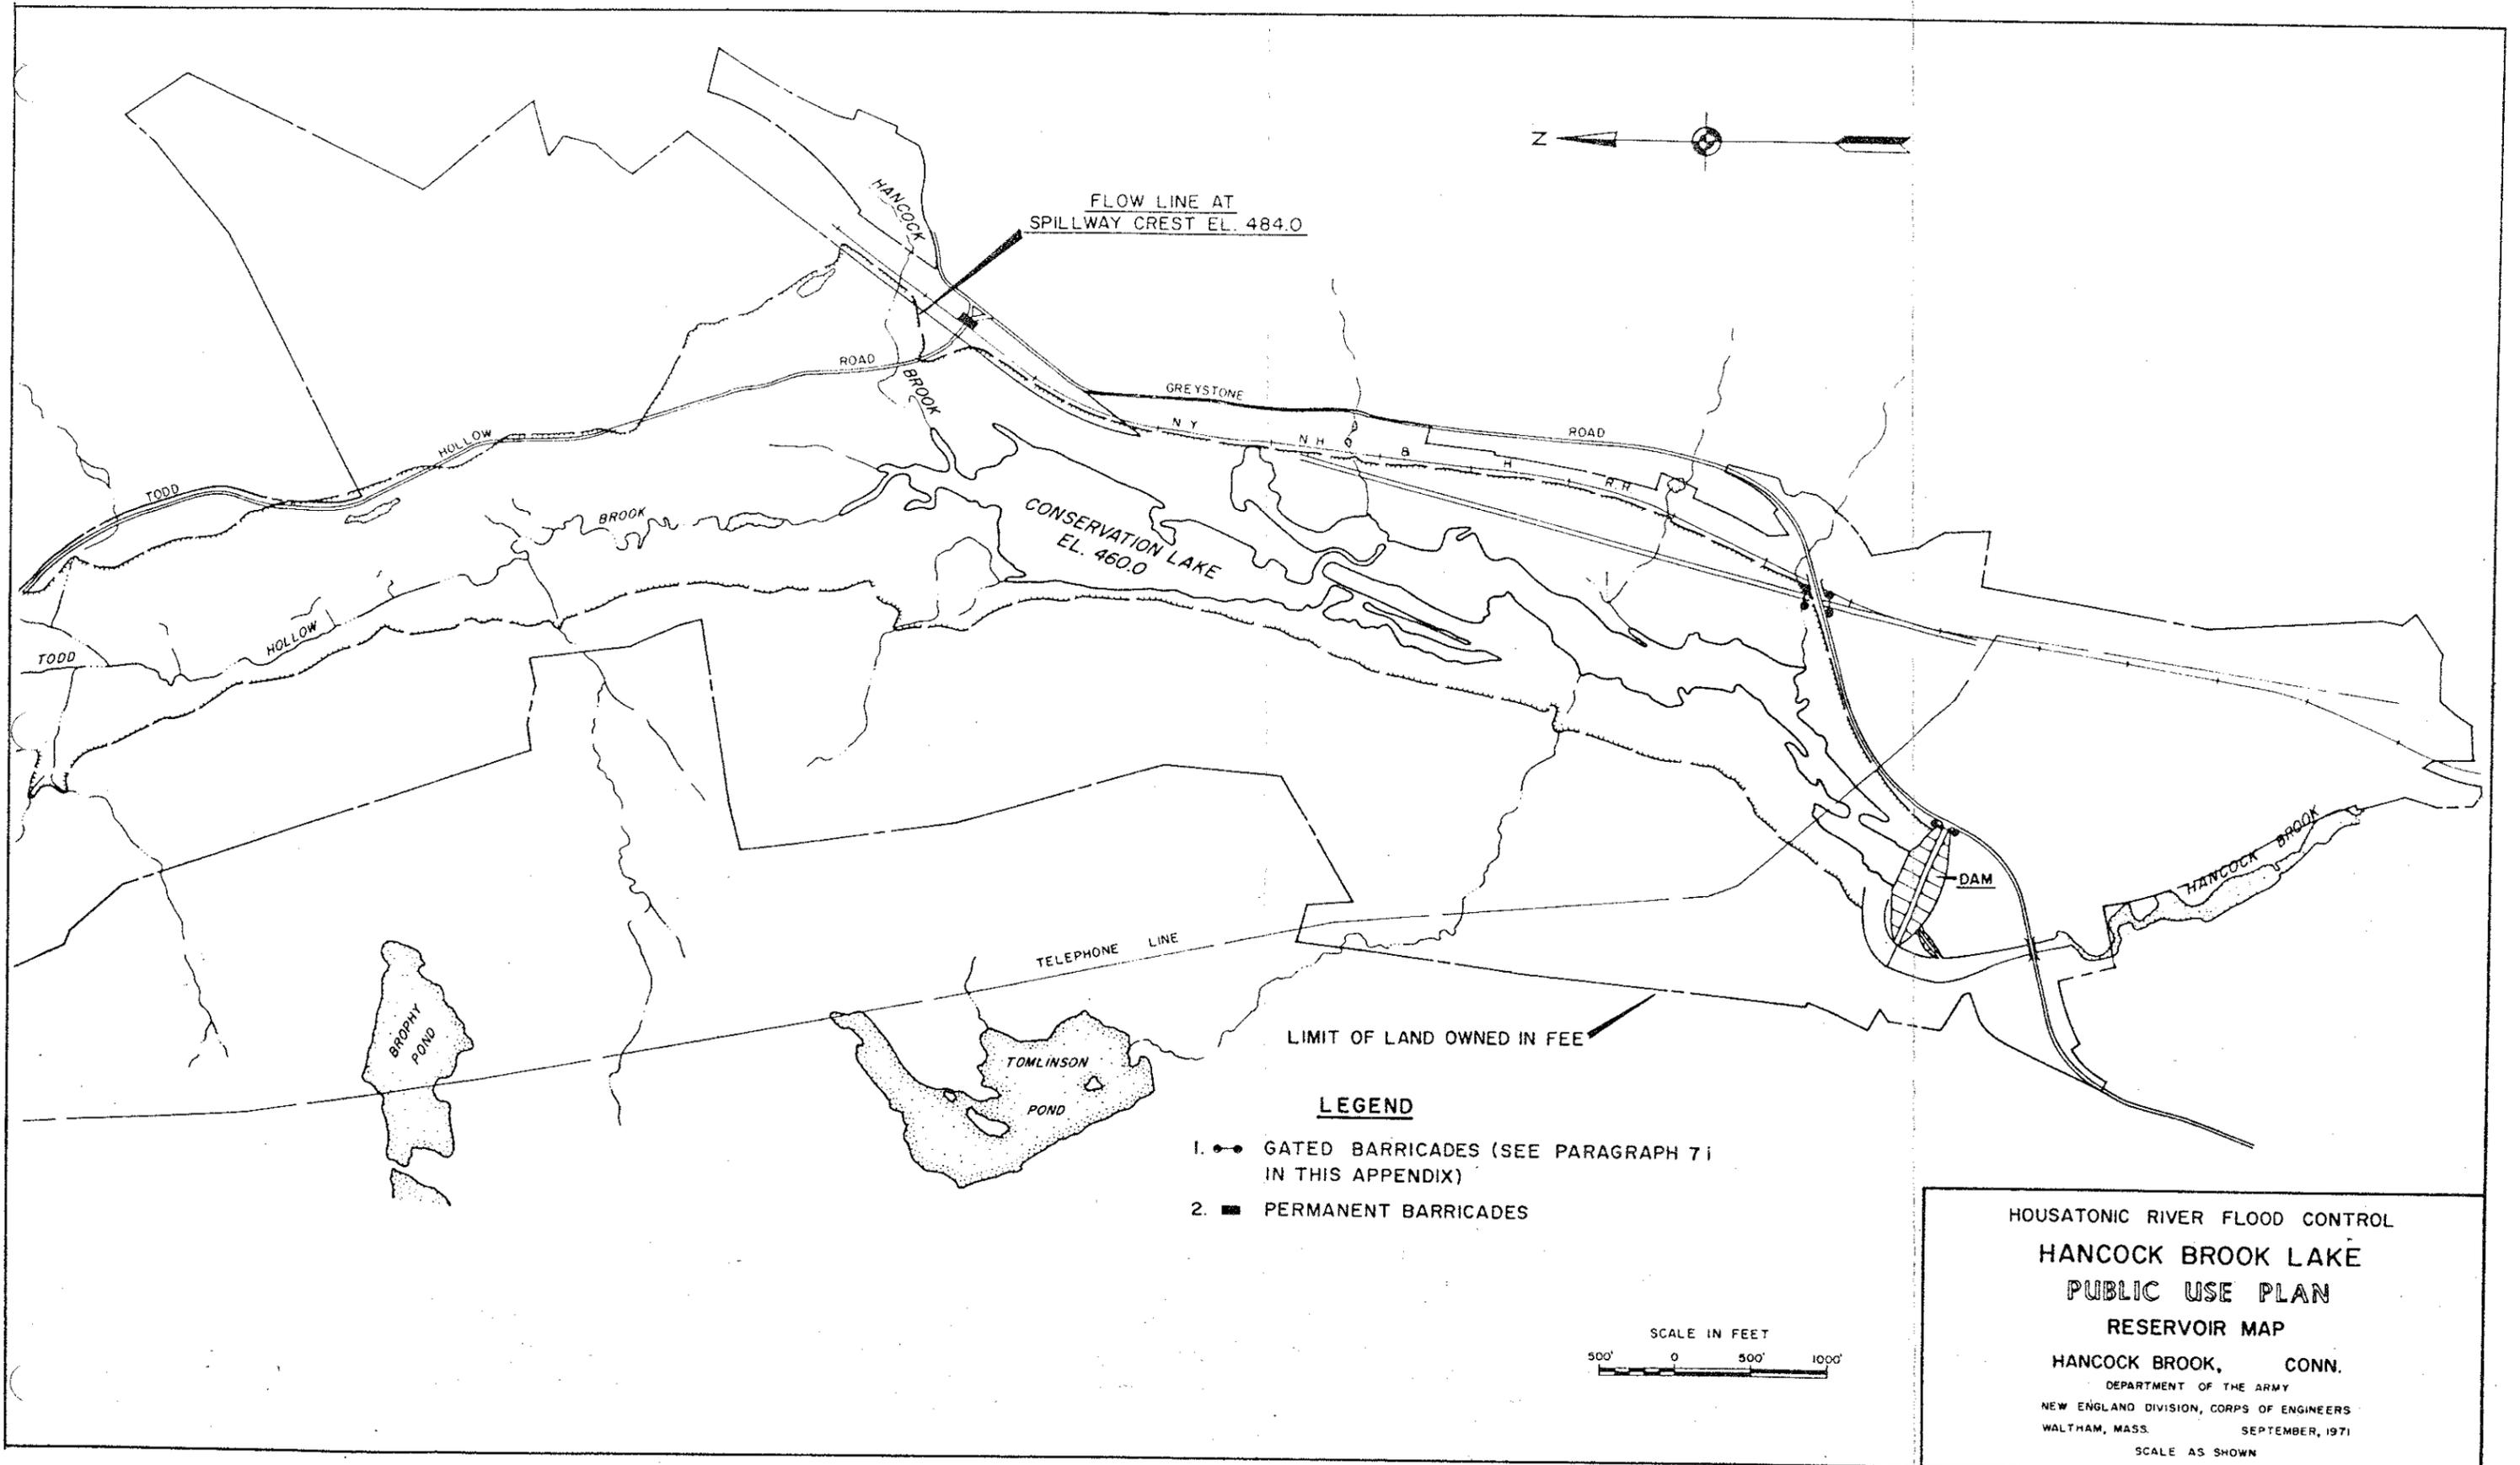
HOUSATONIC RIVER FLOOD CONTROL
HANCOCK BROOK LAKE
PUBLIC USE PLAN
RESERVOIR MAP
HANCOCK BROOK, CONN.
 DEPARTMENT OF THE ARMY
 NEW ENGLAND DIVISION, CORPS OF ENGINEERS
 WALTHAM, MASS. SEPTEMBER, 1971
 SCALE AS SHOWN

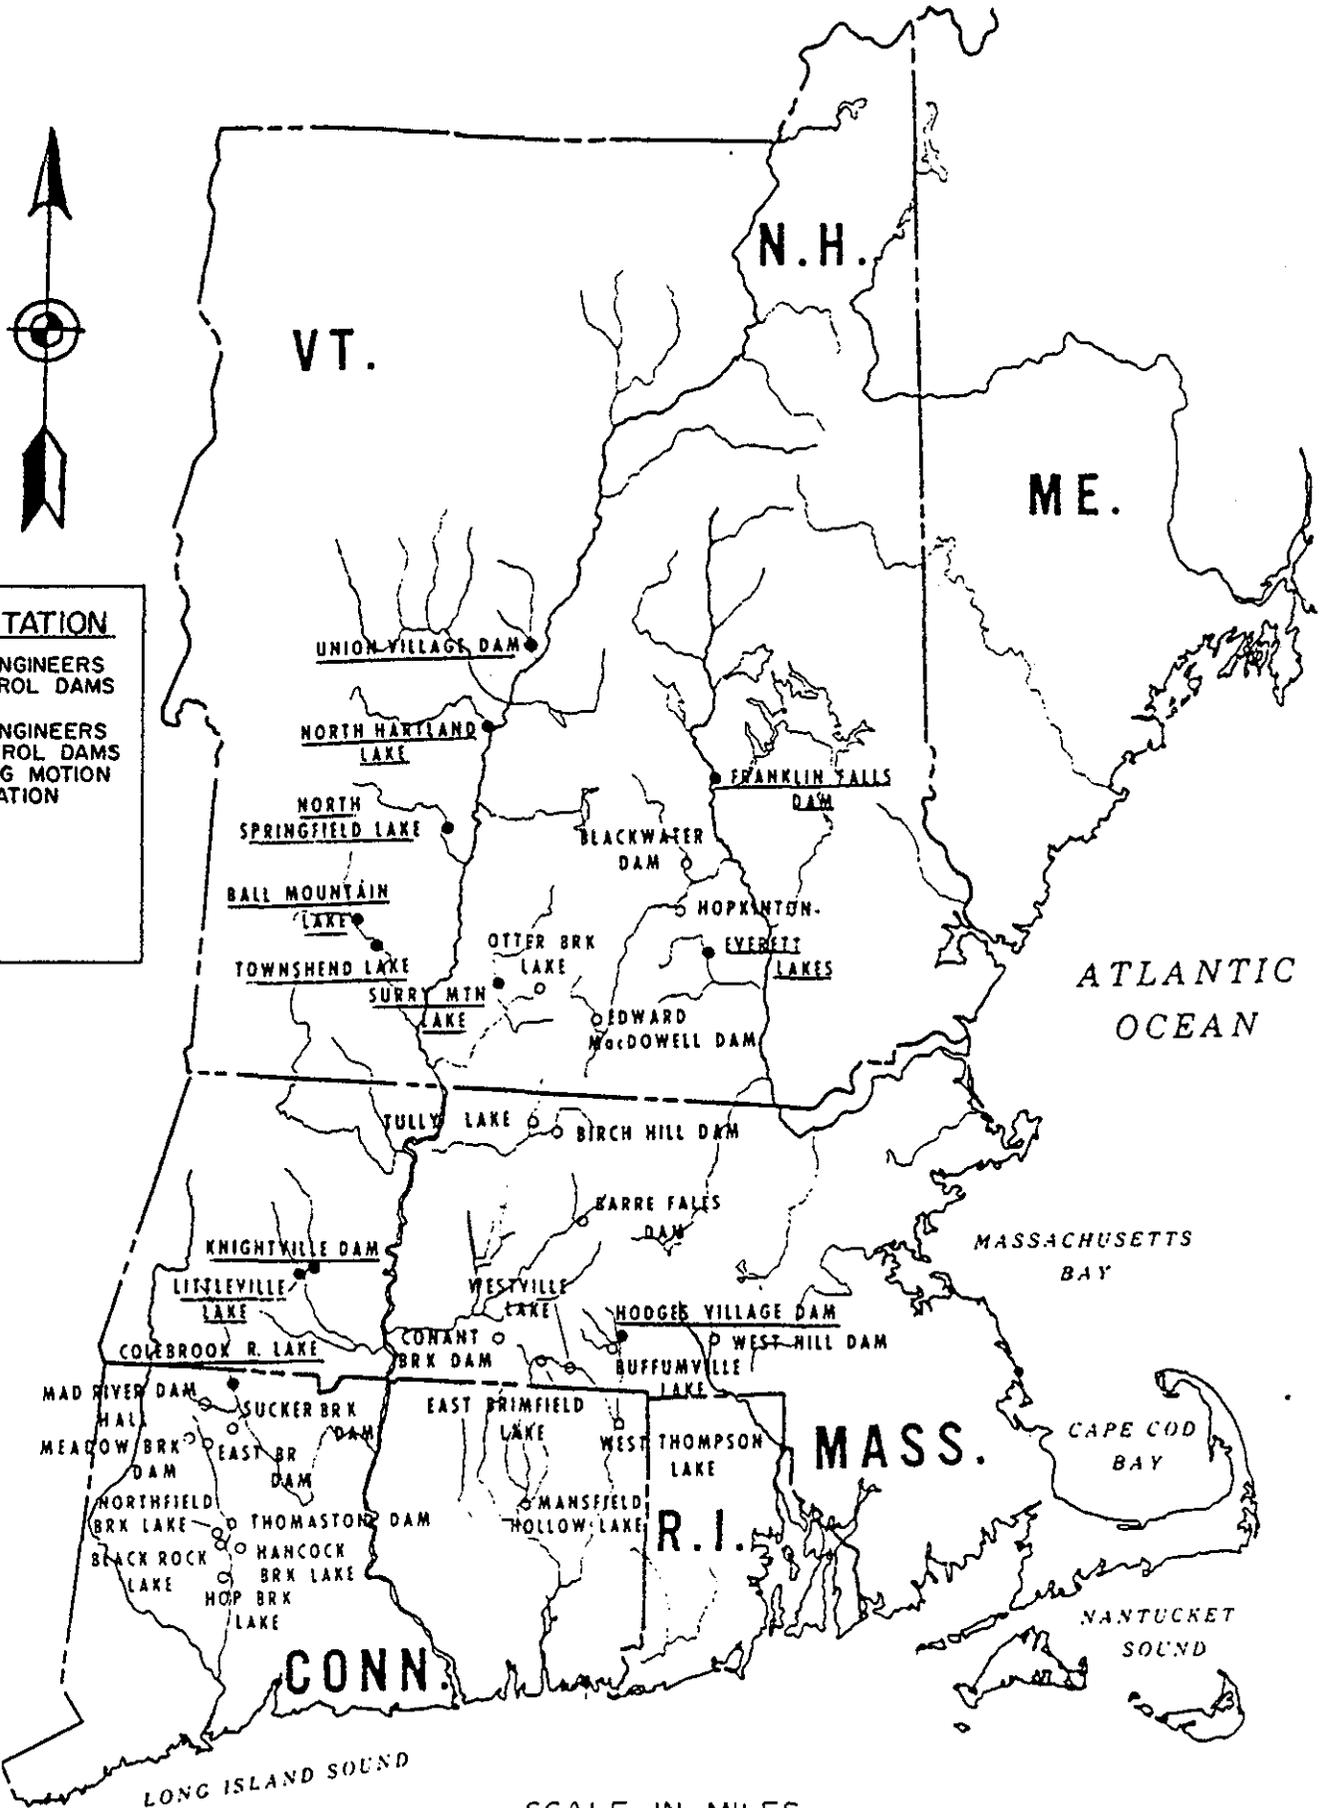
LOCATION OF STRONG MOTION INSTRUMENTATION

INSTRUMENTATION

- CORPS OF ENGINEERS FLOOD CONTROL DAMS
- CORPS OF ENGINEERS FLOOD CONTROL DAMS WITH STRONG MOTION INSTRUMENTATION

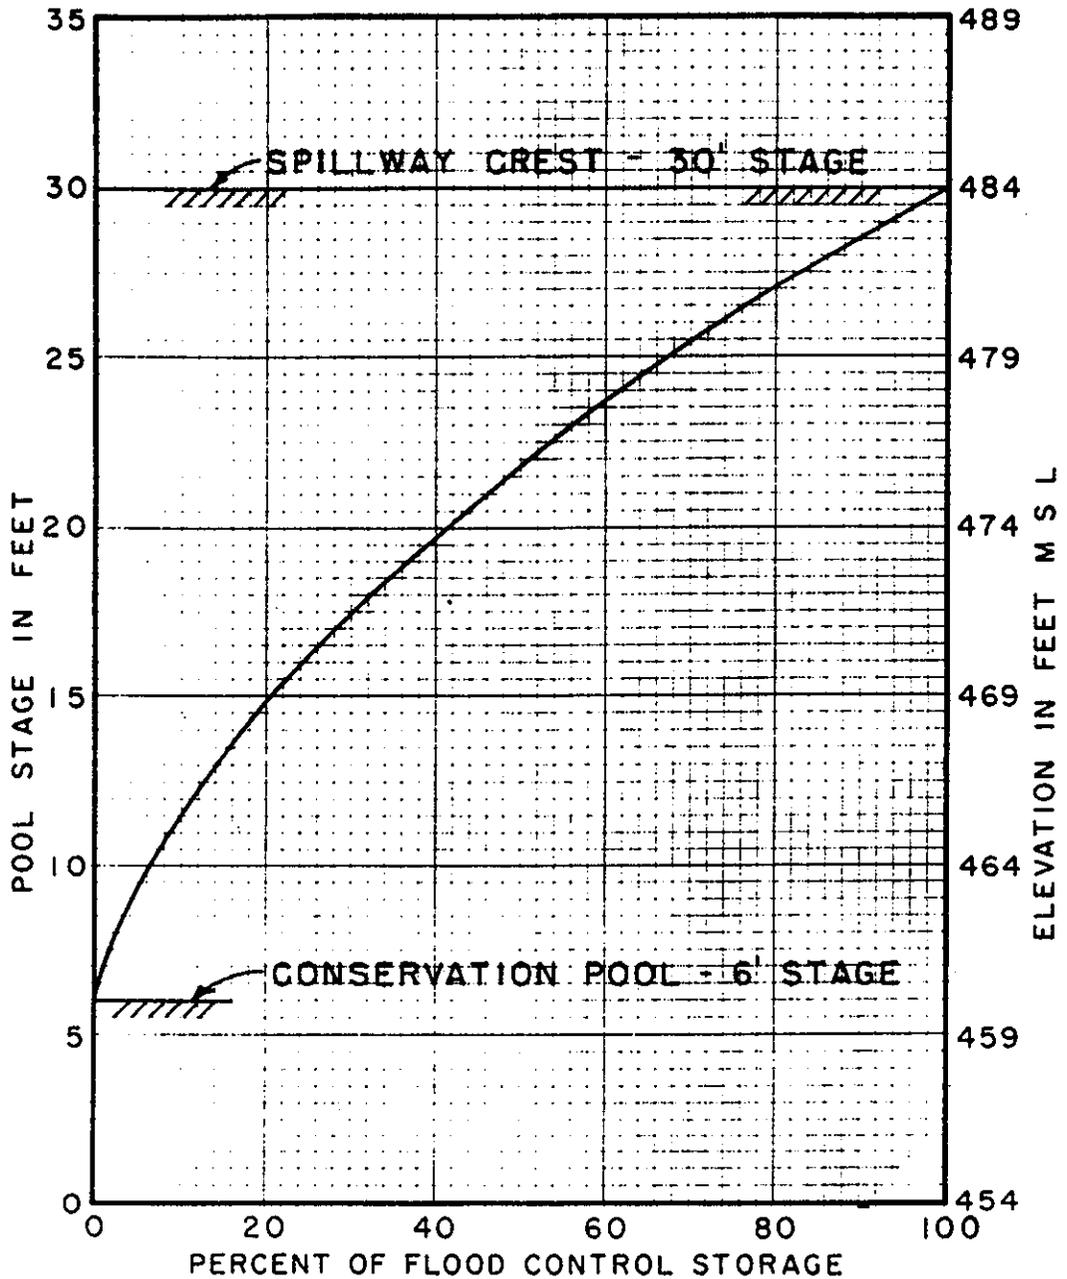
NOTES:

1. DRAINAGE AREA - 12.0 SQ. MI.
2. FLOOD CONTROL STORAGE - 3900 ACRE FEET - 6.1 INCHES.
3. CONSERVATION STORAGE - 130 Ac. Ft. - 0.2 INCHES.
4. 1 INCH RUNOFF = 640 Ac. Ft.

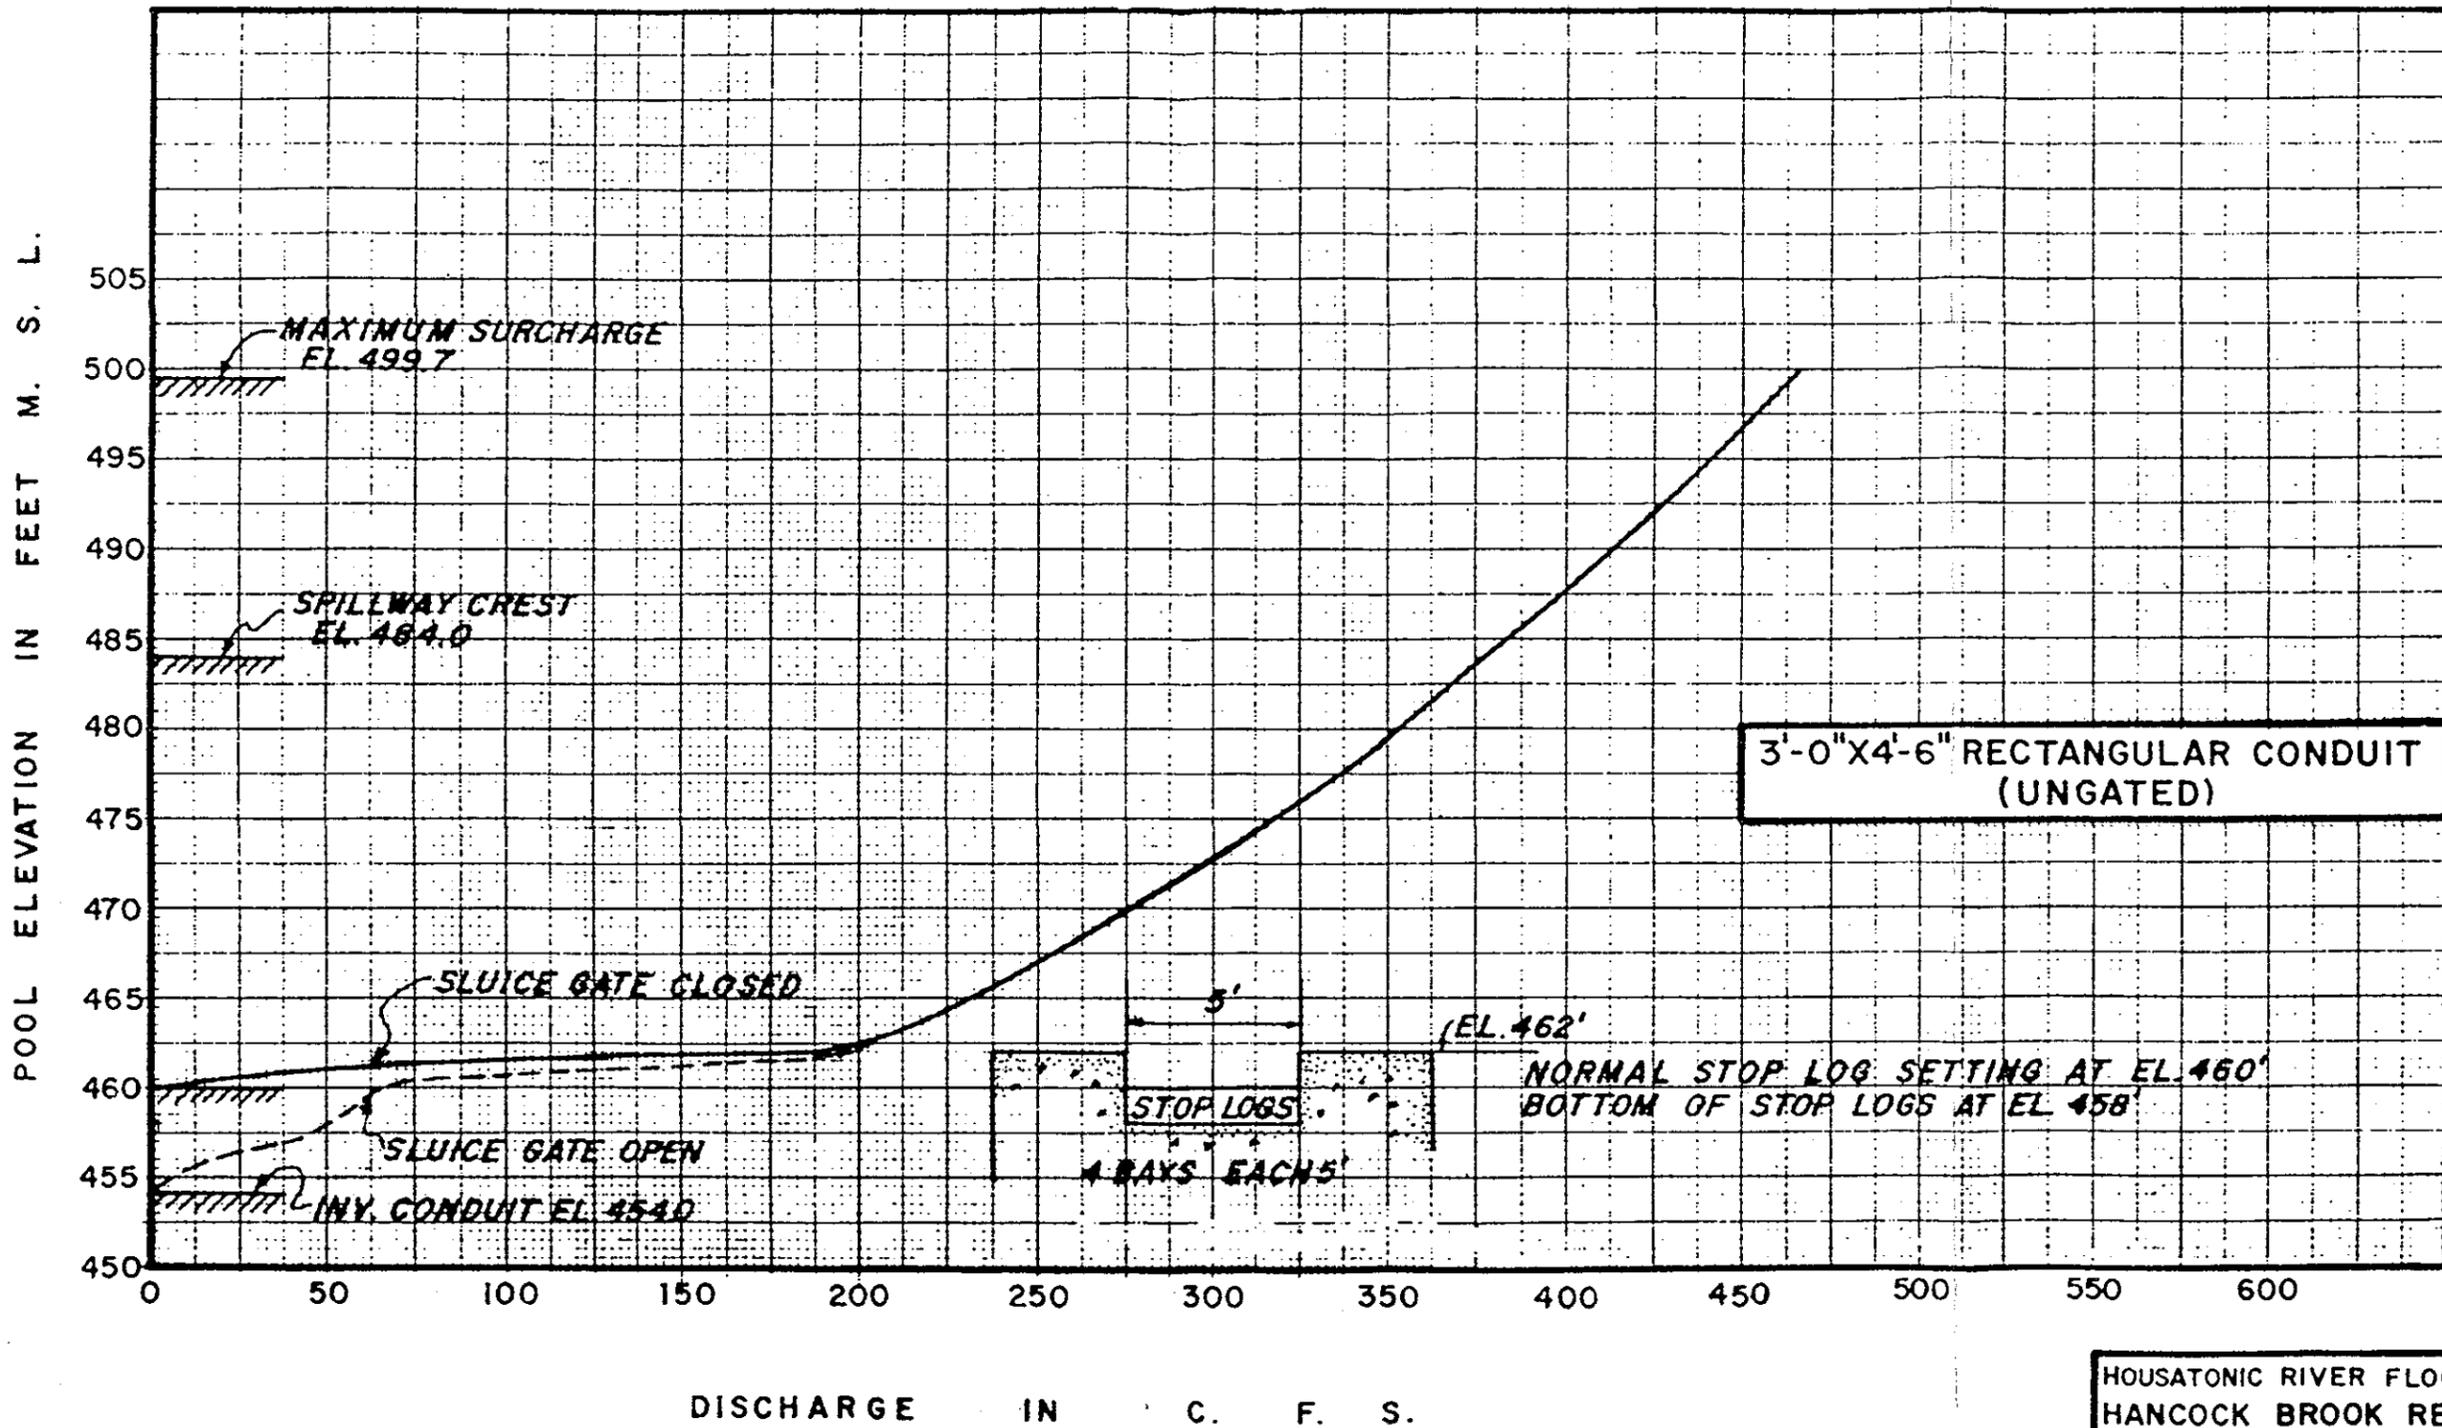
HOUSATONIC RIVER FLOOD CONTROL
HANCOCK BROOK RESERVOIR
HANCOCK BROOK, CONNECTICUT
OUTLET RATING CURVE
U.S. ARMY ENGINEER DIVISION
NEW ENGLAND
WALTHAM, MASS. DECEMBER 1961

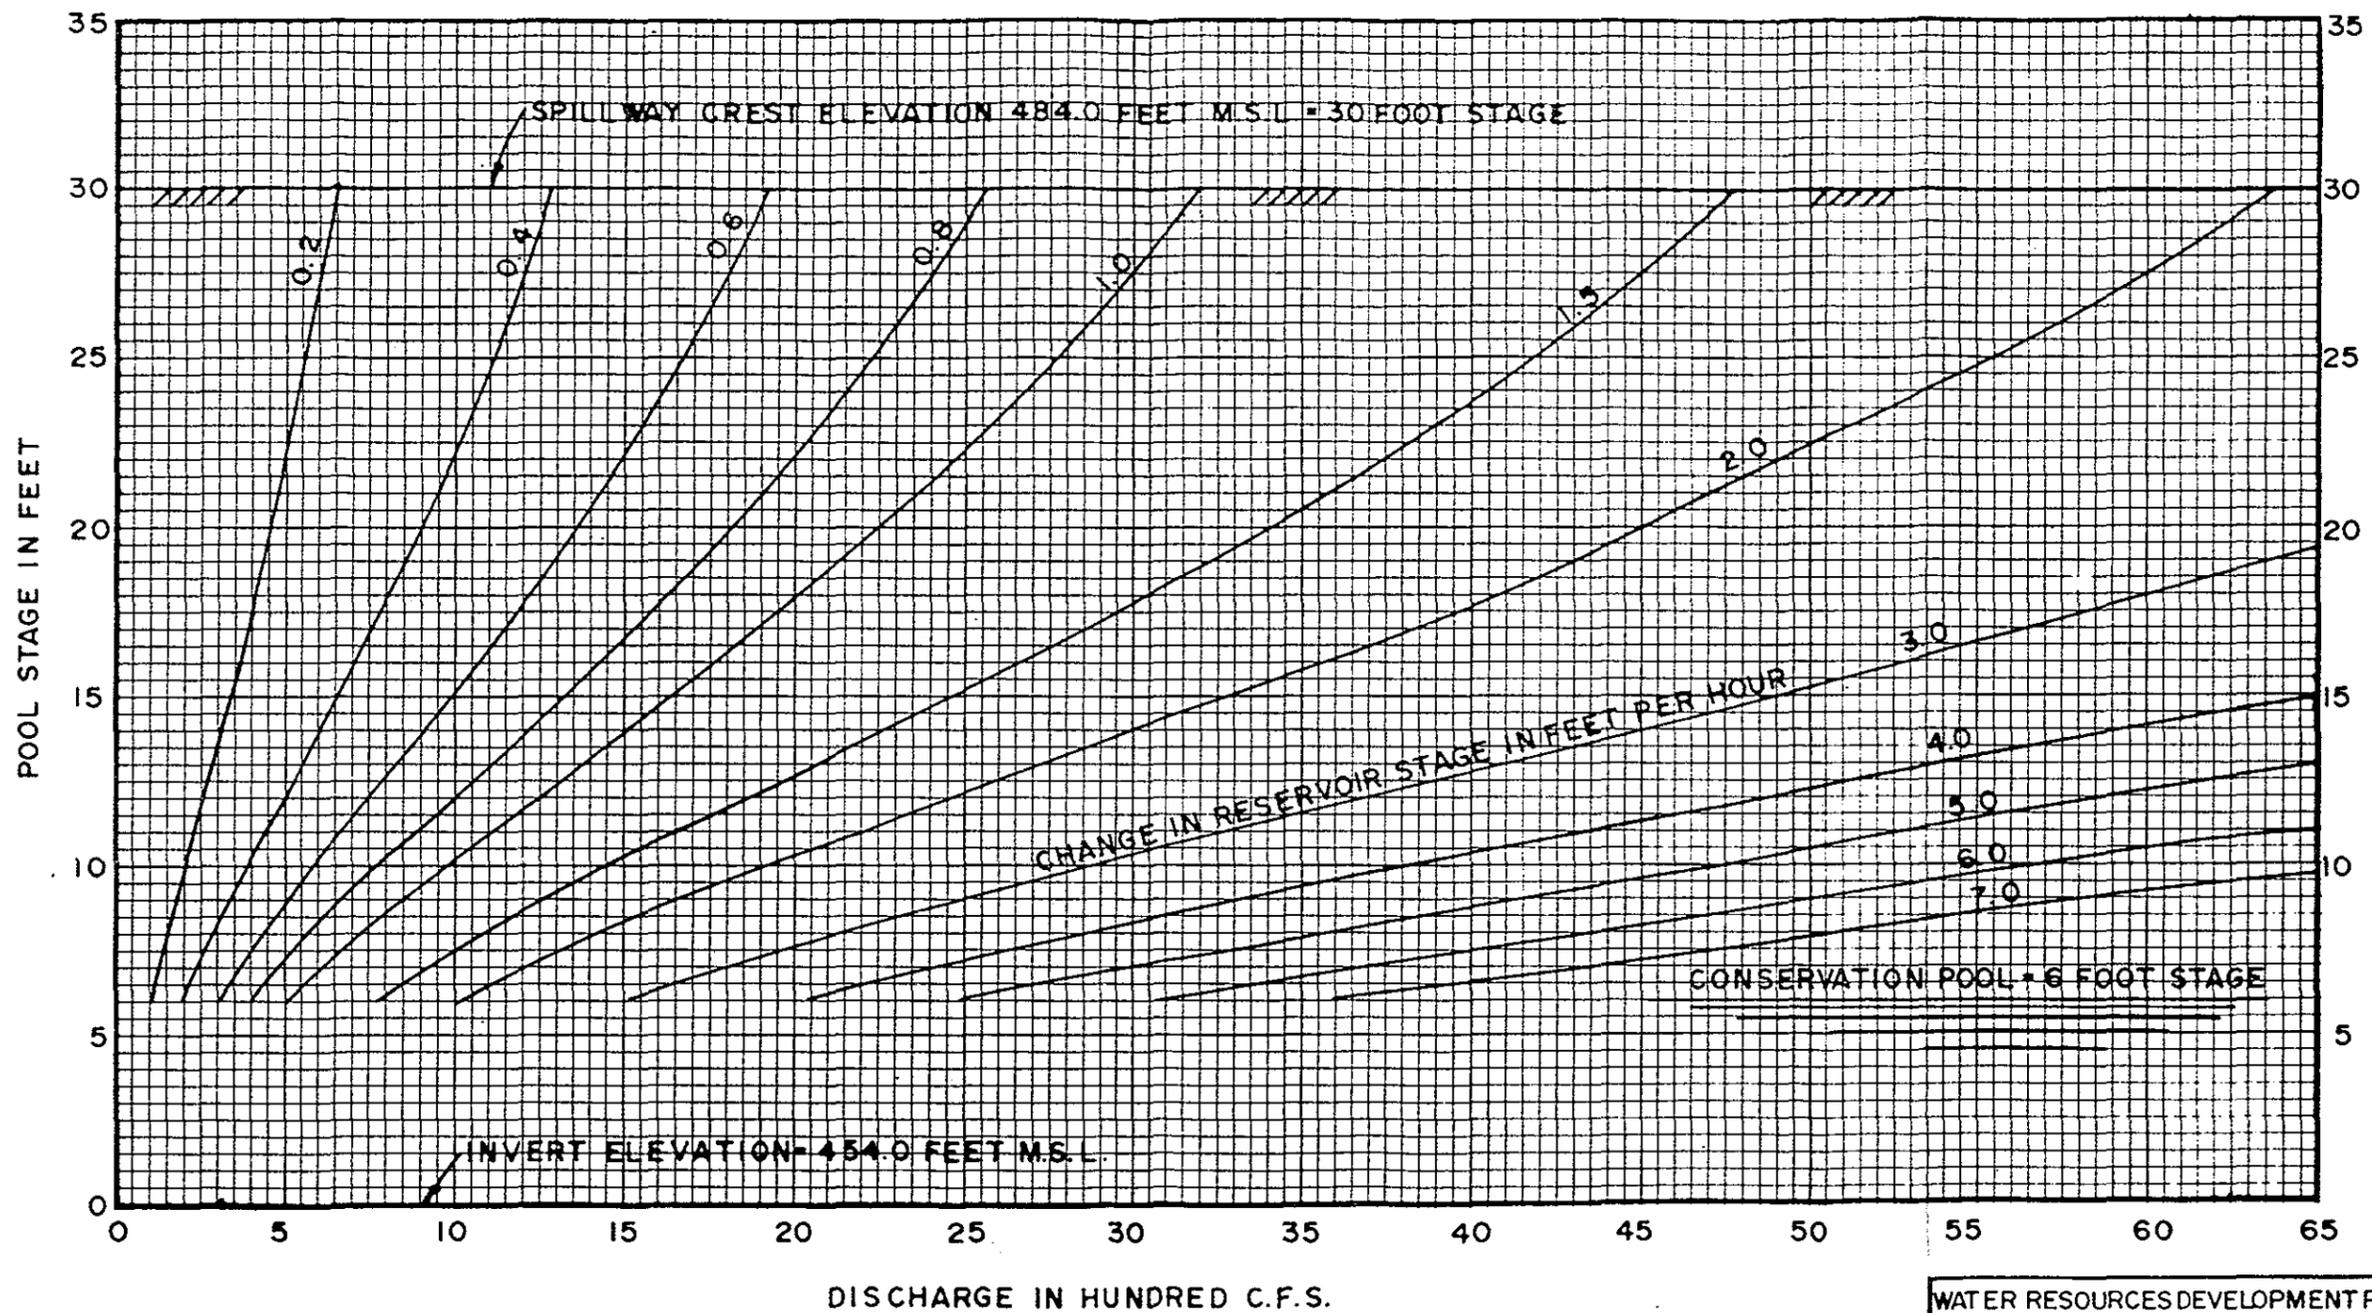
WATER RESOURCES DEVELOPMENT PROJECT
 HOUSATONIC RIVER BASIN
 HANCOCK BROOK LAKE
INFLOW CURVES
 NEW ENGLAND DIVISION, WALTHAM, MASS.
 SEPTEMBER 1976

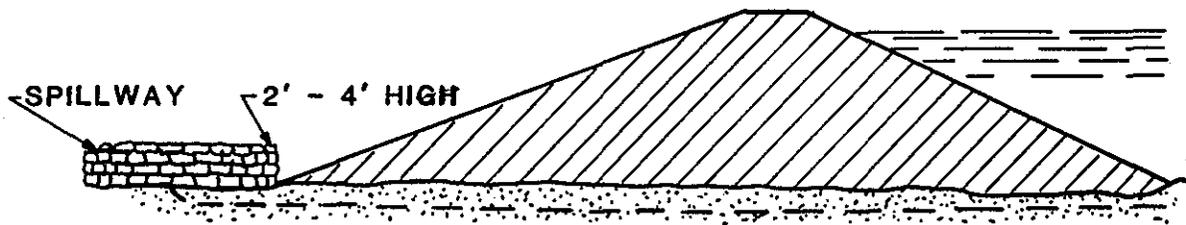
WALL SHOULD BE BUILT ON FIRM ELEVATION
 FOUNDATION, WITH WIDTH OF BASE AT LEAST
 1 1/2 TIMES THE HEIGHT. BE SURE TO PLACE SACKS
 ON GROUND CLEAR OF SAND DISCHARGE. TIE INTO
 DIKE IF BOIL IS NEAR TOE.

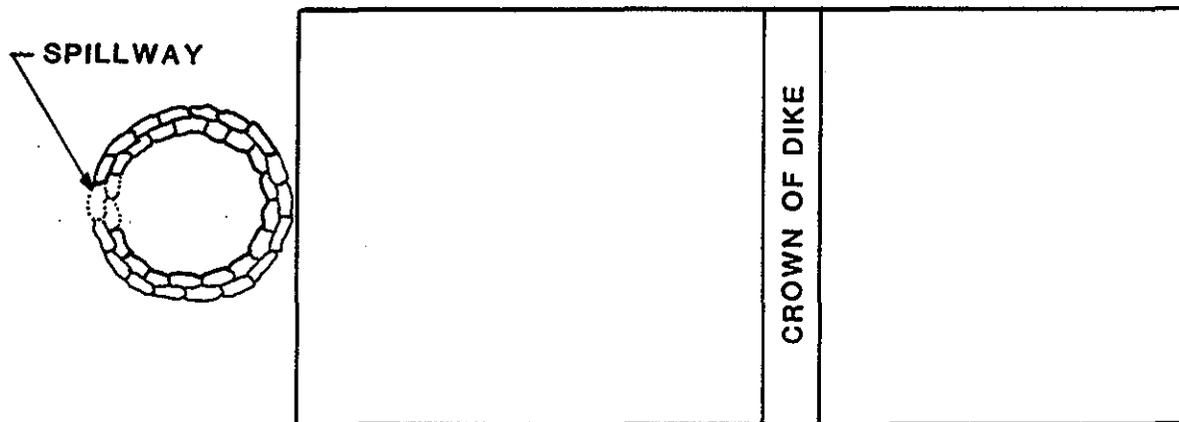
PLAN

DO NOT SACK BOIL WHICH DOES NOT PUT OUT
 MATERIAL. HEIGHT OF SACK LOOP OR RING SHOULD
 BE ONLY SUFFICIENT TO CREATE ENOUGH HEAD TO
 SLOW DOWN FLOW THROUGH BOIL
 SO THAT NO MORE MATERIAL IS
 DISPLACED AND BOIL RUNS CLEAR.
 DO NOT TRY TO STOP FULLY, FLOW
 THROUGH BOIL.

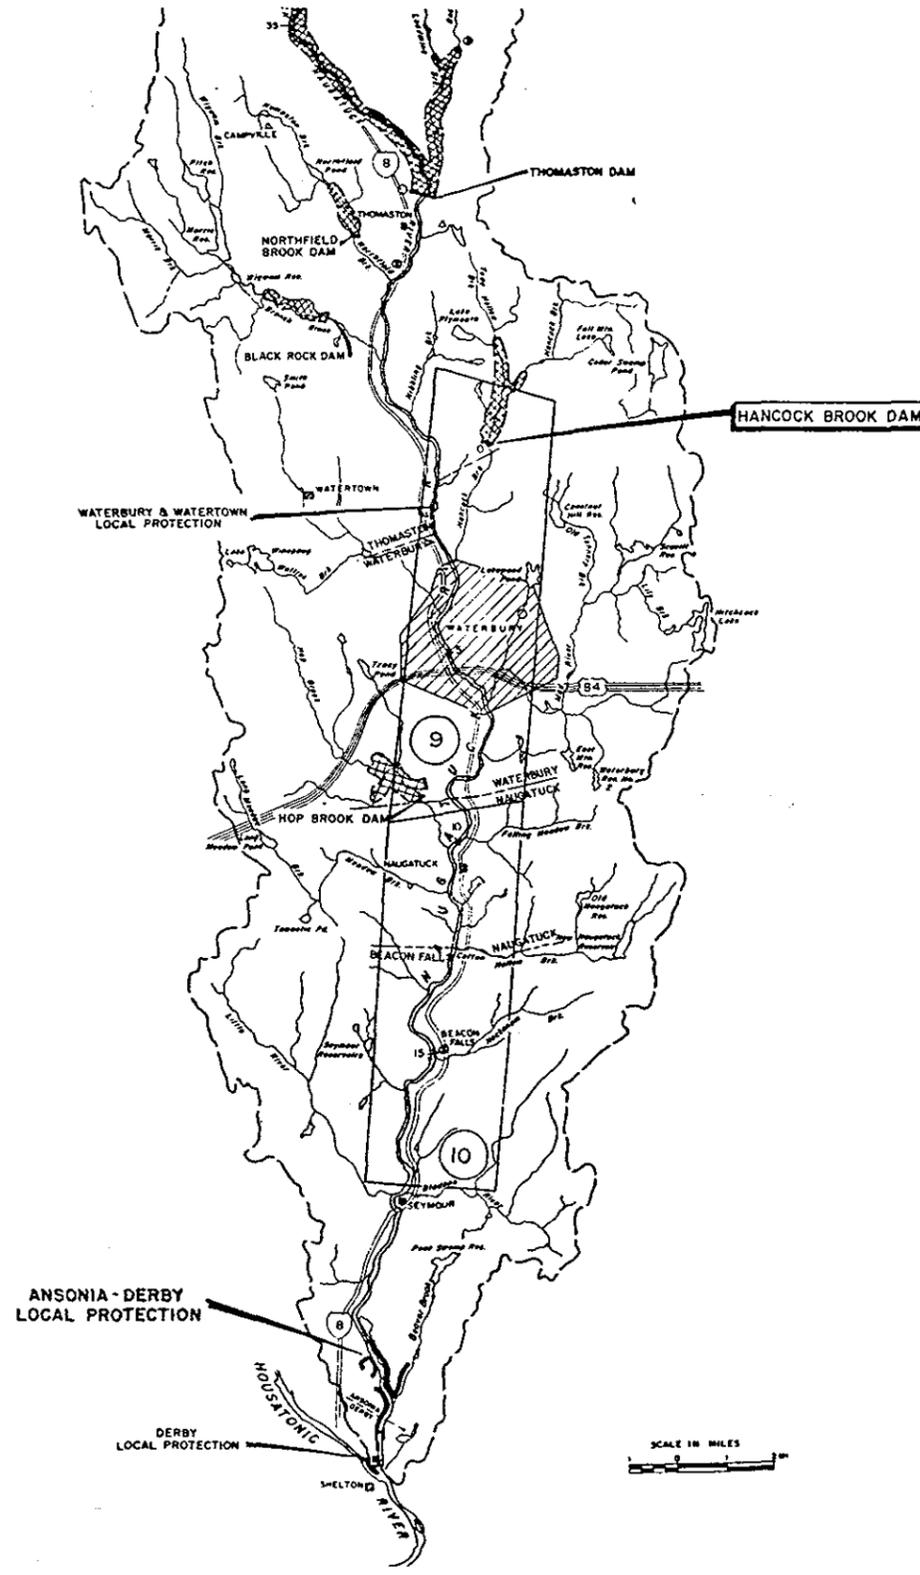
CROSS SECTION DATA						
PLATE NO.	SECTION NO.	RIVER MILE	DIST. D/S FROM DAM (MI.)	DAM BREACH FLOOD		
				ARRIVAL TIME (HOURS)	PEAK TIME (HOURS)	PEAK EL. (FT.-NGVD)
8	0.90	0.90	0.90	0.10	1.02	397.8
8	2.22	2.22	2.22	0.20	1.05	308.2
8	3.70	3.70	3.70	0.60	1.40	286.3
8	5.73	5.73	5.73	1.00	2.00	270.5
8	8.35	8.35	8.35	1.20	2.55	230.7
9	9.50	9.50	9.50	1.40	3.00	214.2
9	12.57	12.57	12.57	1.80	3.75	272.8
9	15.39	15.39	15.39	2.10	4.45	126.7
9	17.91	17.91	17.91	2.50	4.85	96.4

* FROM START OF BREACH FORMATION

HOUSATONIC RIVER BASIN
 NAUGATUCK RIVER WATERSHED
HANCOCK BROOK DAM BREACH FLOOD
 INDEX MAP
