FLOOD EMERGENCY PLAN

Hancock Brook Lake

FLOOD EMERGENCY PLAN
FOR
HANCOCK BROOK LAKE

KASPER ASSOCIATES
Engineers • Surveyors • Planners

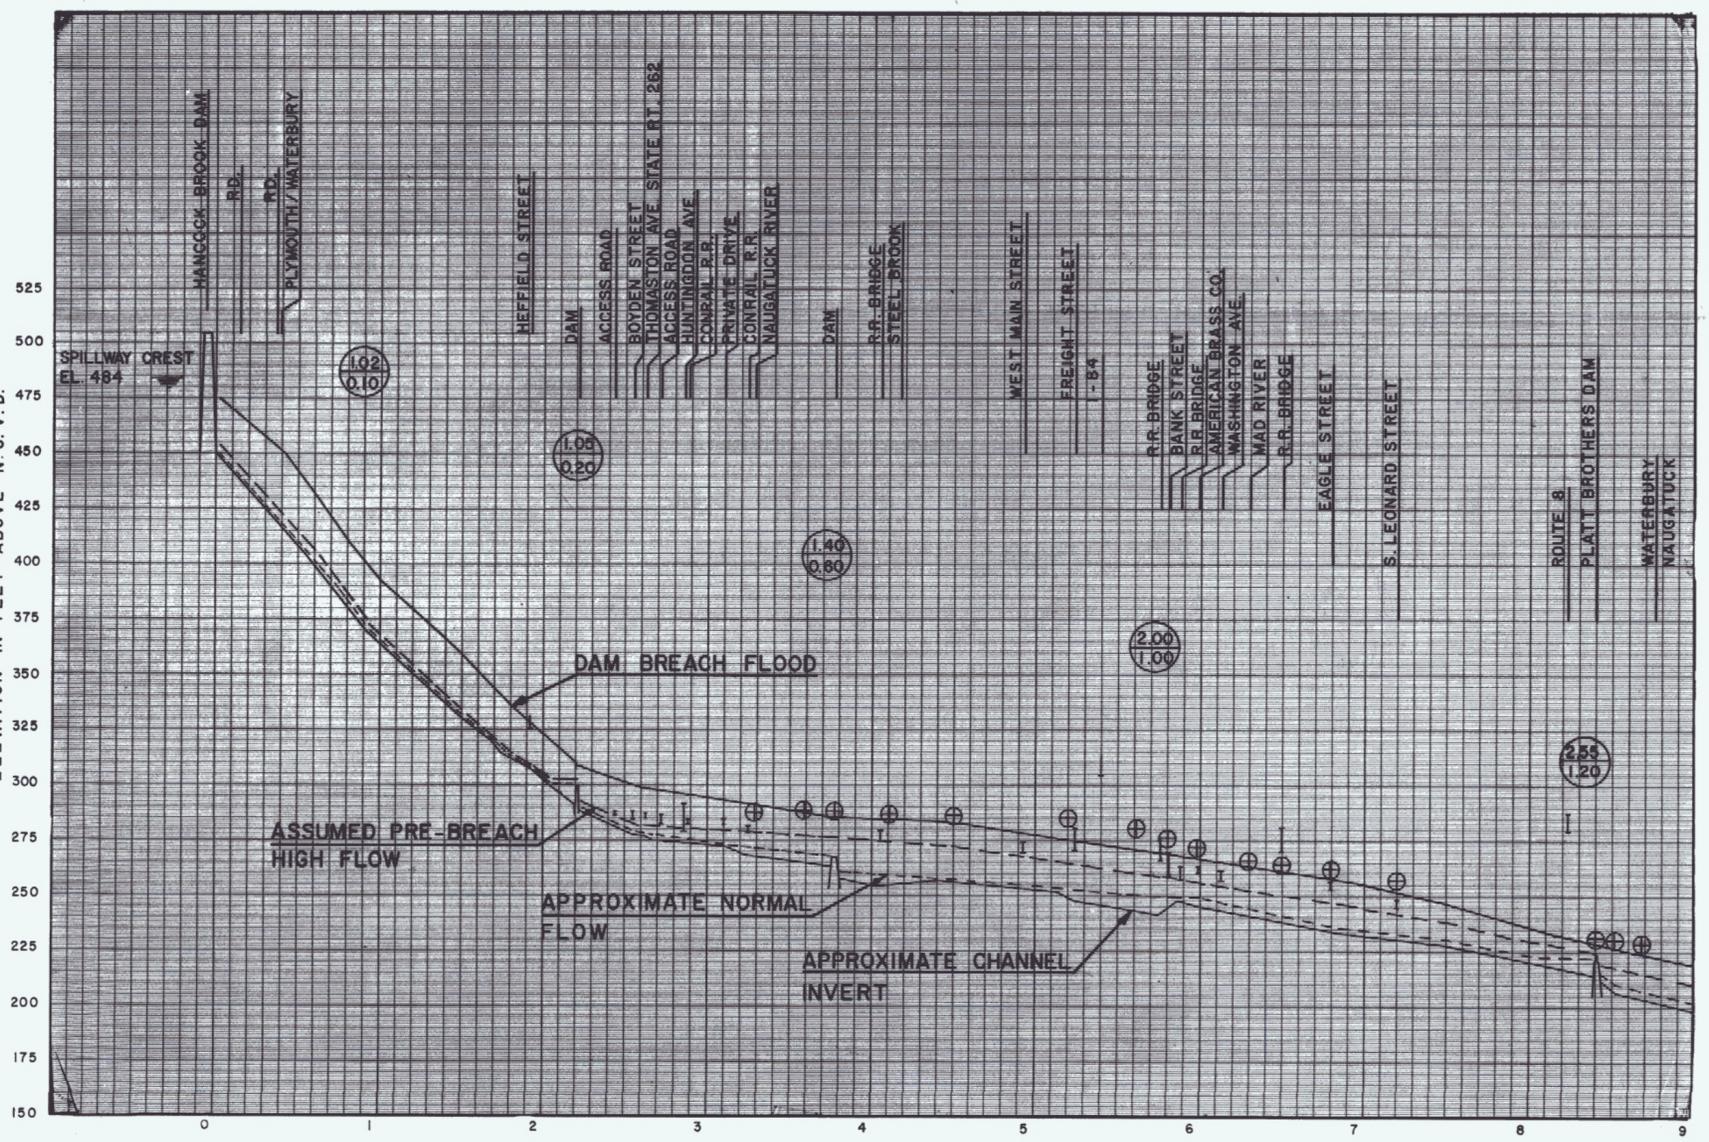
ELEVATION IN FEET ABOVE N. G. V. D.

DISTANCE IN RIVER MILES DOWNSTREAM FROM HANCOCK BROOK DAM

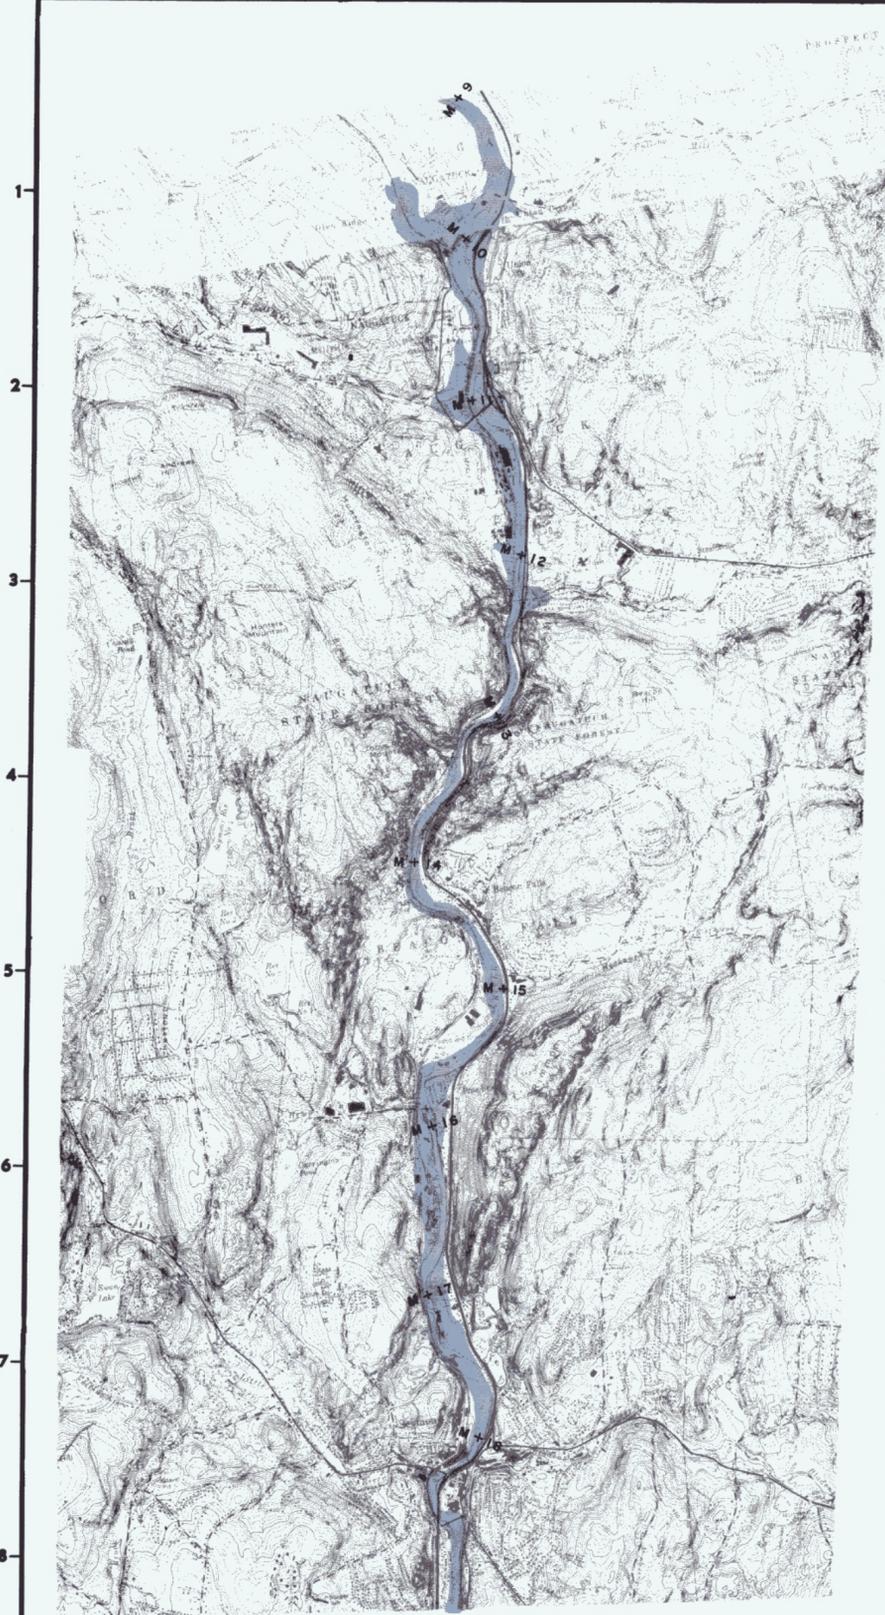
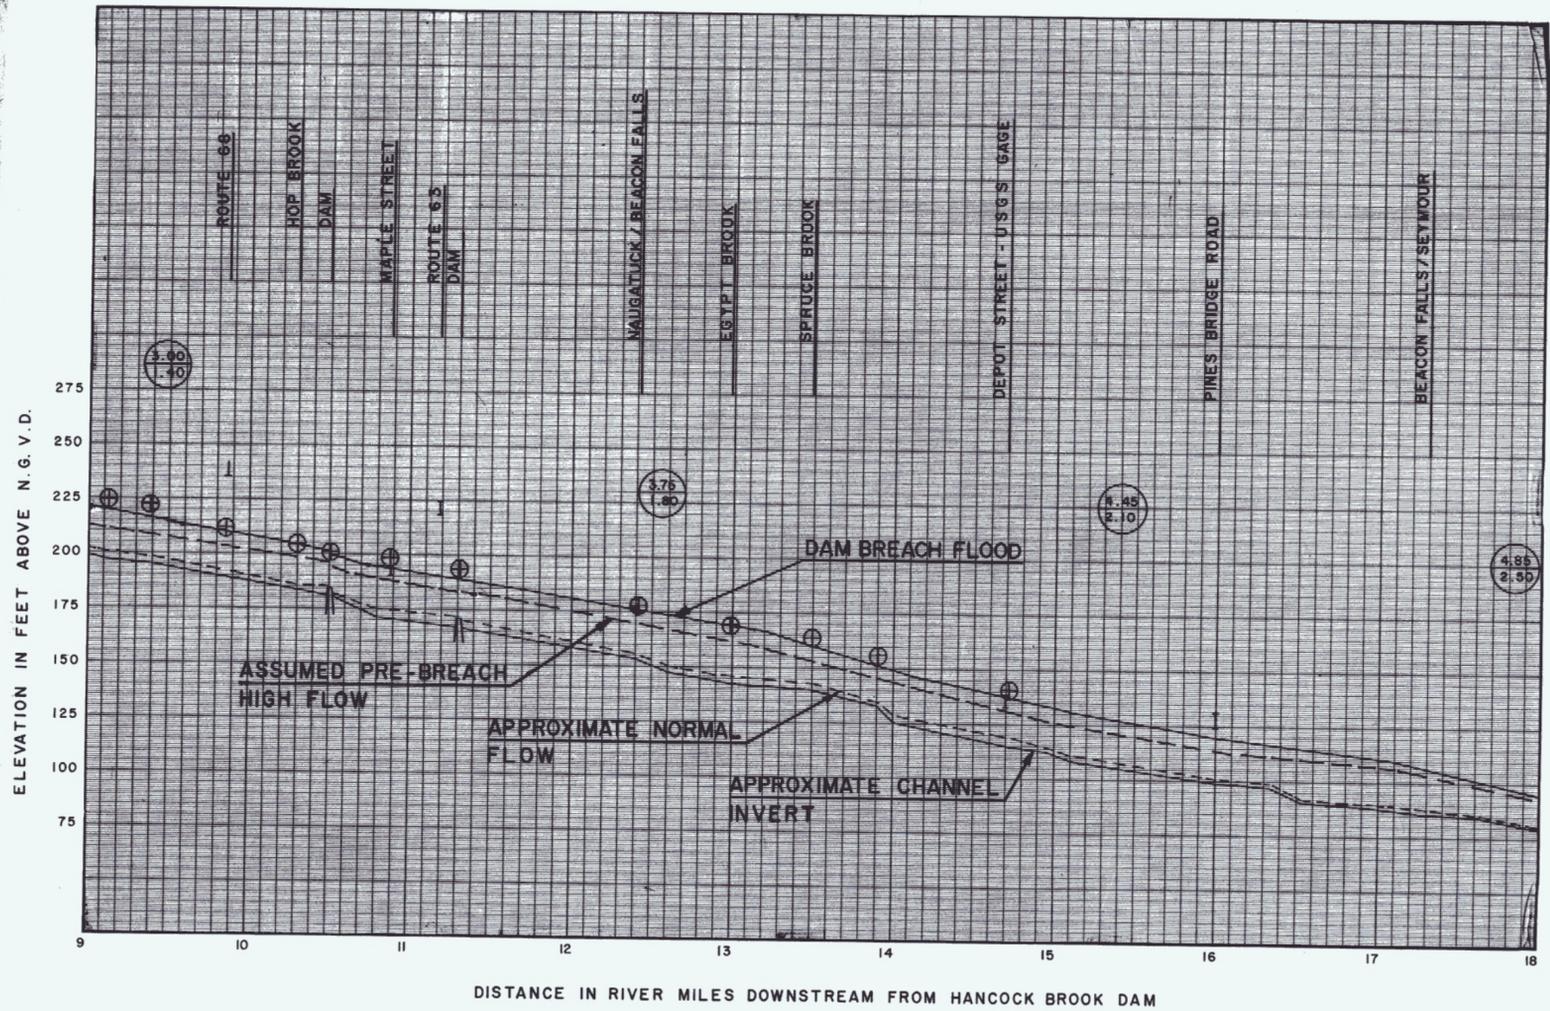
- ⊕ EXPERIENCED AUGUST 1955 FLOOD ELEVATIONS
- ⊕ 3.75 HOURS FROM START OF FAILURE
- ⊕ 1.80 HOURS TO INITIAL RIVER RISE
- ☾ LIMITS OF BREACH FLOOD
