LAKE KONOMOC DAM

CT. 00152

PHASE I INSPECTION REPORT  
NATIONAL DAM INSPECTION PROGRAM

JUNE 1979

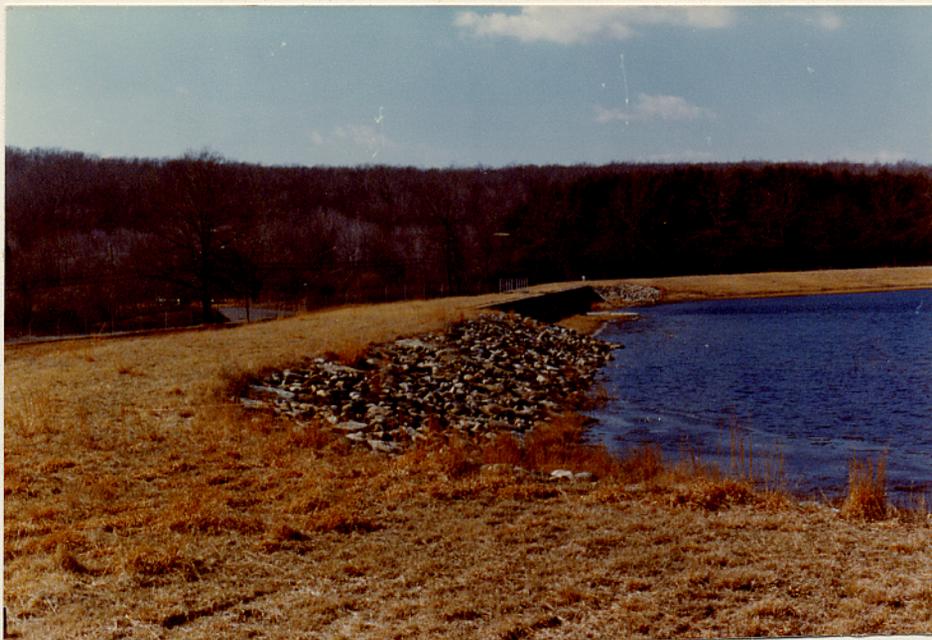
Overview from Left Abutment

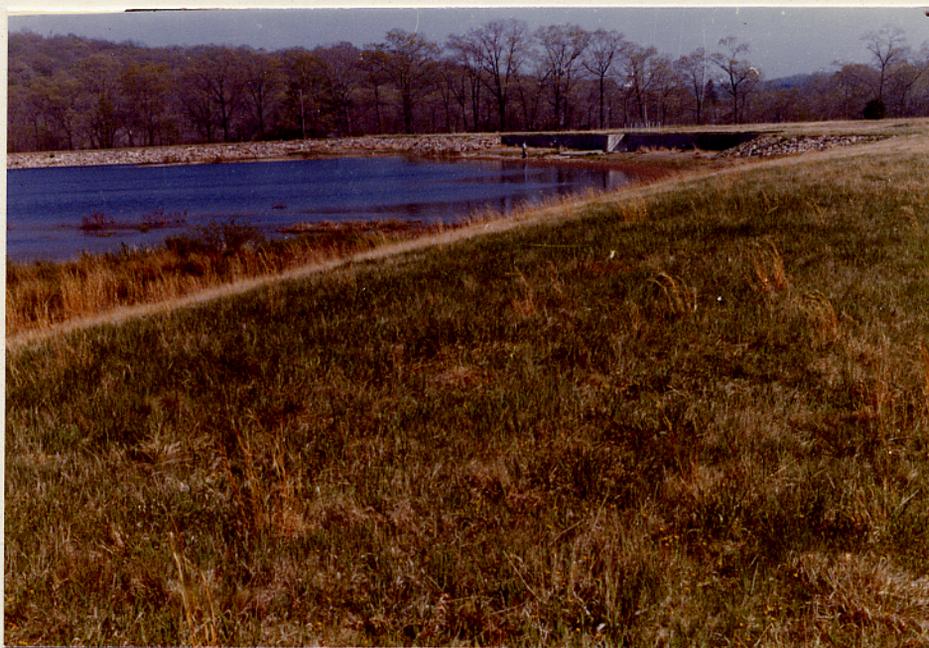
Overview from Right Abutment

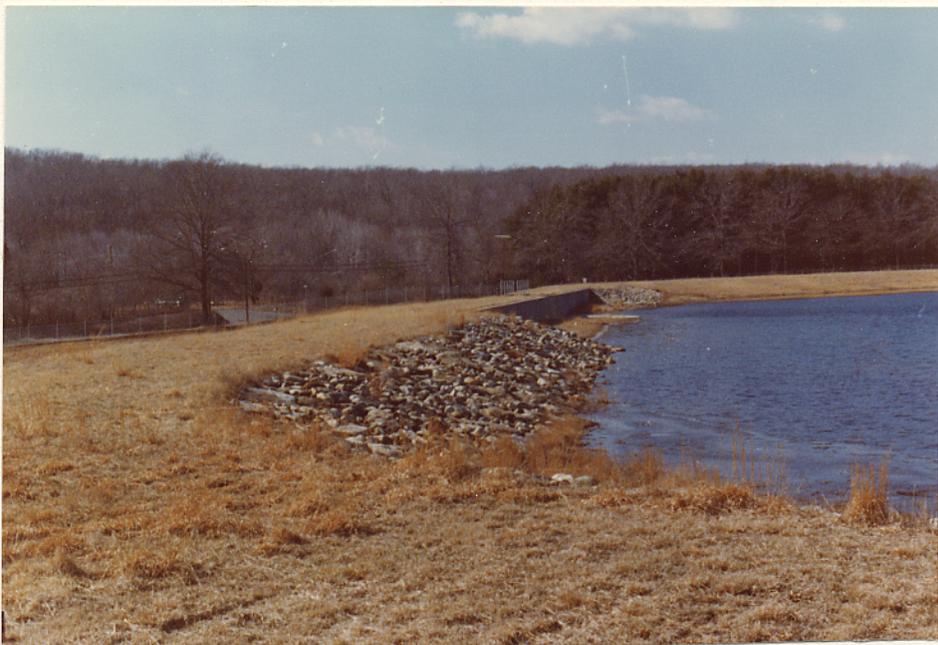
Overview from Left Abutment

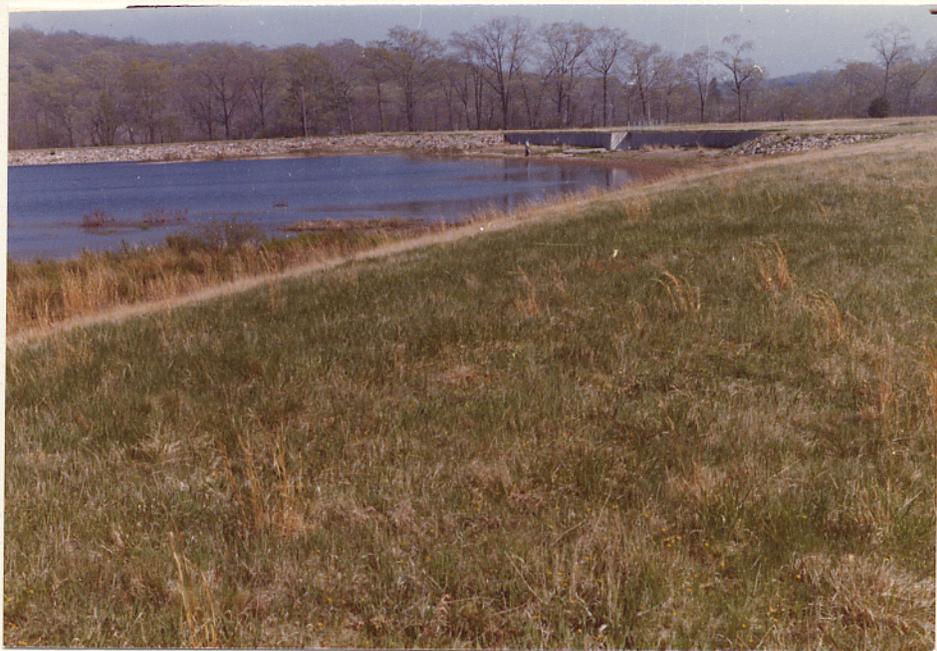
Overview from Right Abutment

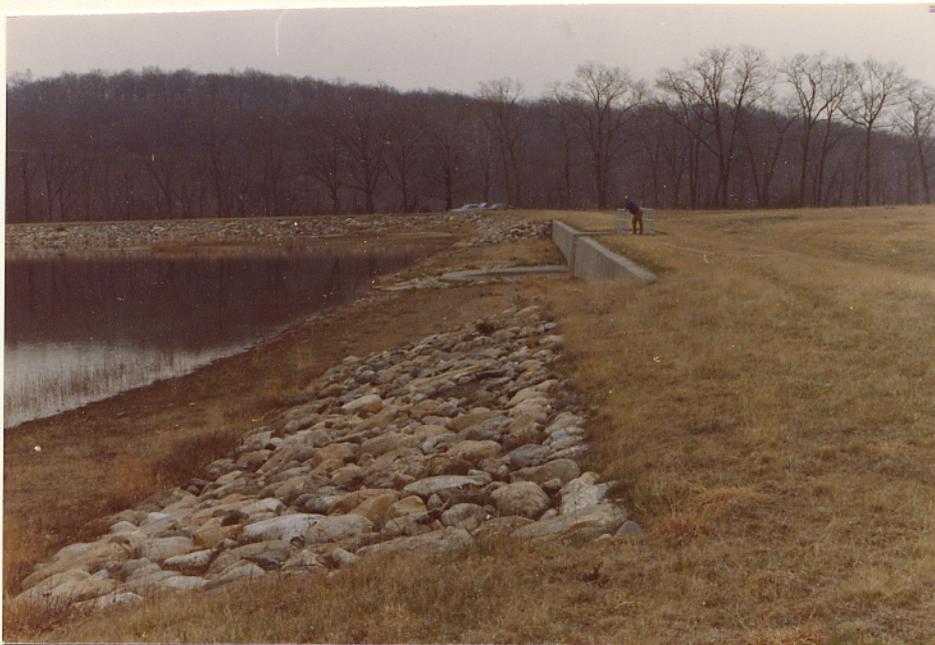
1. Upstream face of dam and left abutment dike.

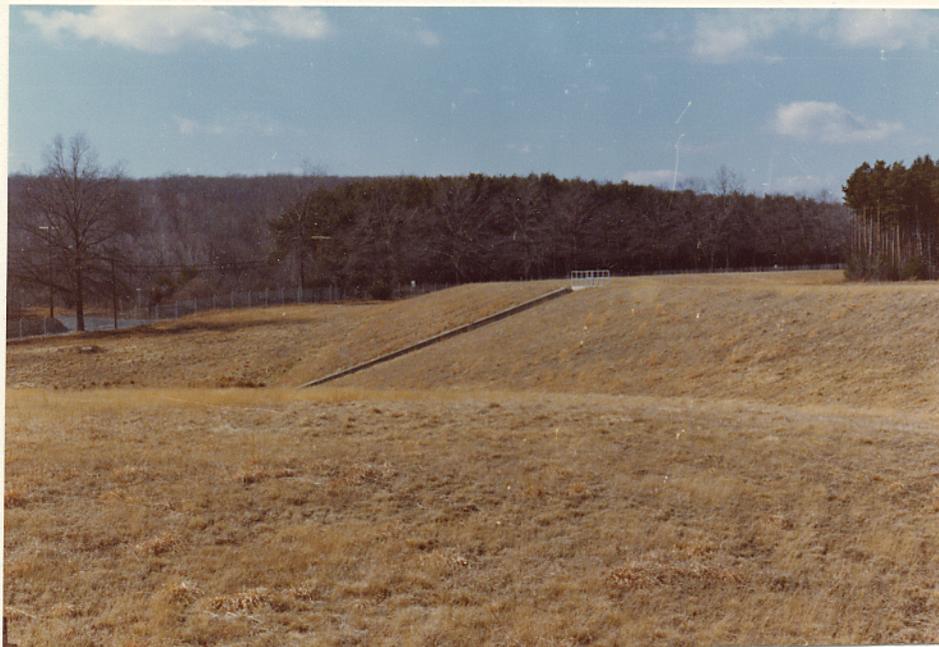
2. Downstream face of dam.

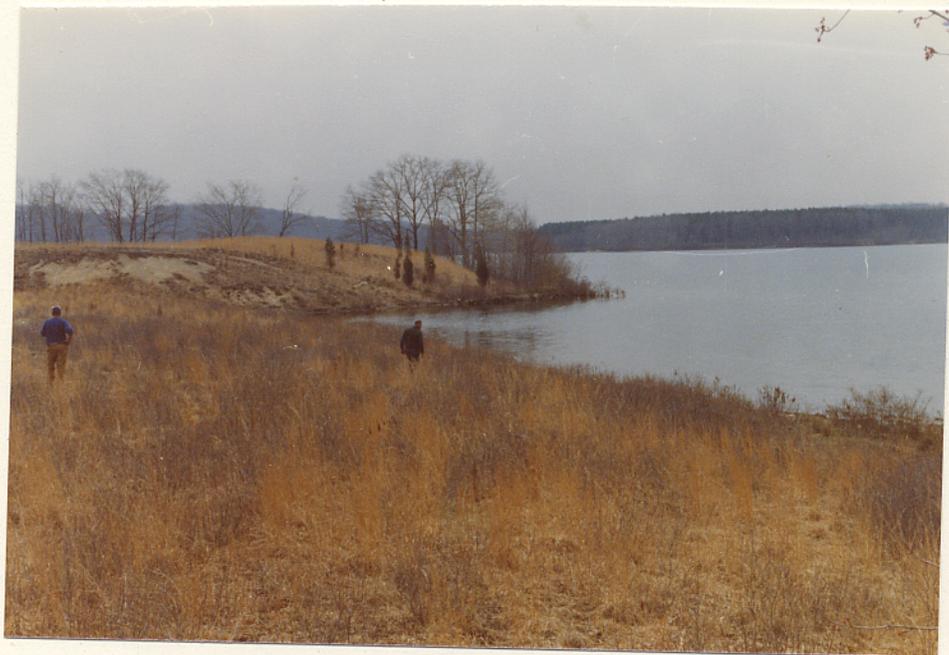
6. Upstream face of Great Swamp Dike.

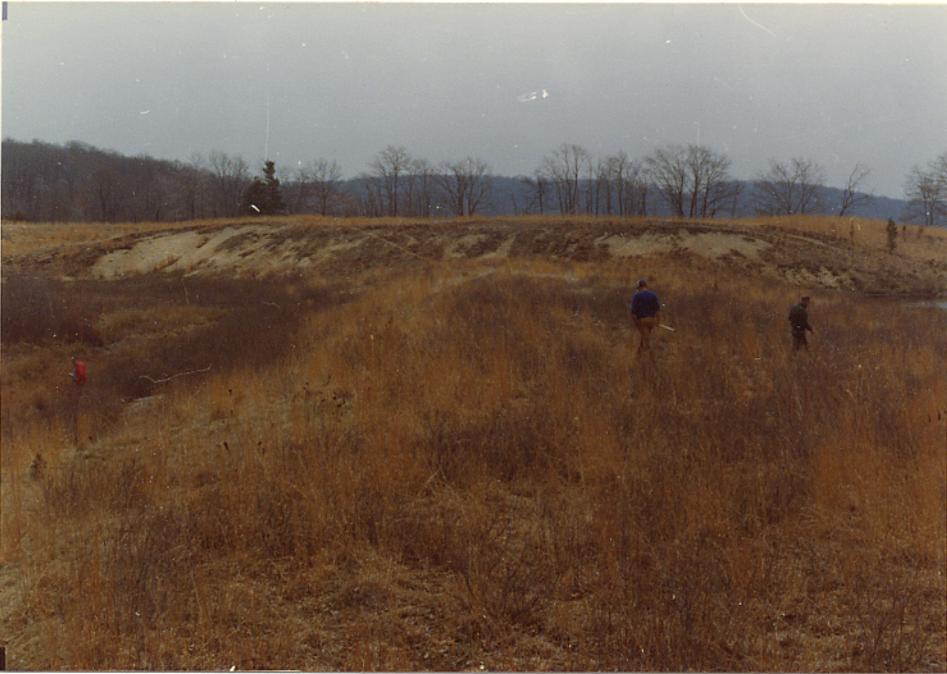
7. Downstream face of Great Swamp Dike.

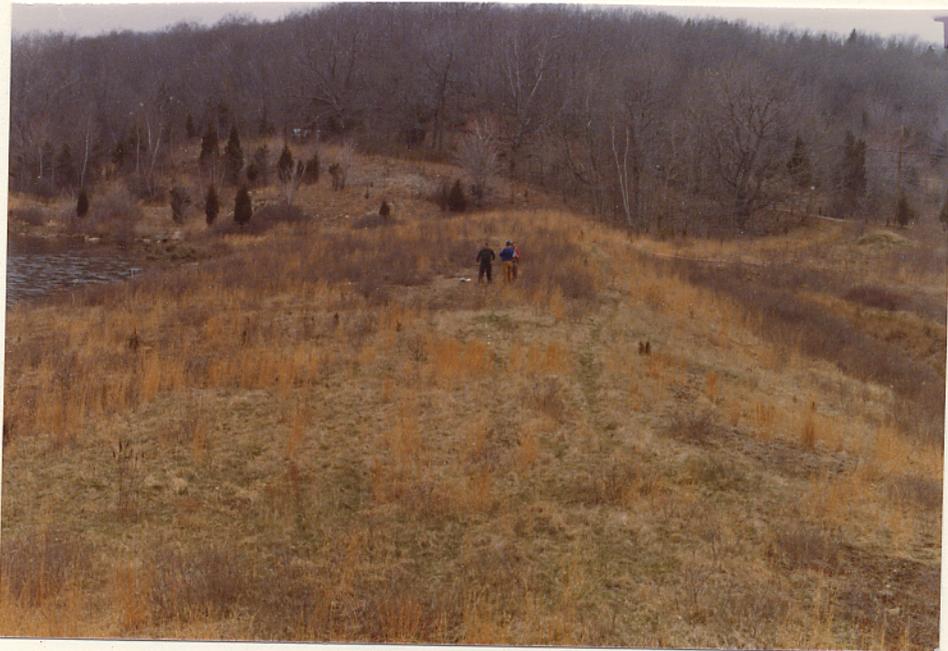
8. View along crest of Great Swamp Dike.

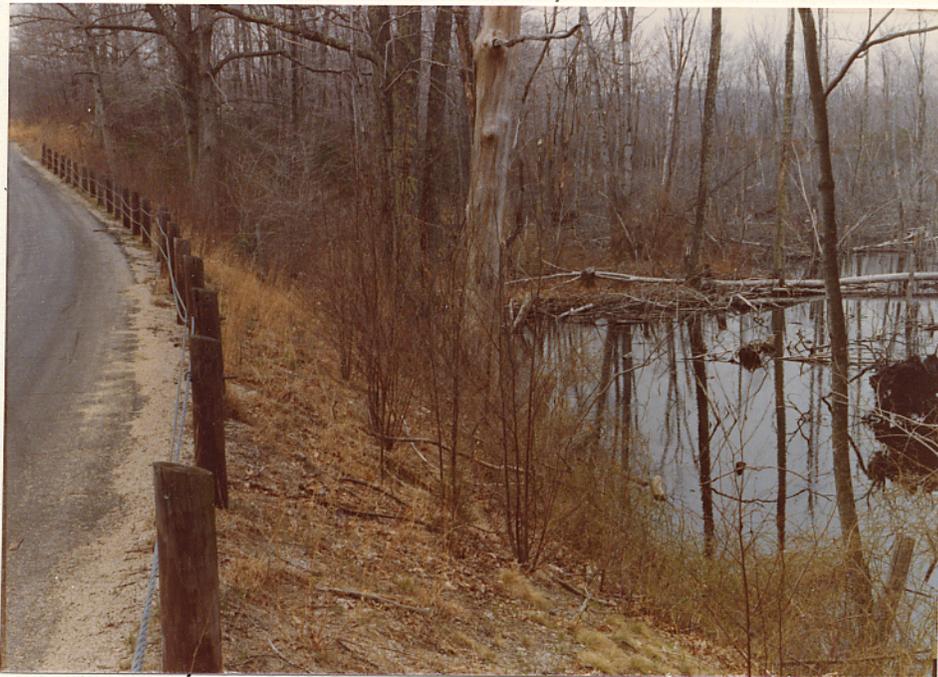
10. Downstream face of Davis Pond Dike.

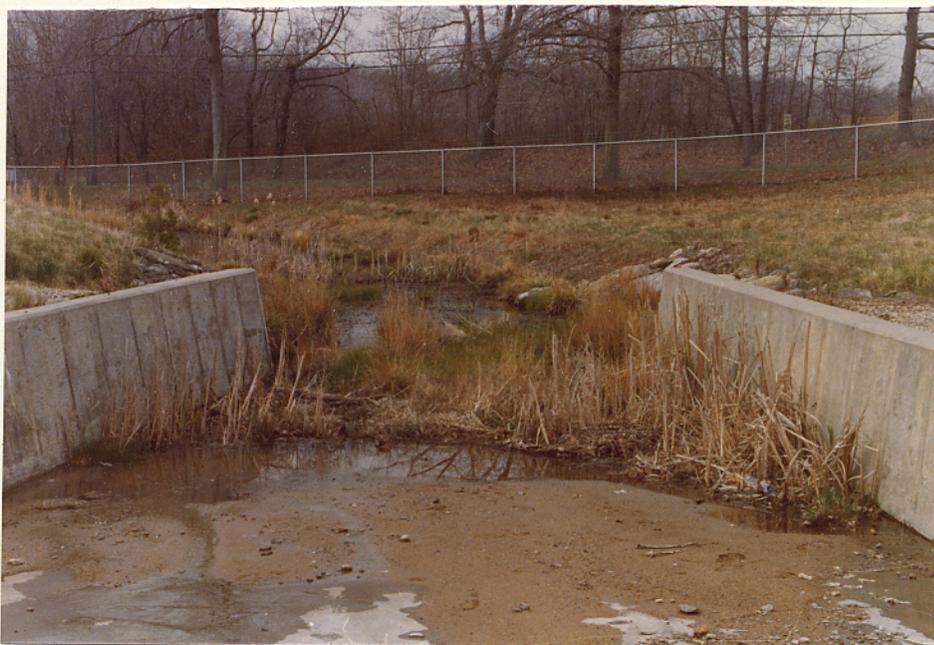
16. Downstream spillway channel.
